Appendix B – Photographs

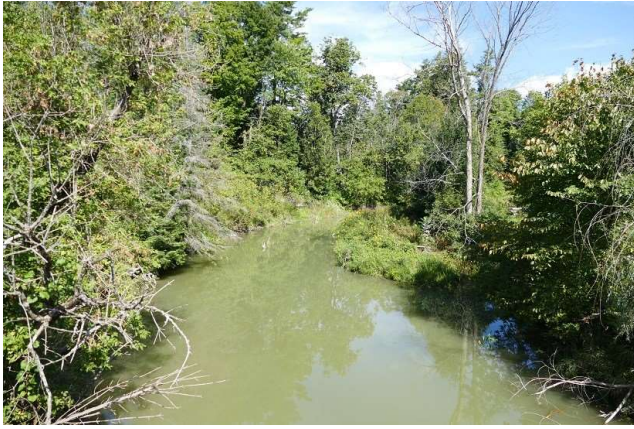
9

Becketts' Creek – views downstream (9) and upstream (10) from Wilhaven Drive. Views downstream (11) and upstream (12) from French Hill Road. Views downstream (13) and upstream (14) of Birchgrove Road. Photo 15 shows a low flow assessment being carried out at Birchgrove Road 560 m south of Etienne Road.

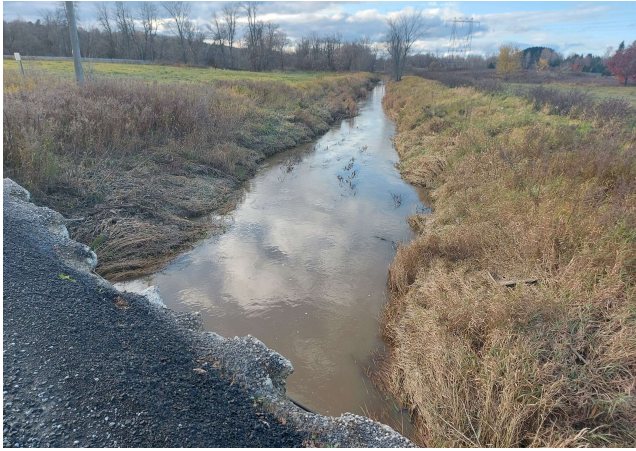
16

Beckett's Creek – views downstream (16) and upstream (17) from Etienne Road.

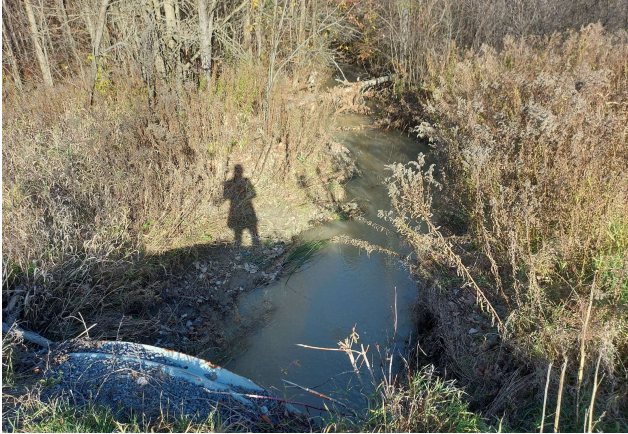
18

Beckett's Creek Tributaries – views downstream (18, 19) and upstream (20, 21) of various tributaries along Emmett Road. Photos 19, 21 and 22 show examples of culverts in need of rehabilitation.

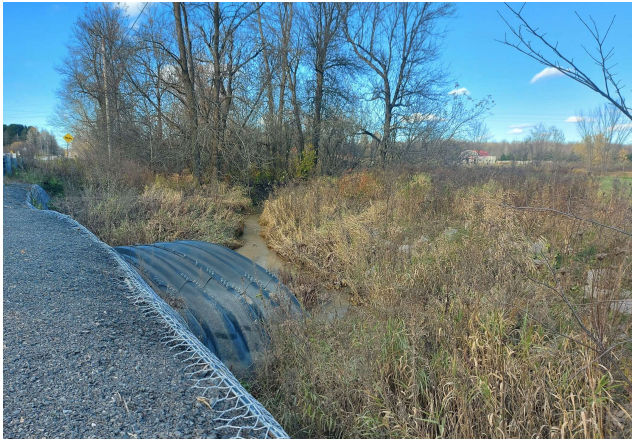
23

Beckett's Creek Tributaries – views downstream (23) and upstream (24) from Birchgrove Road north of Etienne Road. Views downstream (25) and across fields (26) from Sarsfield Road south of Beaton Road. Significant woodland visible on the horizon (26). Views downstream (27) and upstream (28) from Canaan Road, south of Oakwood Drive, showing very minimal flows.

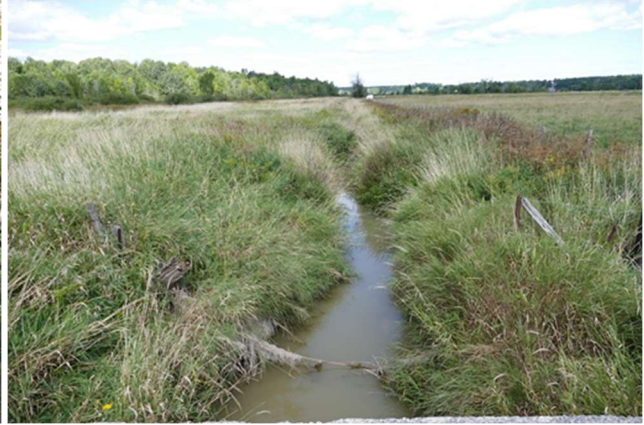
32

Municipal Drains – view of D. LeGault Drain downstream of Birchgrove Road showing submerged culvert (29). View of Beckett Creek Drain downstream (30) along Canaan Road north of Etienne Road. Culvert is perched, making fish passage difficult, and is rusted through in places (31). View of Beckett Creek Drain upstream from Etienne Road (32). View of Mercier Branch Drain north of Innes Road to the west (33) and east (34). Portion of drain has since been cleaned out (34). View of culvert, showing stagnant conditions, along Theodule Vachon Drain at Dunning Road (35).

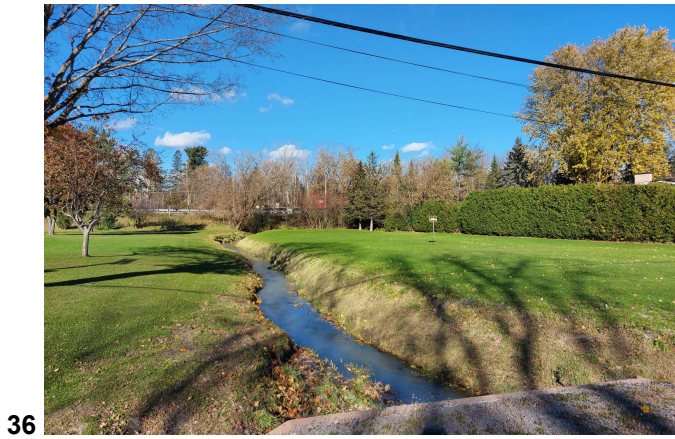
36

Catchment A – views downstream from Old Montréal Road (36) and upstream from Pierrette Drive (37) within Hillside Estates.

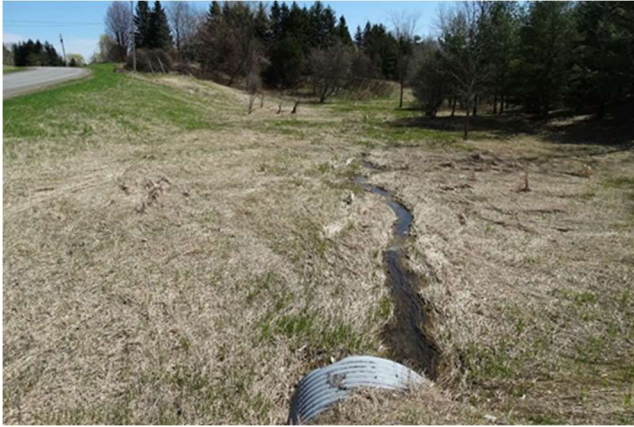
38

Catchment C – view downstream from Kinsella Drive south of Golightly Terrace (38). View upstream from Kinsella Drive east of Byrnes Terrace (39). View downstream from Old Montréal Road (40).

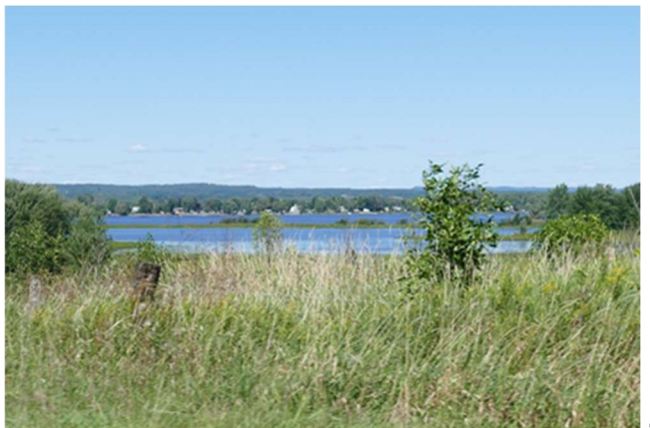
Photo 41 shows a view of the Ottawa River, from Regional Road 174, towards the western extent of the Baie Lafontaine Provincially Significant Wetland.

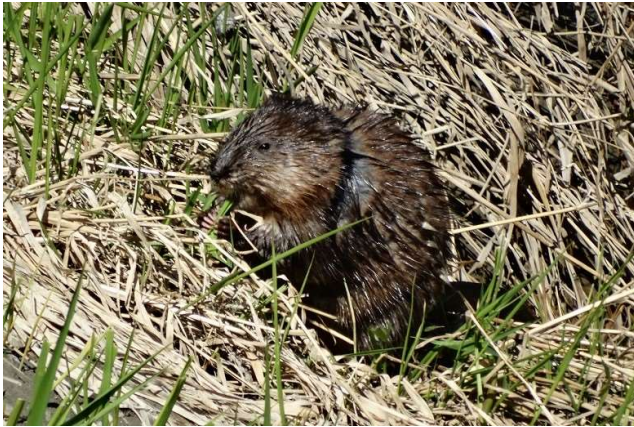
Wildlife – Photo 42 shows a muskrat grazing by Beckett's Creek downstream of Old Montréal Road. Photo 43 shows an eastern kingbird near Beckett's Creek at Wilhaven Drive; yellow-rumped warbler, tree swallow, mallard and robin were also observed. Photo 44 shows a ruffed grouse observed along Lough Drive. Photo 45 shows a monarch butterfly, a species of special concern, on a willow shrub near Beckett Creek Drain. Photo 46 shows a northern leopard frog near Beckett's Creek along French Hill Road. Photo 47 shows a school of minnows in a pool of a small tributary to Beckett's Creek downstream of McTeer Road. In smaller tributaries, pools often provide refuge for small fish, frogs and other aquatic life during low-flow periods. Photos 42-44 were taken on May 6, 2014. Photos 45-47 were taken on September 7, 2018.
