# Tree Information Report v2.0

Submitted as part of Building Permit Application for the City of Ottawa

**Address:** 514 Manor

**Date:** March 31, 2023

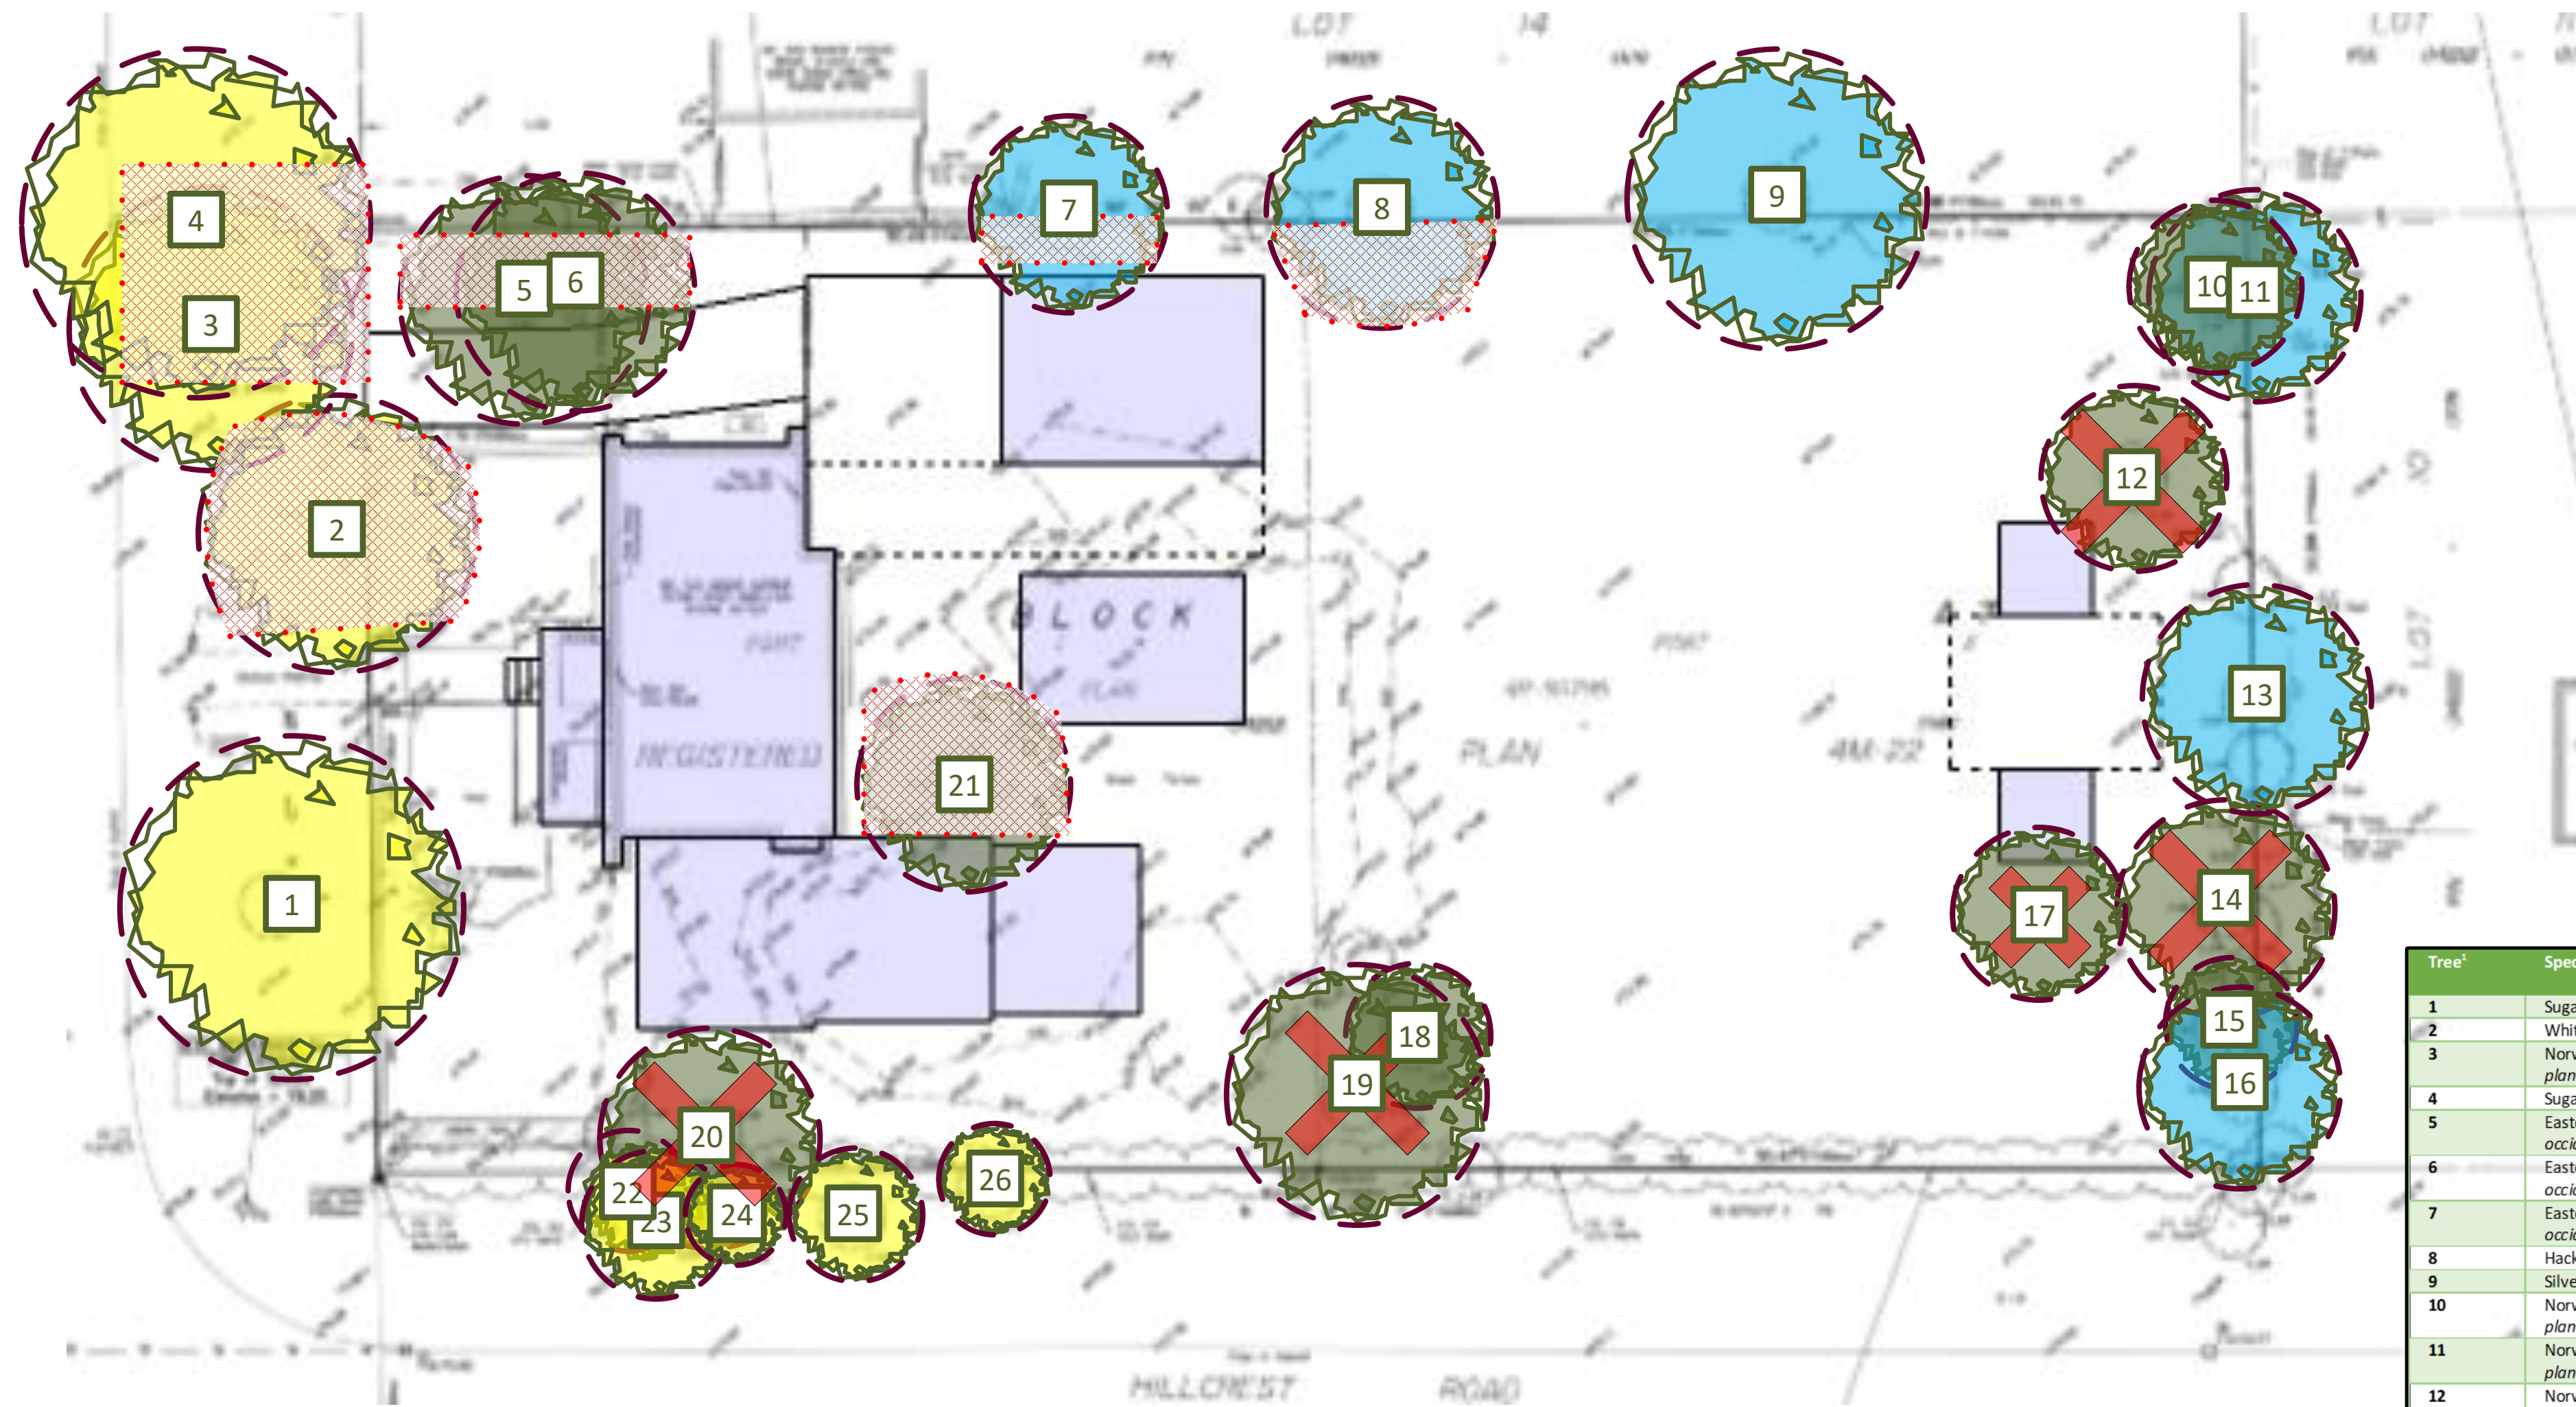
Tree#	Species	Diameter at breast height (cm)	Arborist Recommendations
1	Sugar maple ( <i>Acer saccharum</i> )	52	Contact city for removal
2	White spruce ( <i>Picea glauca</i> )	42	Retain and protect as per City of Ottawa Tree Protection Specifications (March 2021)
3	Norway maple ( <i>Acer platanoides</i> )	43	Retain and protect as per City of Ottawa Tree Protection Specifications (March 2021)
4	Sugar maple ( <i>Acer saccharum</i> )	53	Retain and protect as per City of Ottawa Tree Protection Specifications (March 2021)
5	Eastern white cedar ( <i>Thuja occidentalis</i> )	37	Retain and protect as per City of Ottawa Tree Protection Specifications (March 2021)
6	Eastern white cedar ( <i>Thuja occidentalis</i> )	37	Retain and protect as per City of Ottawa Tree Protection Specifications (March 2021)
7	Eastern white cedar ( <i>Thuja occidentalis</i> )	30 (estimate)	Retain and protect as per City of Ottawa Tree Protection Specifications (March 2021)

8	Hackberry ( <i>Celtis occidentalis</i> )	35 (estimate)	Retain and protect as per City of Ottawa Tree Protection Specifications (March 2021)
9	Silver maple ( <i>Acer saccharinum</i> )	45 (estimate)	No action required; far enough from proposed construction
10	Norway maple ( <i>Acer platanoides</i> )	26	No action required; far enough from proposed construction
11	Norway maple ( <i>Acer platanoides</i> )	32	No action required; far enough from proposed construction
12	Norway maple ( <i>Acer platanoides</i> )	28	Recommend removal based on health and invasive species – <b>no permit required for removal</b>
13	Norway maple ( <i>Acer platanoides</i> )	35, 18, 15	Retain and protect as per City of Ottawa Tree Protection Specifications (March 2021)
14	Norway maple ( <i>Acer platanoides</i> )	33	Remove based on health and invasive species – <b>Tree Permit required for removal</b>
15	Eastern white cedar ( <i>Thuja occidentalis</i> )	20	No action required; far enough from proposed construction

16	Eastern white cedar ( <i>Thuja occidentalis</i> )	30	No action required; far enough from proposed construction
17	Norway maple ( <i>Acer platanoides</i> )	27	Remove based on health and invasive species – <b>no permit required for removal</b>
18	Norway maple ( <i>Acer platanoides</i> )	22	Retain; if removal preferred due to poor species (invasive), no permit required for removal
19	Norway maple ( <i>Acer platanoides</i> )	40	Remove based on health and invasive species – <b>Tree Permit required for removal</b>
20	Norway maple ( <i>Acer platanoides</i> )	33	Remove based on health and invasive species – <b>Tree Permit required for removal</b>
21	Bur oak ( <i>Quercus macrocarpa</i> )	32	Retain and protect during all site works as per City of Ottawa Tree Protection Specifications (March 2021); reduce excavation within CRZ and pre-sever any roots prior to excavation); recommend soil aeration and deep root fertilizer a year after construction

Note that the tree layer has been added to the original survey plan supplied by the client in pdf format. This layer refers to the trees only, and the original survey plan has not been altered in the process. Refer to the original plan for details on grading as quality is lost when importing the plan into the mapping software used to create the tree layer.  
Note: the location of tree 17 has been estimated
