December 5, 2022

Tree Information Report – 28 Oakridge Street

28-30 OAKRIDGE BOULEVARD
 NEPEAN ONTARIO
TREE INFORMATION REPORT

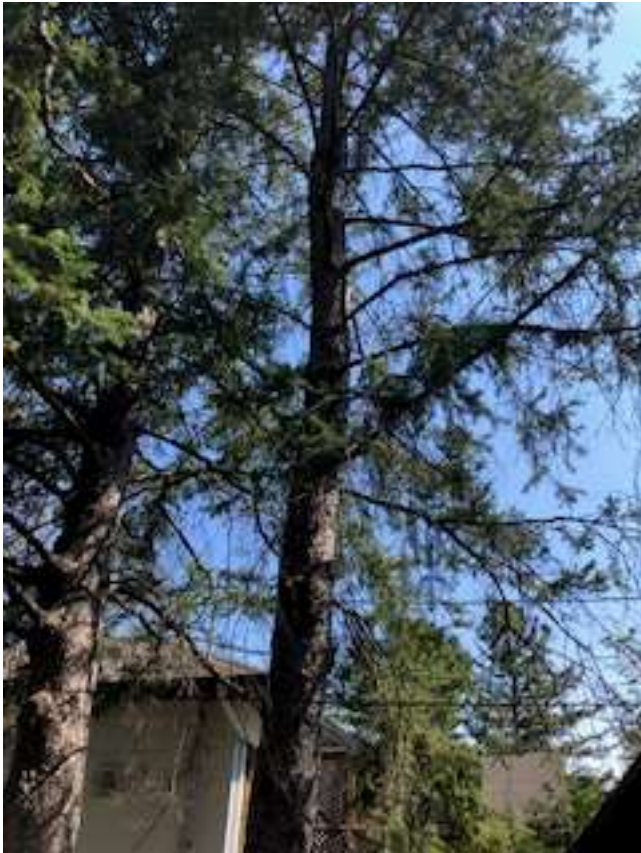
Tree #16

15	Locust	49	Private	Decay in trunk, co dominate stems, structure is poor. Health and vigour are fair. Significant deadwood present.	Conflict with construction.	Remove - conflict. Overall condition is poor.
16	White Spruce	40	Private	Borer damage present, causing decline. Health and vigour are fair.	Conflict with construction.	Remove - conflict.
17	White spruce	55	Private	Borer damage present, causing decline. Health and vigour are fair.	Conflict with construction.	Remove - conflict.
<p>*In addition to above trees there are 3 trees on the property that are dead, and will be removed.</p> <p>*Along west side sucker trees owned by neighbour to be retained, mt.ash, Norway maple, buckthorn, all under 10cm dbh. Construction fencing will protect CRZ.</p> <p>*Along south side, lilacs owned by neighbour to be retained, all under 10cm dbh. Construction fencing will protect CRZ.</p> <p>The following are measures to be implemented prior and during the construction process.</p> <ul style="list-style-type: none"> -Critical root zone of retained trees must be protected as outlined above. Snow or metal fencing must be erected around the CRZ and signage should be installed to identify tree is being protected. -Pruning must be performed prior to construction to ensure tree limbs will not be in conflict with equipment and construction. Permission must be obtained to prune Municipal or neighbors trees. (performed by Certified Arborist). -No material or equipment is permitted within any CRZ. -No signs, notices or posters may be attached to the tree. -No grade changes within any CRZ. -Ensure exhaust fumes from equipment are not directed towards tree canopy's.
