Tree Information Report

Submitted as part of Committee of Adjustment Application to the City of Ottawa

Address: 1044 Secord Ave
Date of Report: November 17, 2022
Date of Site Visit: October 26, 2022
Prepared by: Astrid Nielsen, RPF, ISA Certified Arborist®
131 Smirle Ave, Ottawa, K1Y 0S4
Astrid.nielsen@dendronforestry.ca
Client: Cesare Santaguida, ces@vsclimited.com

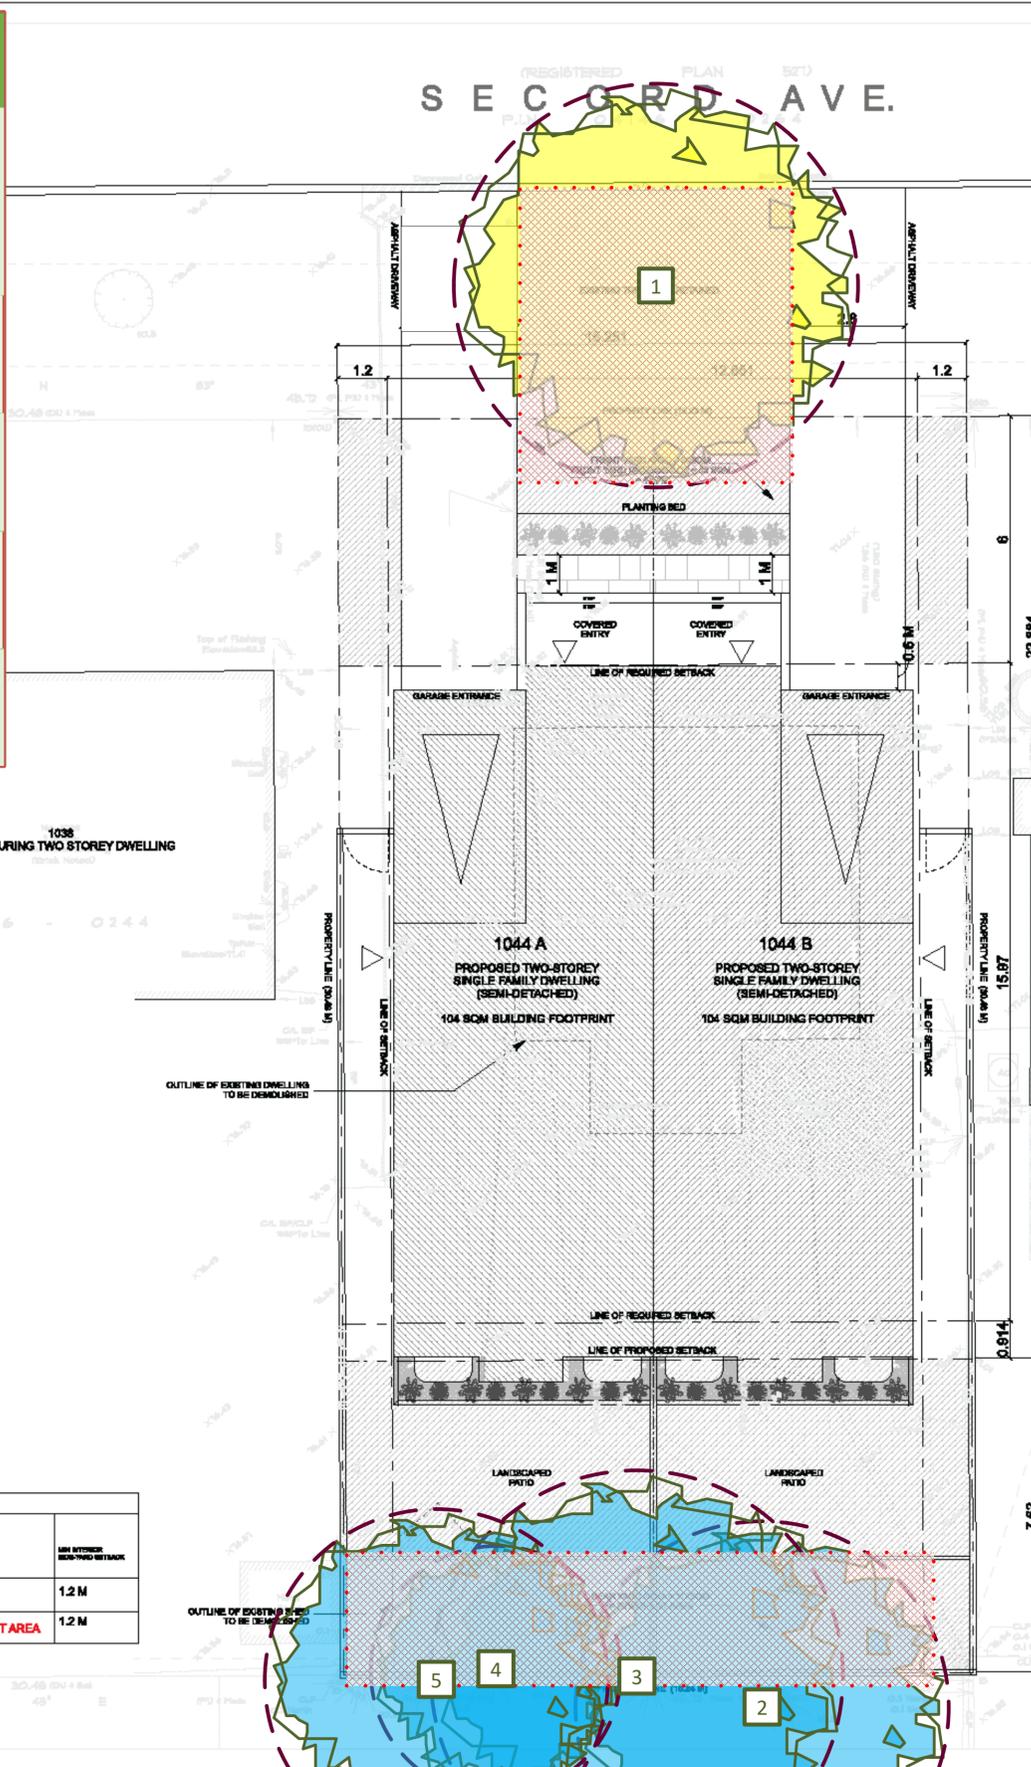
Tree ¹	Species	Diameter at breast height (cm)	Arborist Recommendations
1	Norway maple (<i>Acer platanoides</i>)	47 cm	Removal and replace with a new tree post construction is recommended; if tree is retained mitigation measures include placing services under driveway, capping existing services out of the CRZ and arborist to pre-sever roots prior to driveway construction
2	White pine (<i>Pinus strobus</i>)	48 cm	Retain and protect with City of Ottawa Tree Protection Specifications (March 2021); recommend pruning of dead and failing branches
3	White pine (<i>Pinus strobus</i>)	55 cm	Retain and protect with City of Ottawa Tree Protection Specifications (March 2021); recommend pruning of dead and failing branches
4	Scots pine (<i>Pinus resinosa</i>)	31,32 cm	Retain and protect with City of Ottawa Tree Protection Specifications (March 2021); recommend pruning of dead and failing branches
5	White pine (<i>Pinus strobus</i>)	44 cm	Retain and protect with City of Ottawa Tree Protection Specifications (March 2021); recommend pruning of dead and failing branches
