Tree Information Report

Prepared by Colleen Eames, Arborist.
Arborist Consulting Ottawa
arboristconsultingottawa@gmail.com
613-884-3394

Tree Owner	Ashwin Jain
Tree Owner's address and contact	Ashwin.jain@owlpark.ca
Address of Tree(S)	6817 Notre Dame St, Orleans
Date of Inspection:	July 22, 2021
Reason for application	Infill development
Boundary trees or trees on neighbouring properties.	Yes, see below
Regulations	None, no butternut present.

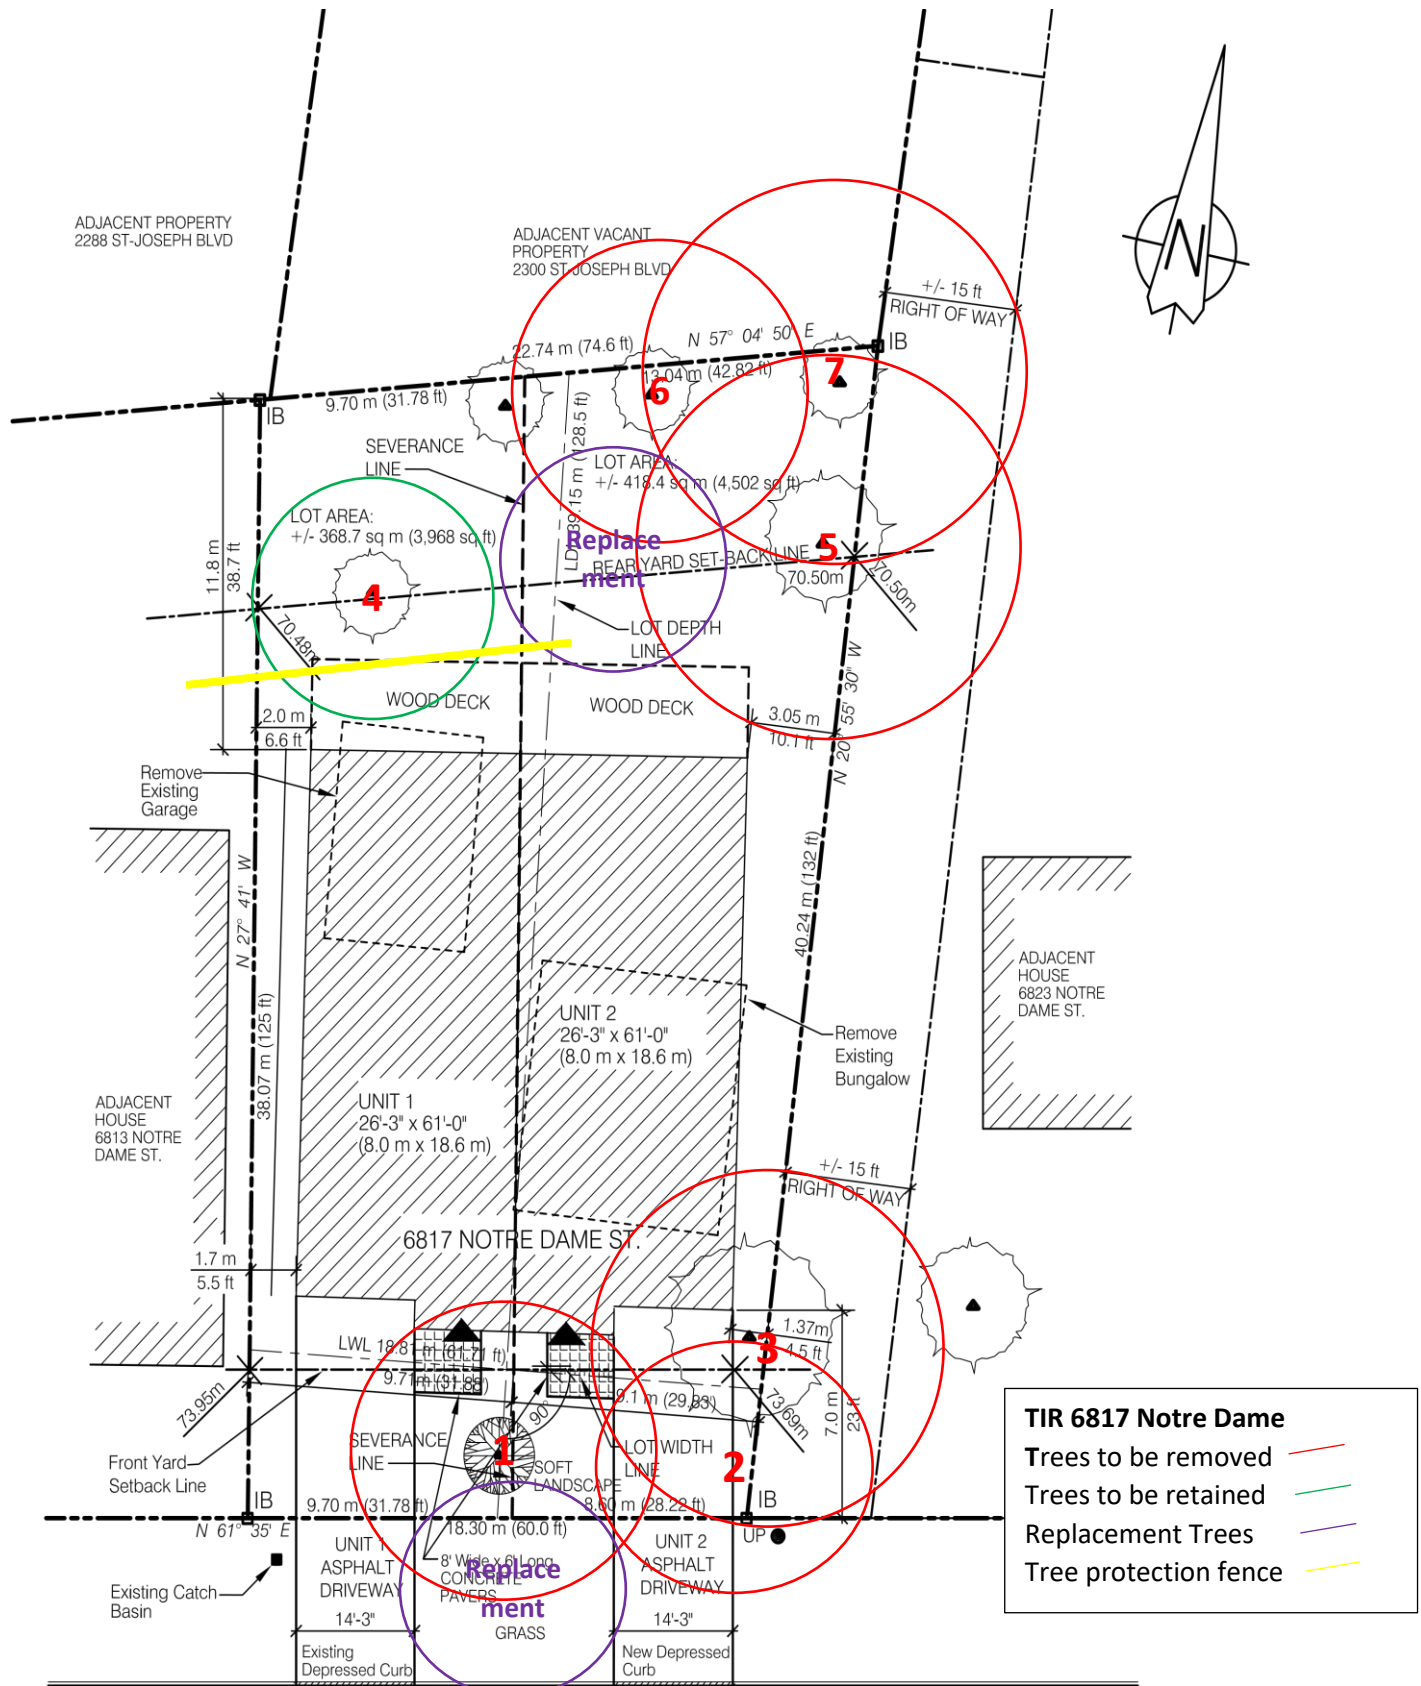
Tree #6, Manitoba maple behind existing shed in back, 67cm. Has rot at joining of two main stems and dead branches. Removal recommended.
