URBAN FORESTRY & FOREST MANAGEMENT CONSULTING

April 5, 2022

RE: TREE INFORMATION REPORT (FULL) FOR 131 WINDING WAY

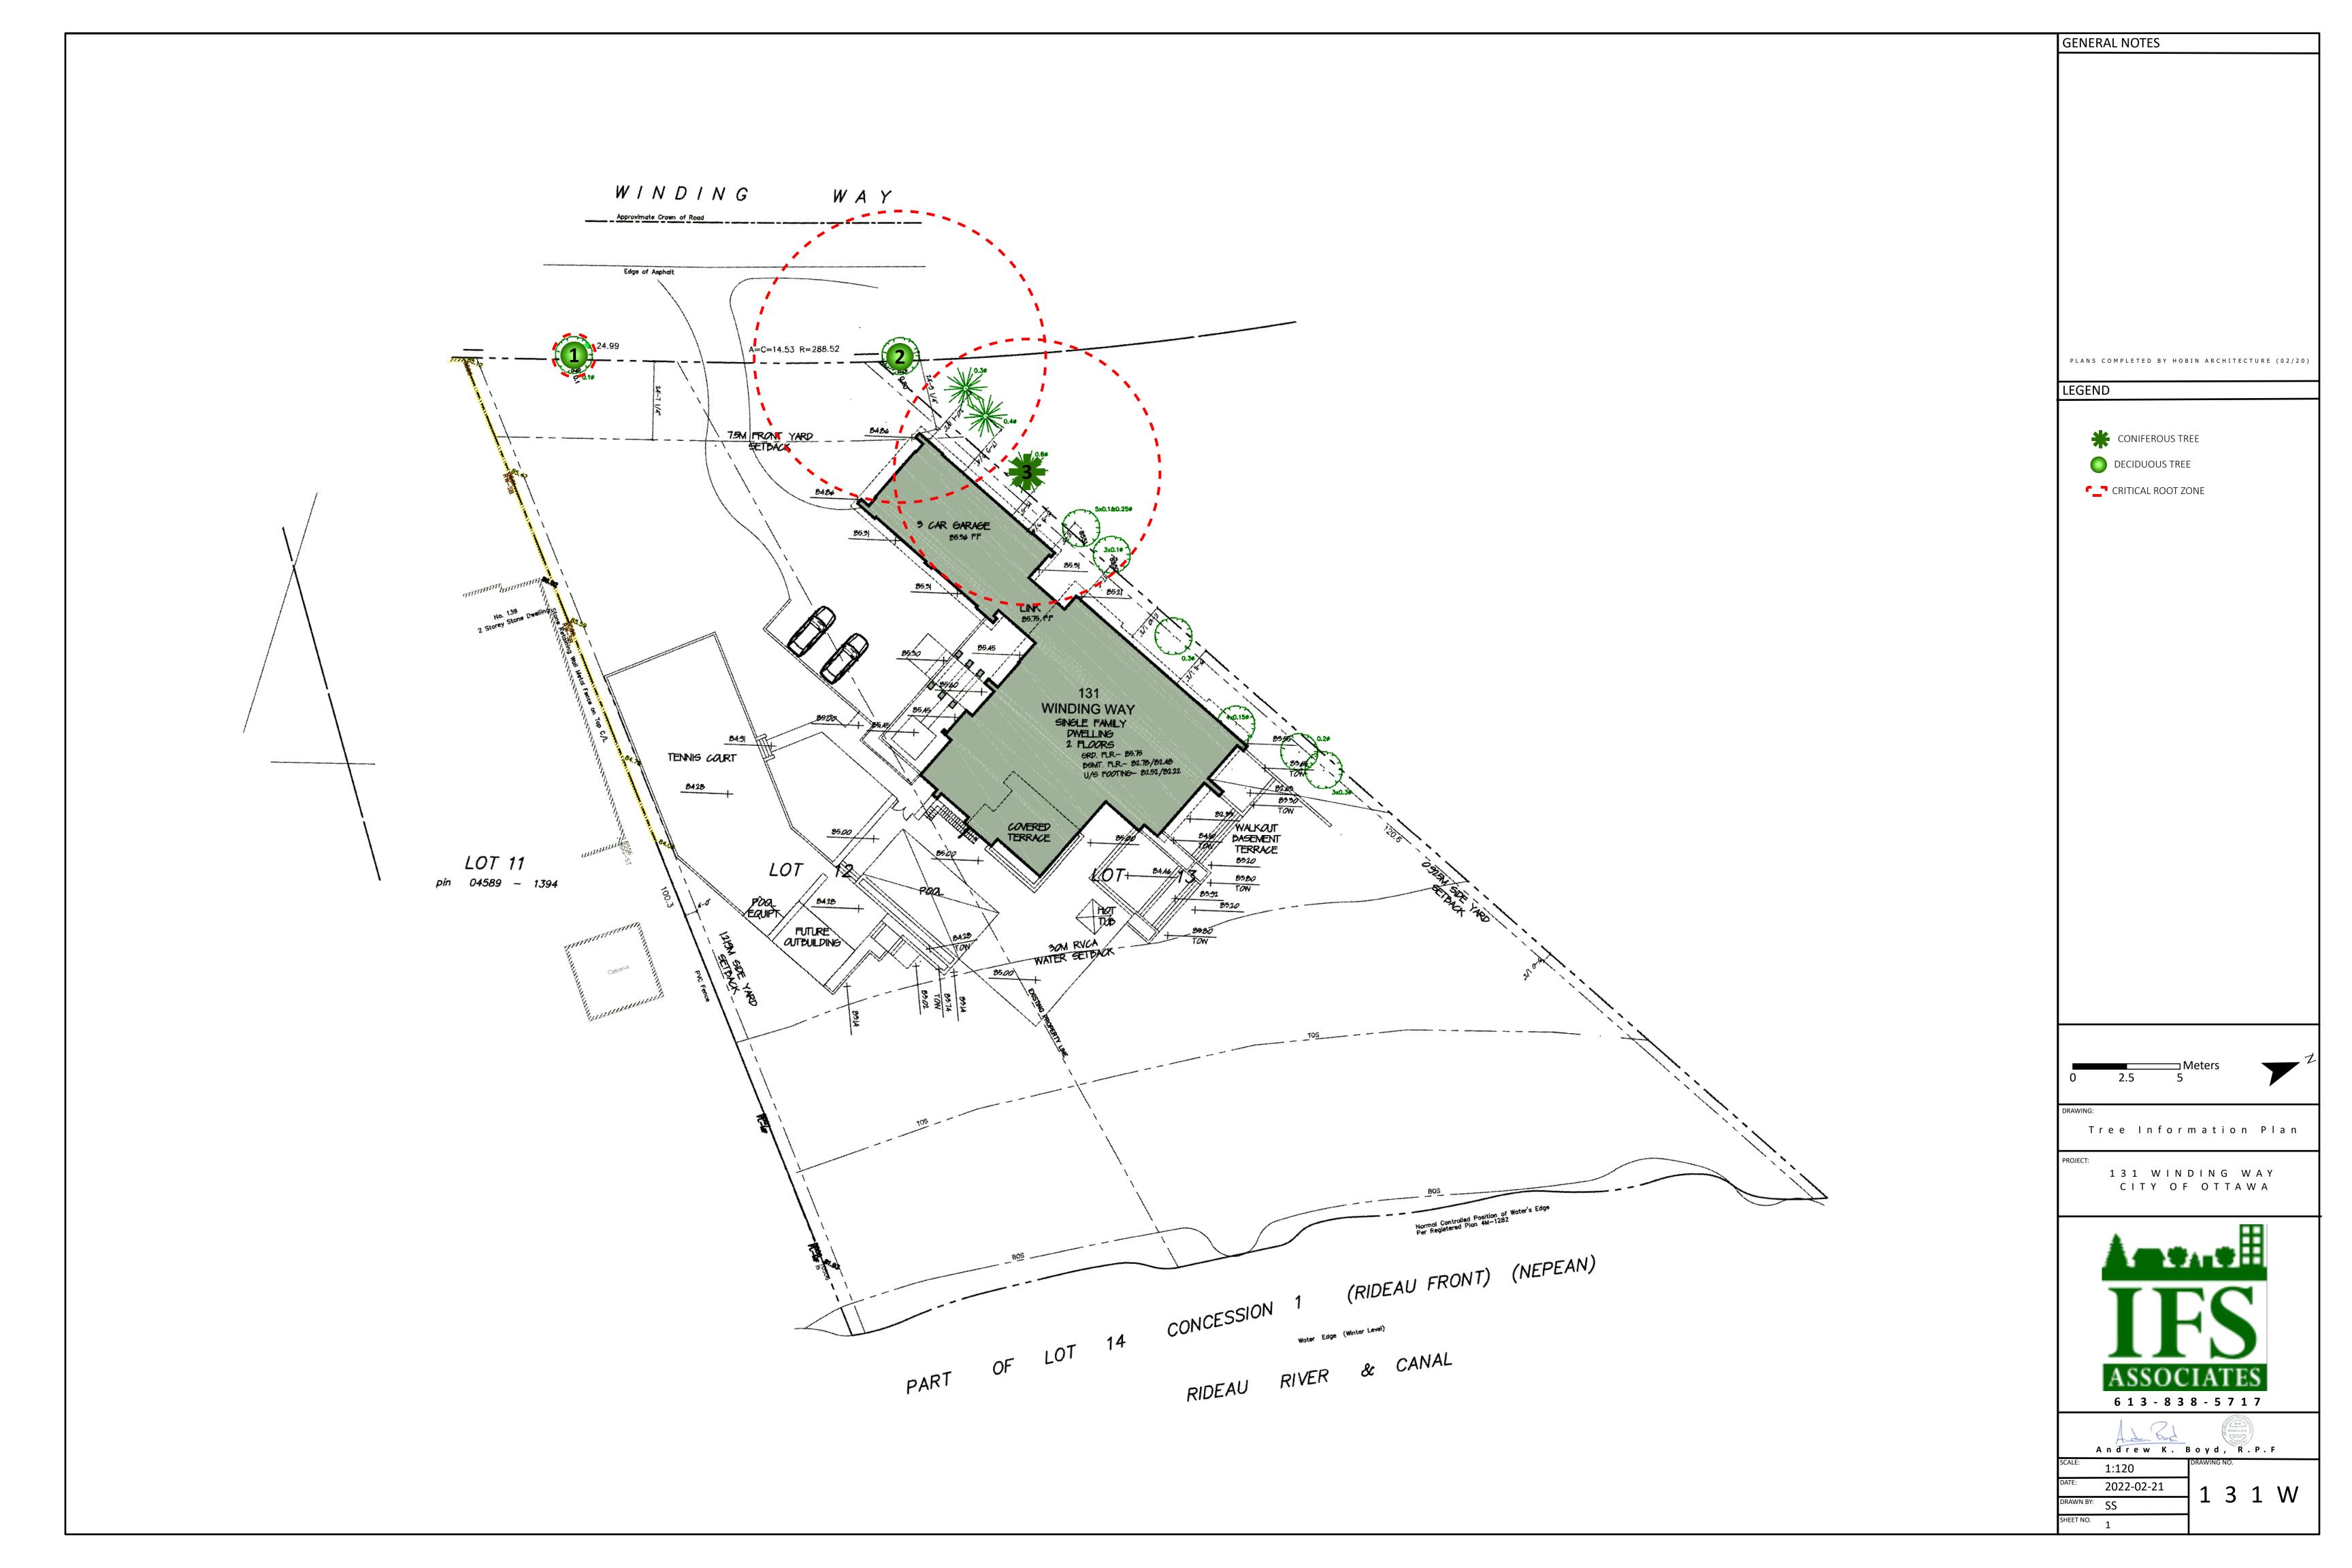
Picture 1. Red maple (tree #2) on City property adjacent to 131 Winding Way (photograph taken March 2021)

As the CRZ of trees #2 and 3 conflict with the excavation necessary for the proposed garage, measures intended to mitigate long-term damage to these trees will centre on minimizing root loss. To this end the following measure is recommended to promote their survival during and following construction:

1. Use of hydro excavation along the garage foundation in closest proximity to the trees so as to carefully expose any roots. This will allow any unearthed roots to be properly cut and sealed before being reburied. Excavation can then resume using traditional mechanical means. Sealing the cleanly cut root ends with a beeswax product will help prevent the loss of moisture and facilitate healing.
