Property is 49 Fairmont Ave., Ottawa

Inspection date: 2023-06-12

The objective of this preliminary report is to identify all protected trees on this and adjacent properties whose Critical Root Zones (CRZ's) fall within the proposed area of construction along with their condition.

Tree Information Report for 49 Fairmont Avenue, Ottawa

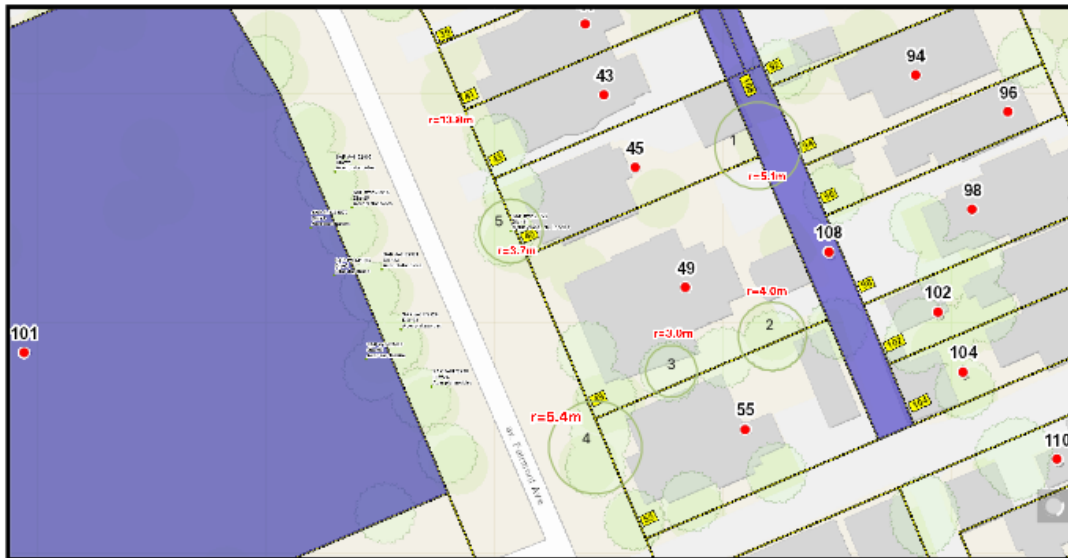
GeoOttawa Drawing #1

The site is a large city lot with a multi-unit dwelling, the front of which faces Fairmont Ave. The back property line abuts a ROW that allows access to parking for several dwellings. There are 2 protected trees on the property; a Manitoba Maple, #2 on the GeoOttawa drawing below and in Table #1 and an American elm which is #3. The neighbouring protected trees are listed below.

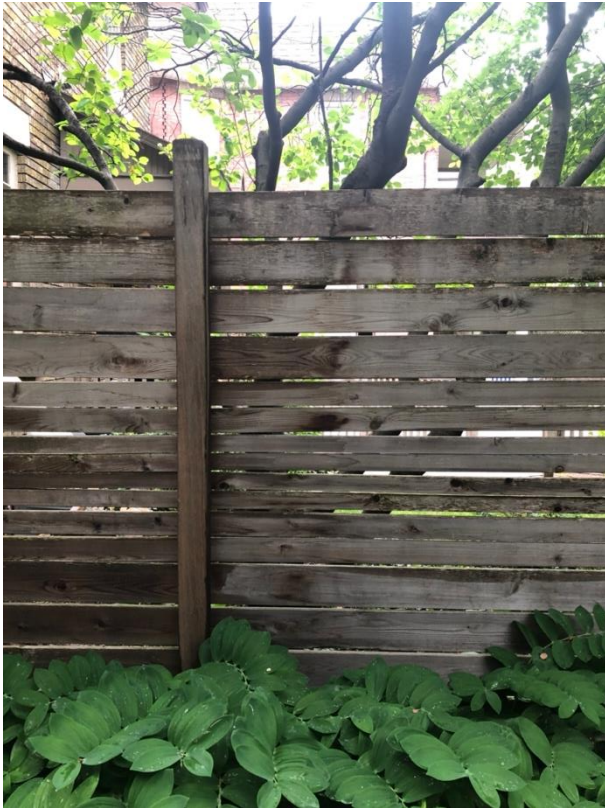
There are 3 very small trees in the backyard of 45 Fairmont. One is a multi-stemmed crab apple or serviceberry tree. See Photo 12 below.

Photo 12 View of multi-stemmed tree in back of 45 Fairmont seen through fence at 49.

The other two trees are single stem trees with dbh no more than 12-14 cm.
