## Tree Information Report

Submitted as part of Building Permit Application for the City of Ottawa

**Address:** 372 Roosevelt  
**Date:** April 5, 2022  
**Prepared by:** Astrid Nielsen, RPF, ISA Certified Arborist ®  
 131 Smirle Ave, Ottawa, K1Y 0S4  
[Astrid.nielsen@dendronforestry.ca](mailto:Astrid.nielsen@dendronforestry.ca)  
**Prepared for:** Goli Monjazebe, golchehr.monjazebe@gmail.com  
**Site Visit:** April 5, 2022

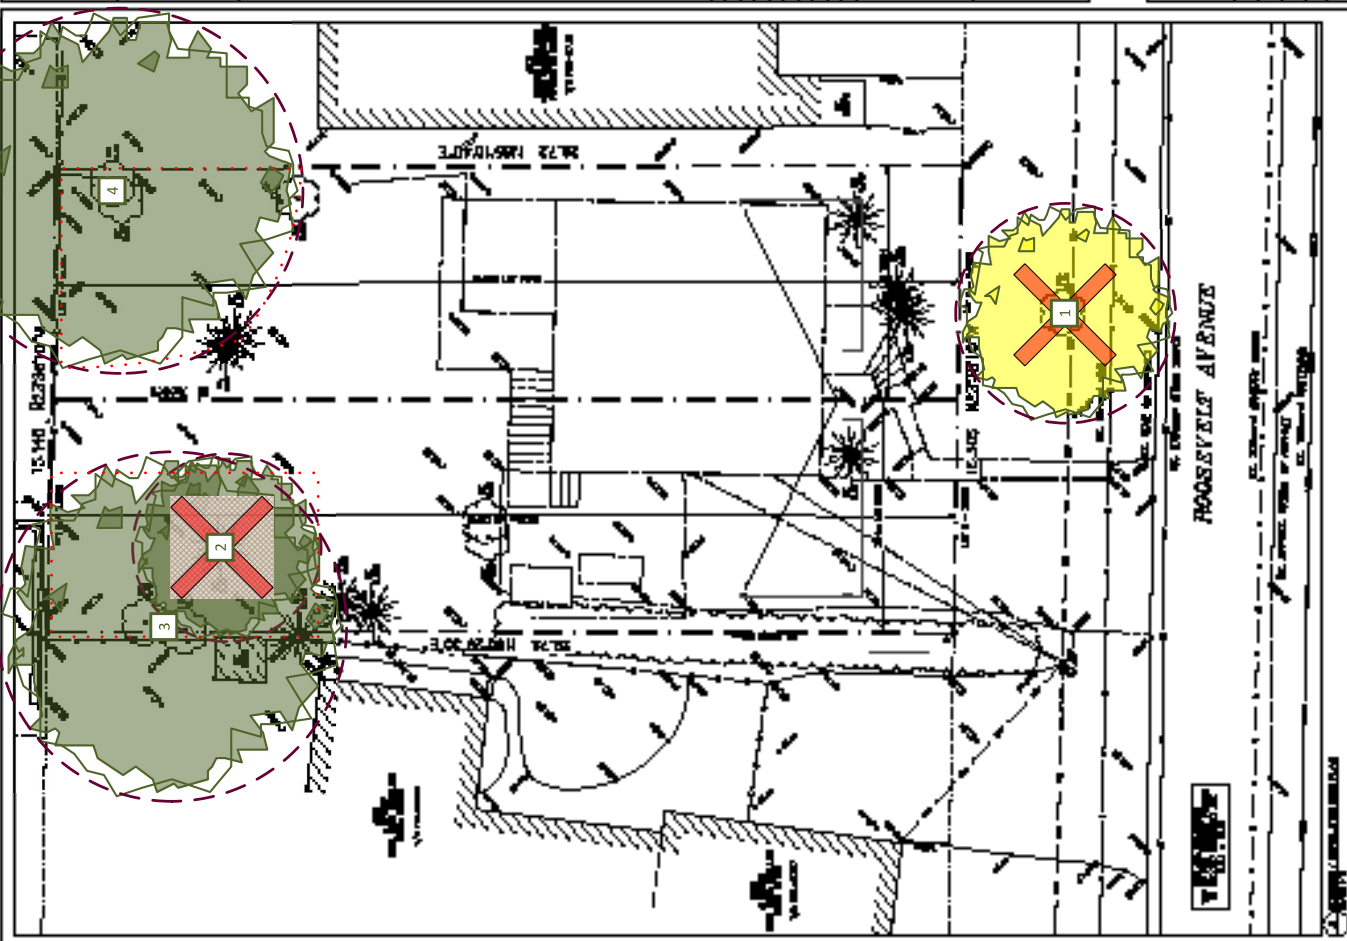
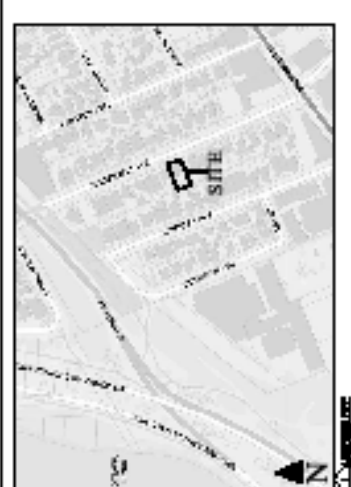
**ESP1**

Note that the tree layer has been added to the original survey plan supplied by the client in pdf format. This layer refers to the trees only, and the original survey plan has not been altered in the process. Refer to the original plan for details on grading as quality is lost when importing the plan into the mapping software used to create the tree layer.
