Tree Information Report

Date of Report: May 23, 2024
Property Address: 556 Mansfield Avenue
Prepared for: Frank Curcio; frank@bedrockdevelopments.ca
Prepared by: Kevin Myers, ISA Certified Arborist®; kevin.myers@dendronforestry.ca
Date of Site Visit: May 1, 2024

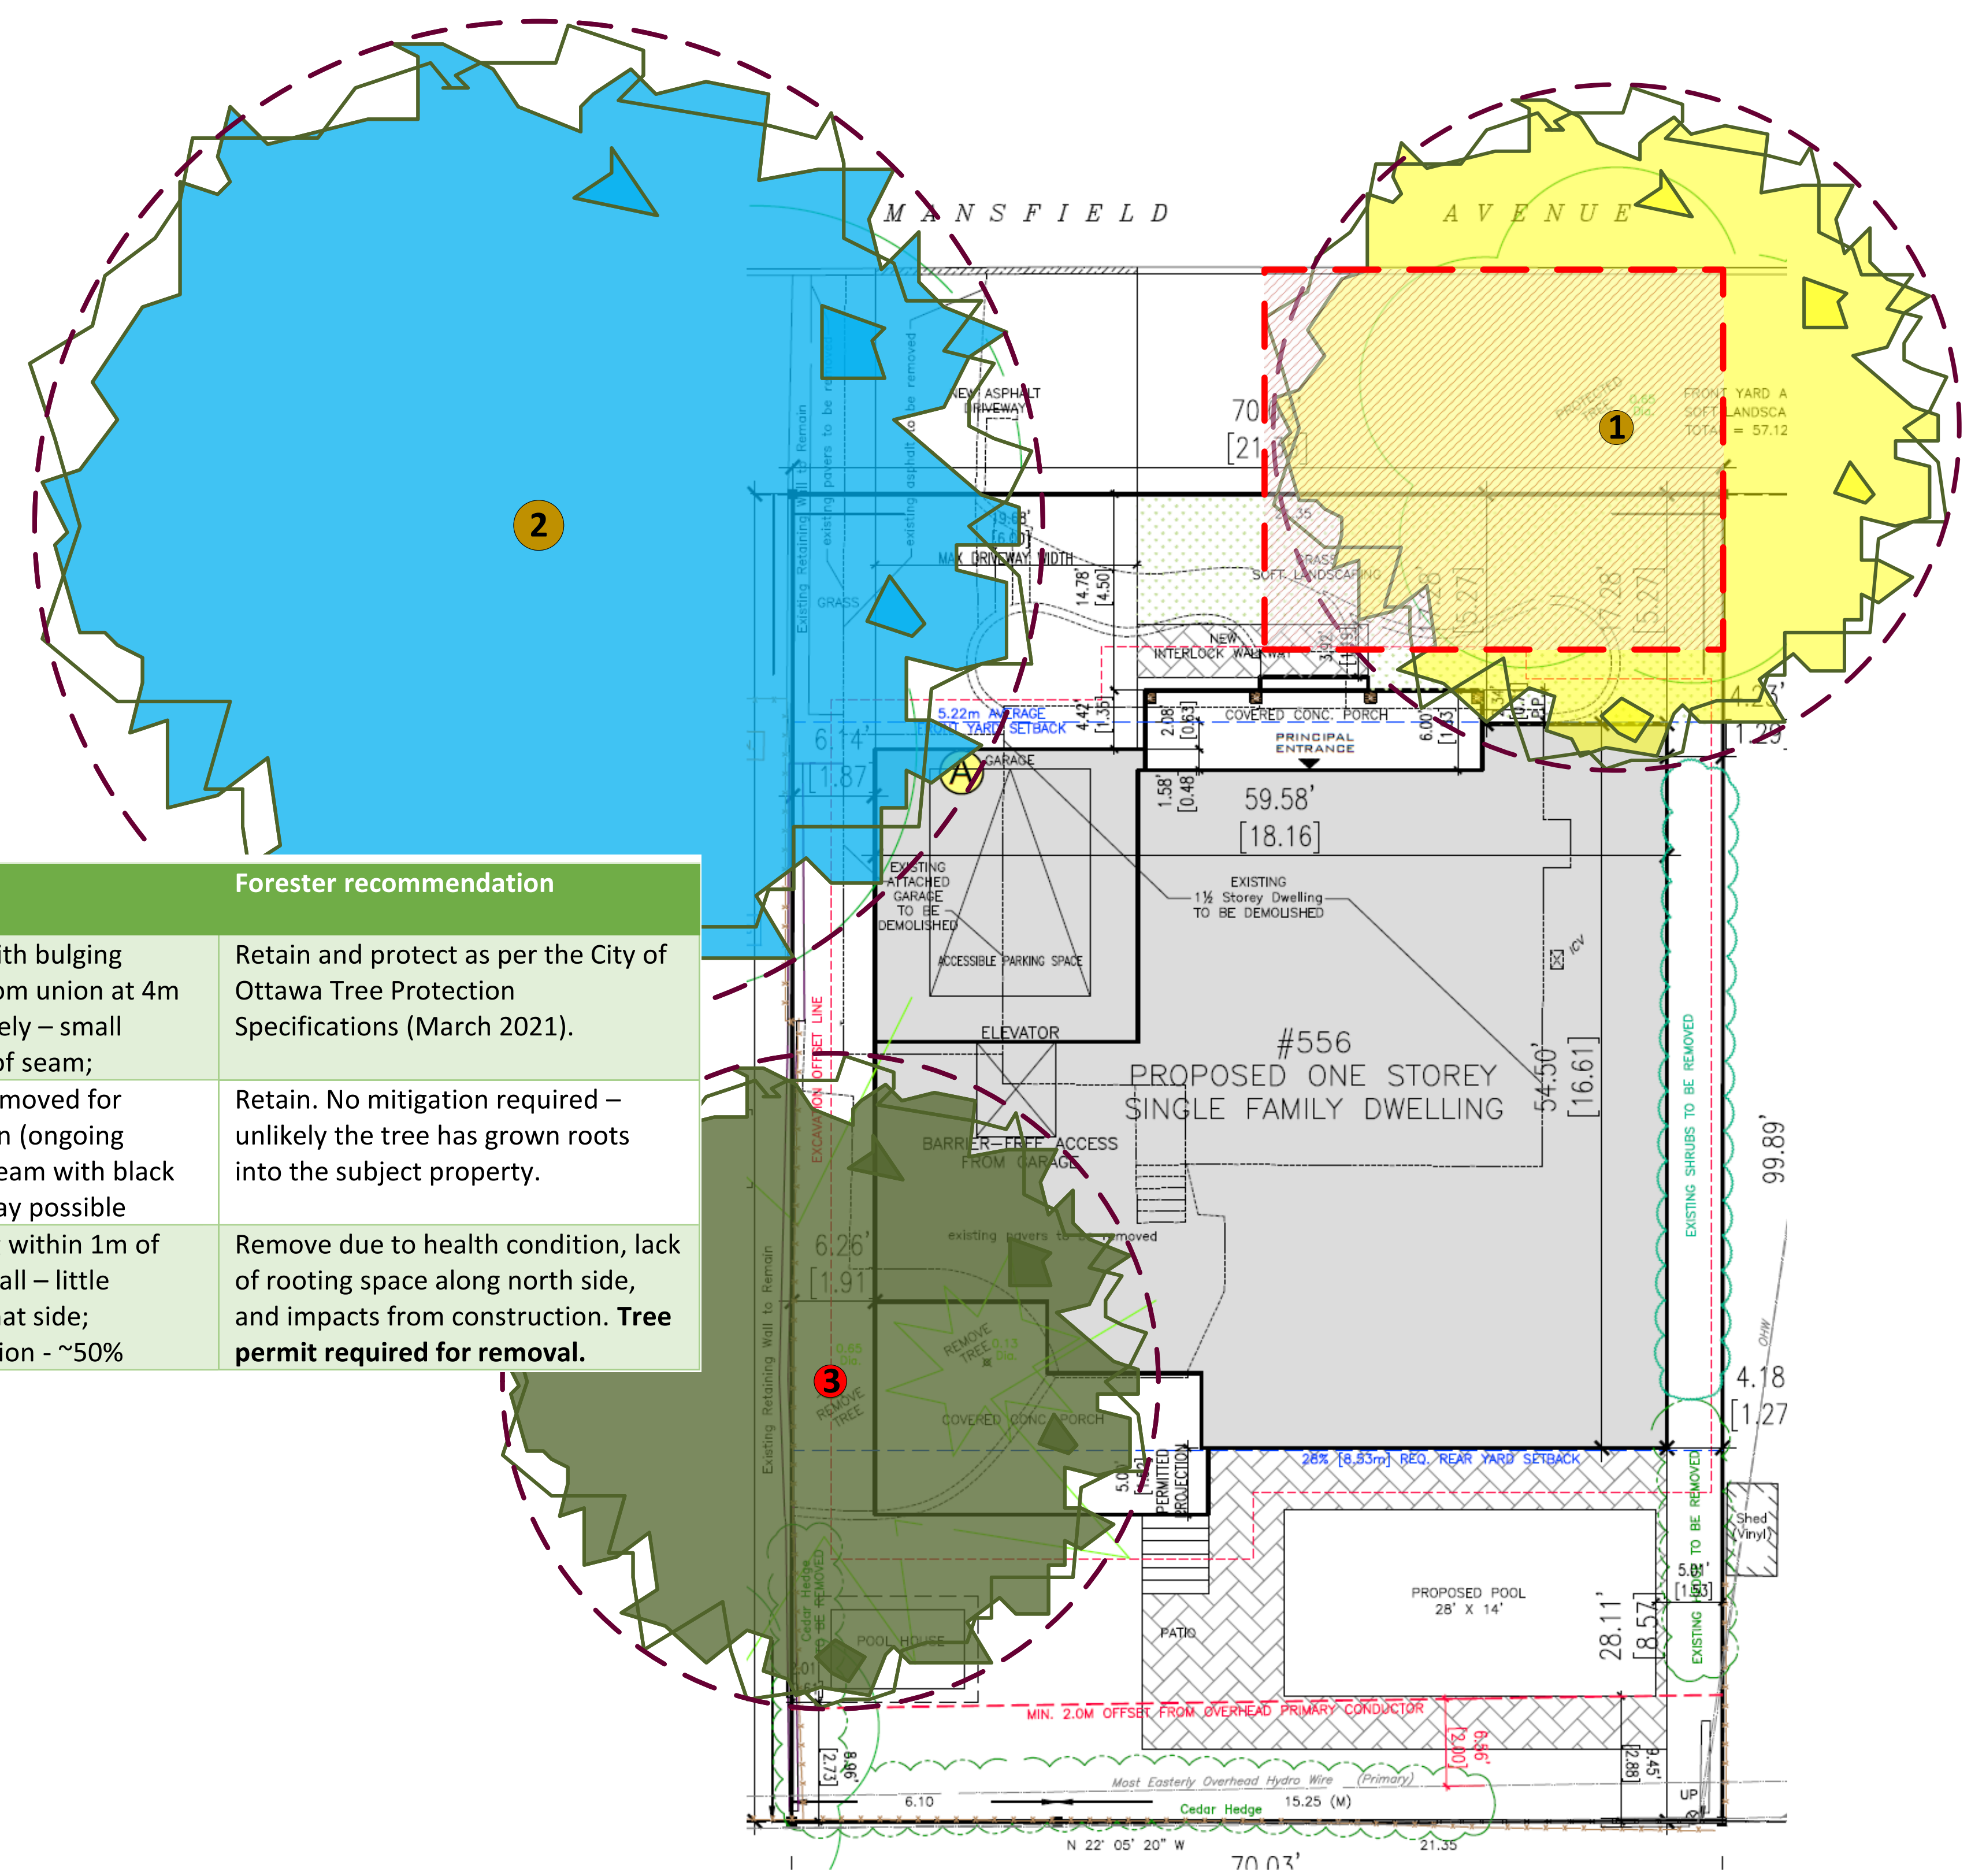
TIR Map – 556 Mansfield Avenue		
Date	Revision	Prepared By
03/05/2024	Version 1	KM
23/05/2024	Version 2 – new site plan	KM

Tree ¹	Species	DBH (cm)	Tree condition	Forester recommendation
1	Norway maple (<i>Acer platanoides</i>)	75	Fair/Poor: seam with bulging growth extends from union at 4m to base – decay likely – small opening near top of seam;	Retain and protect as per the City of Ottawa Tree Protection Specifications (March 2021).
2	Red oak (<i>Quercus rubra</i>)	111	Fair: large limbs removed for recent construction (ongoing during site visit); seam with black bark at base – decay possible	Retain. No mitigation required – unlikely the tree has grown roots into the subject property.
3	Norway spruce (<i>Picea abies</i>)	72	Poor/Fair: growing within 1m of ~70cm retaining wall – little rooting space at that side; significant defoliation - ~50%	Remove due to health condition, lack of rooting space along north side, and impacts from construction. Tree permit required for removal.
