Property is 845 Dundee Avenue
Ottawa, ON
K2B 5S8

The owner is applying for a permit to demolish the existing structure and build four attached two-story residential units.

Inspection date: 2023-02-27

Tree Information Report for 845 Dundee Avenue, Ottawa

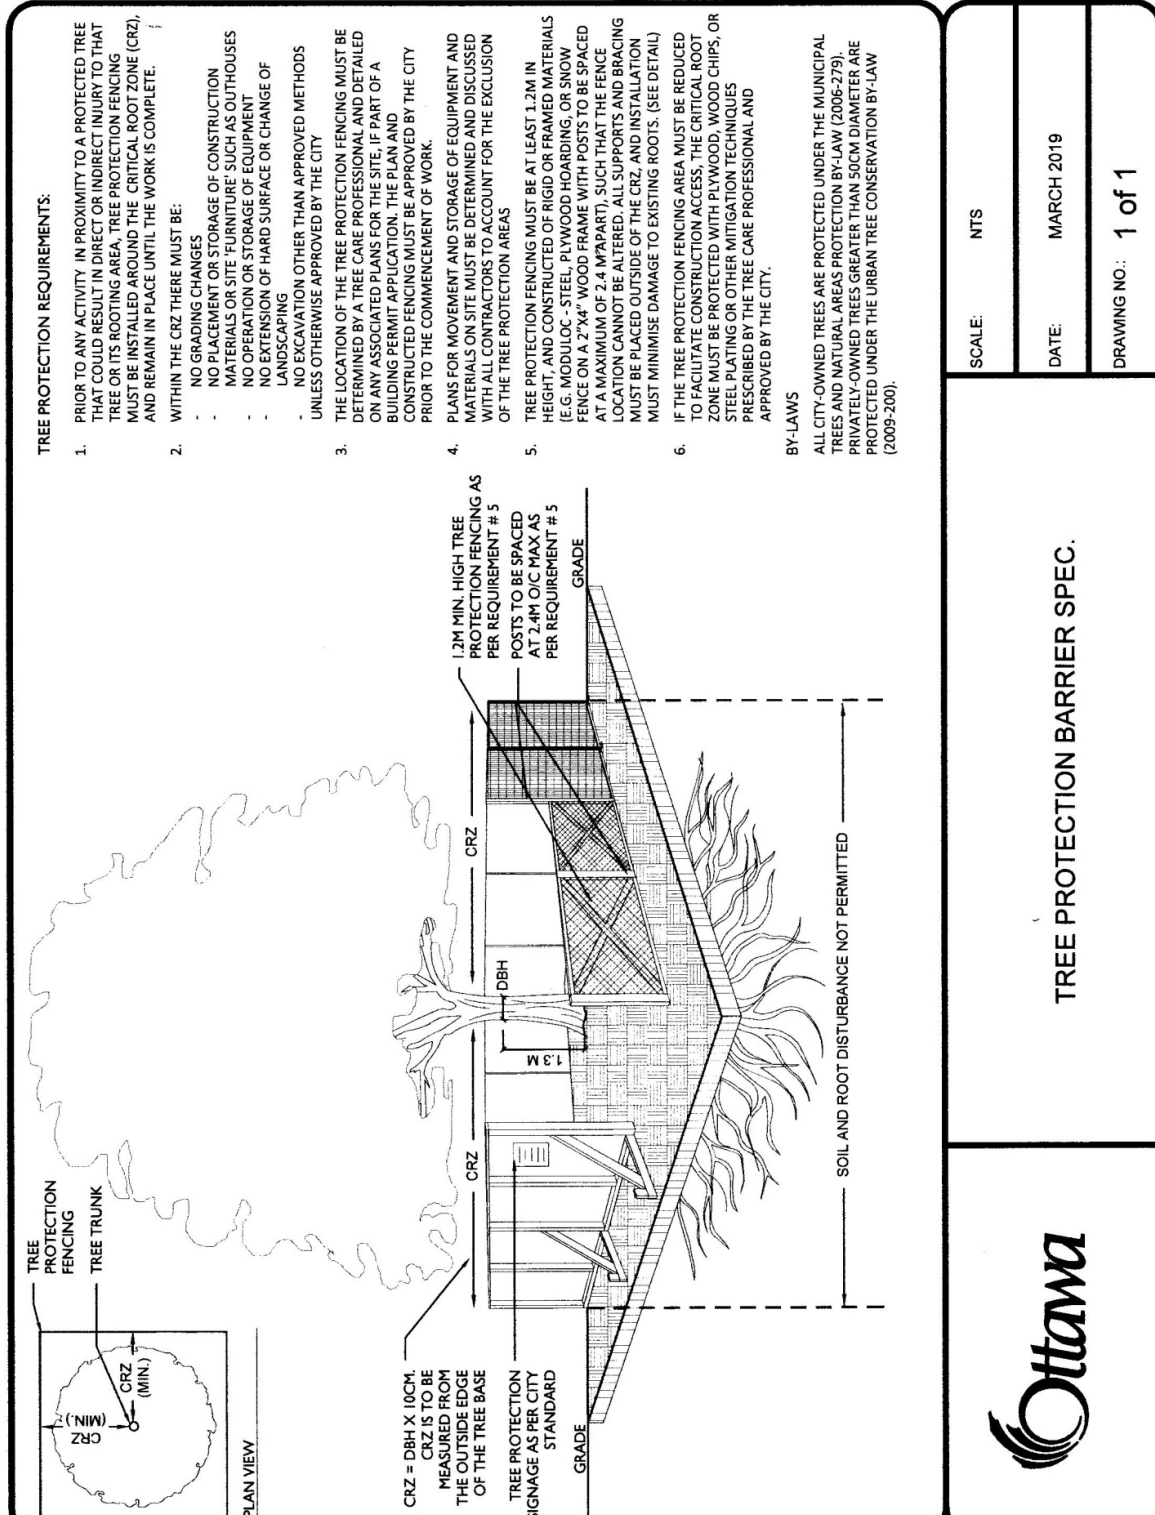
Diagram #1

The existing foundation is 2.86 M from the boundary line between 845 and 851 Dundee. This has limited the space for the existing cedar roots to less than standard dimension for CRZ's.

The CRZ's for these cedars extends up to the existing foundation on the side of 845 Dundee. Excavation will remove slightly more than 10 % of the actual area of the existing roots for these two trees. As cedars show very good tolerance of root loss and infill soils, these two trees should not be adversely affected by the construction as long as all Steps to Conserve trees are followed.

These two cedars have CRZ's that have been restricted by the foundation at 845 Dundee. The limit of excavation will be narrowed along the section within their illustrated CRZ's to preserve the amount of undisturbed soil extending from the base of these two trees. This will leave a distance of 120 cm which is equivalent to 30% of the CRZ based on the tree diameters at breast height. In order to mitigate damage to their roots in this zone, a mechanical shovel is not to be used there. (See orange dotted line in Diagram #2). Excavation will be carried out by hand with a sharp spade or by using hydro pressure with special attention to No. 6 and 7 of Steps to Conserve Trees. It is anticipated that by following these steps Cedars #4 and #5 will be able to tolerate the work.
