May 14, 2024

RE: TREE CONSERVATION REPORT – 2140 BASELINE ROAD, OTTAWA

**APARTMENT
BUILDING**
2140 BASELINE ROAD

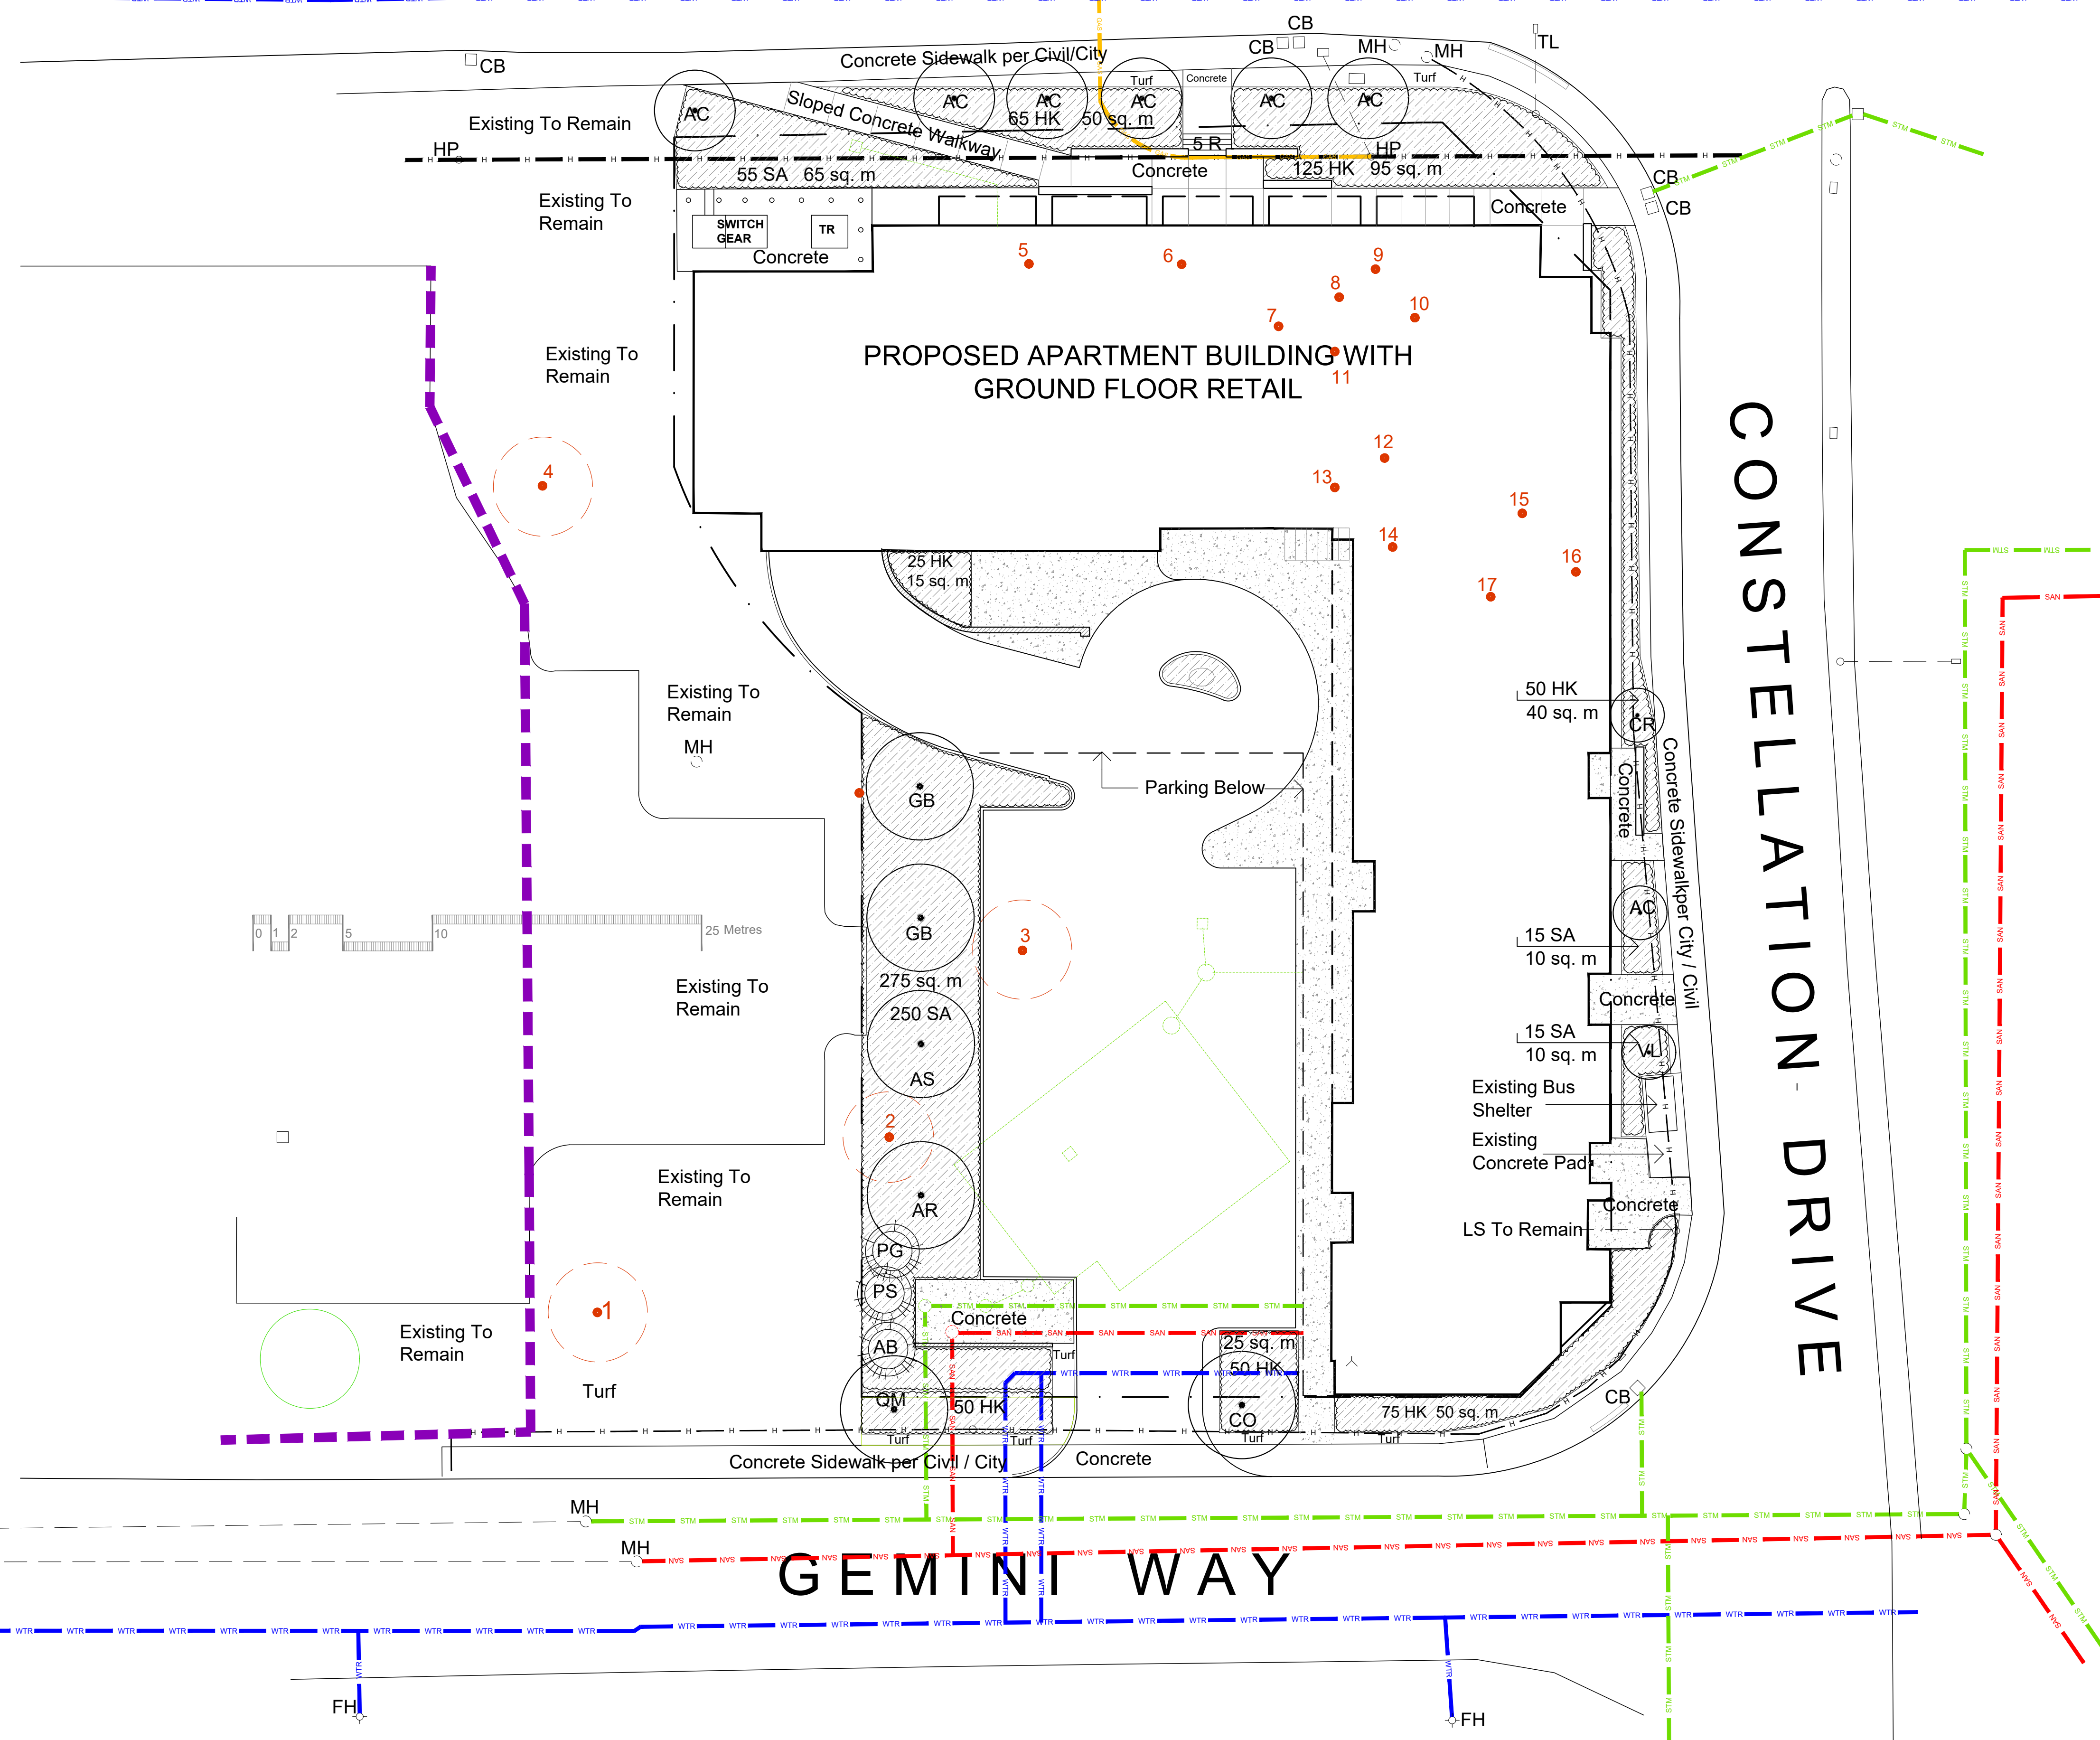
Table 1 on pages 2 and 3 details the species, condition, size (diameter) and status of the individual trees on and adjacent to the subject property. Each of these trees is referenced by the numbers plotted on the tree conservation plans included on pages 5 and 6 of this report (both plans prepared by Gino J. Aiello, Landscape Architect).
