## Tree Information Report

**Date of Report:** July 31, 2024  
**Property Address:** 1551 Vercheres Street  
**Prepared for:** Justin Seguin; justin@justinseguin.ca  
**Prepared by:** Kevin Myers, ISA Certified Arborist®; [kevin.myers@dendronforestry.ca](mailto:kevin.myers@dendronforestry.ca)  
**Date of Site Visit:** July 29, 2024

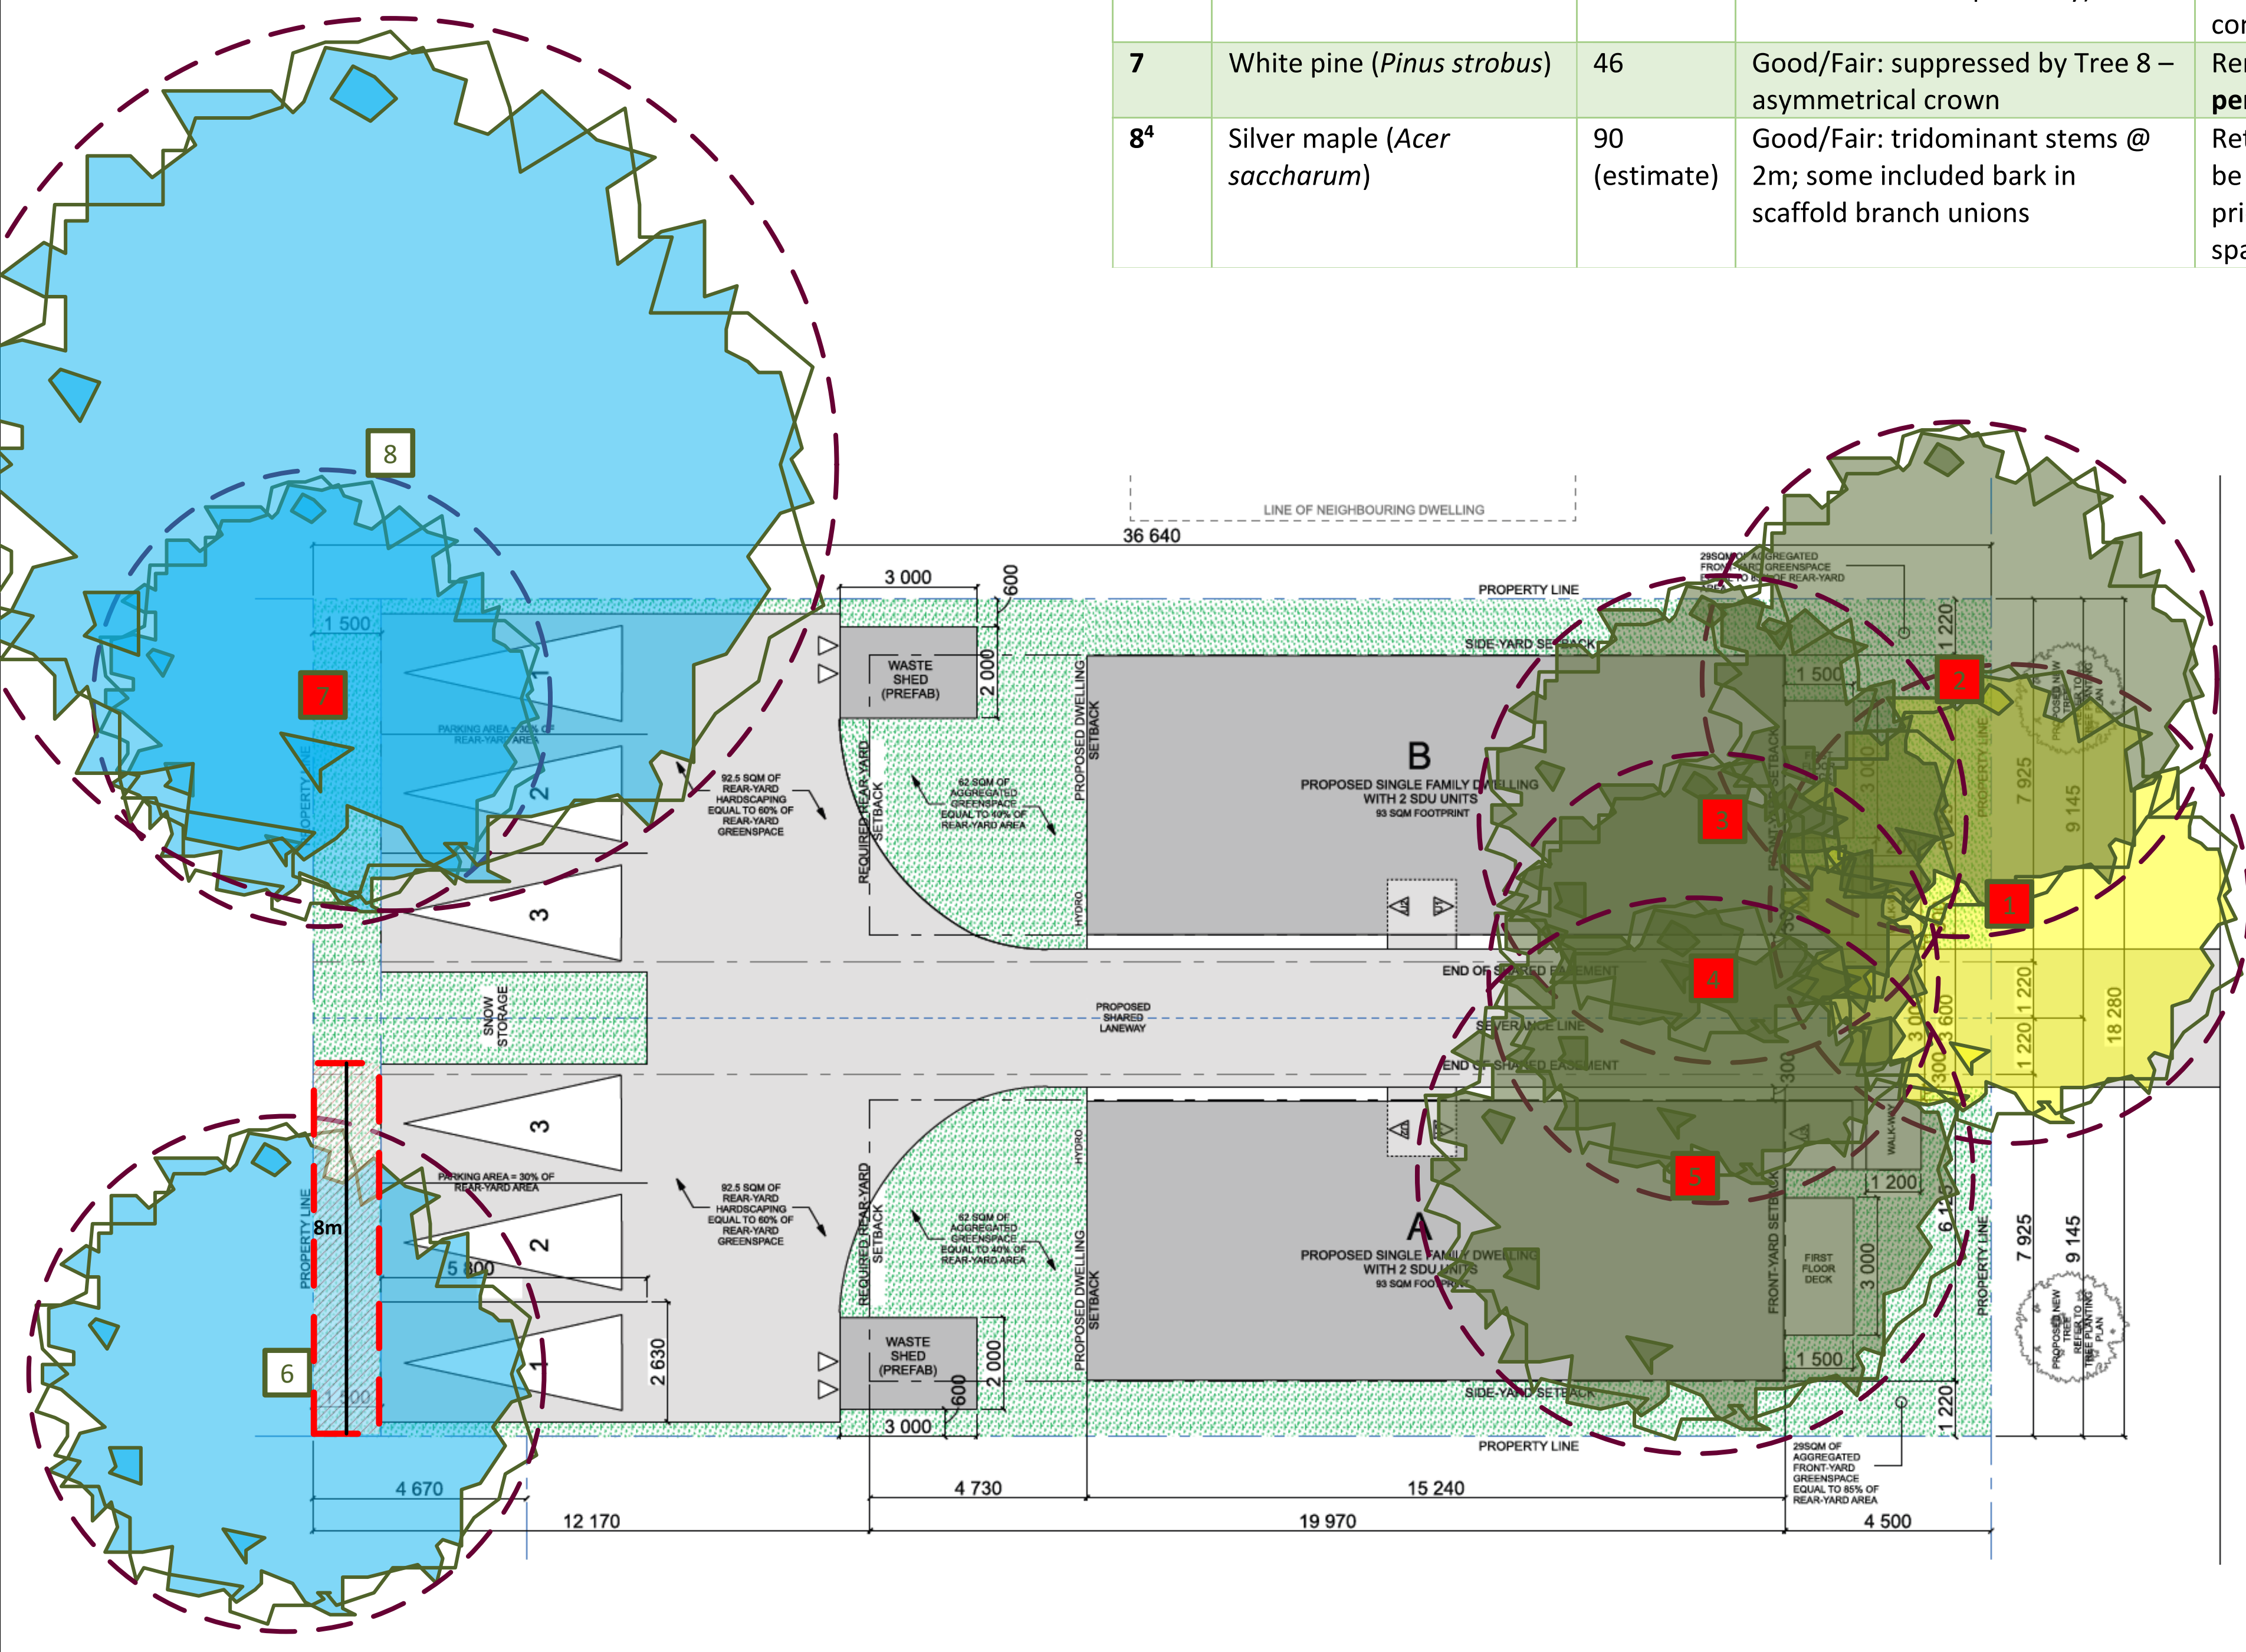
**TIR Map – 1551 Vercheres Street**

Tree <sup>1</sup>	Species	DBH (cm)	Tree condition	Forester recommendation
1	Trembling aspen ( <i>Populus tremuloides</i> )	48	Poor: overmature; large wounds with decay on trunk; central leader broken with decay; slightly asymmetrical crown	Remove due to health status and impacts from construction. <b>Tree permit required for removal.</b>
2	Trembling aspen ( <i>Populus tremuloides</i> )	52	Poor: overmature; large branch attachment wound with decay; central leader broken with decay; slight lean to the northwest	Remove due to health status and impacts from construction. <b>Tree permit required for removal.</b>
3	White pine ( <i>Pinus strobus</i> )	50.5	Good/Fair: slight lean to the northwest	Remove: within building footprint. <b>Tree permit required for removal.</b>
4	White pine ( <i>Pinus strobus</i> )	45	Good: small broken branches	Remove: in excavation footprint. <b>Tree permit required for removal.</b>
