# **Tree Information Report v2.0**

Submitted as part of Building Permit Application to the City of Ottawa

**Date of Report:** April 16, 2024

**Property Address:** 1598 Prince of Wales Drive

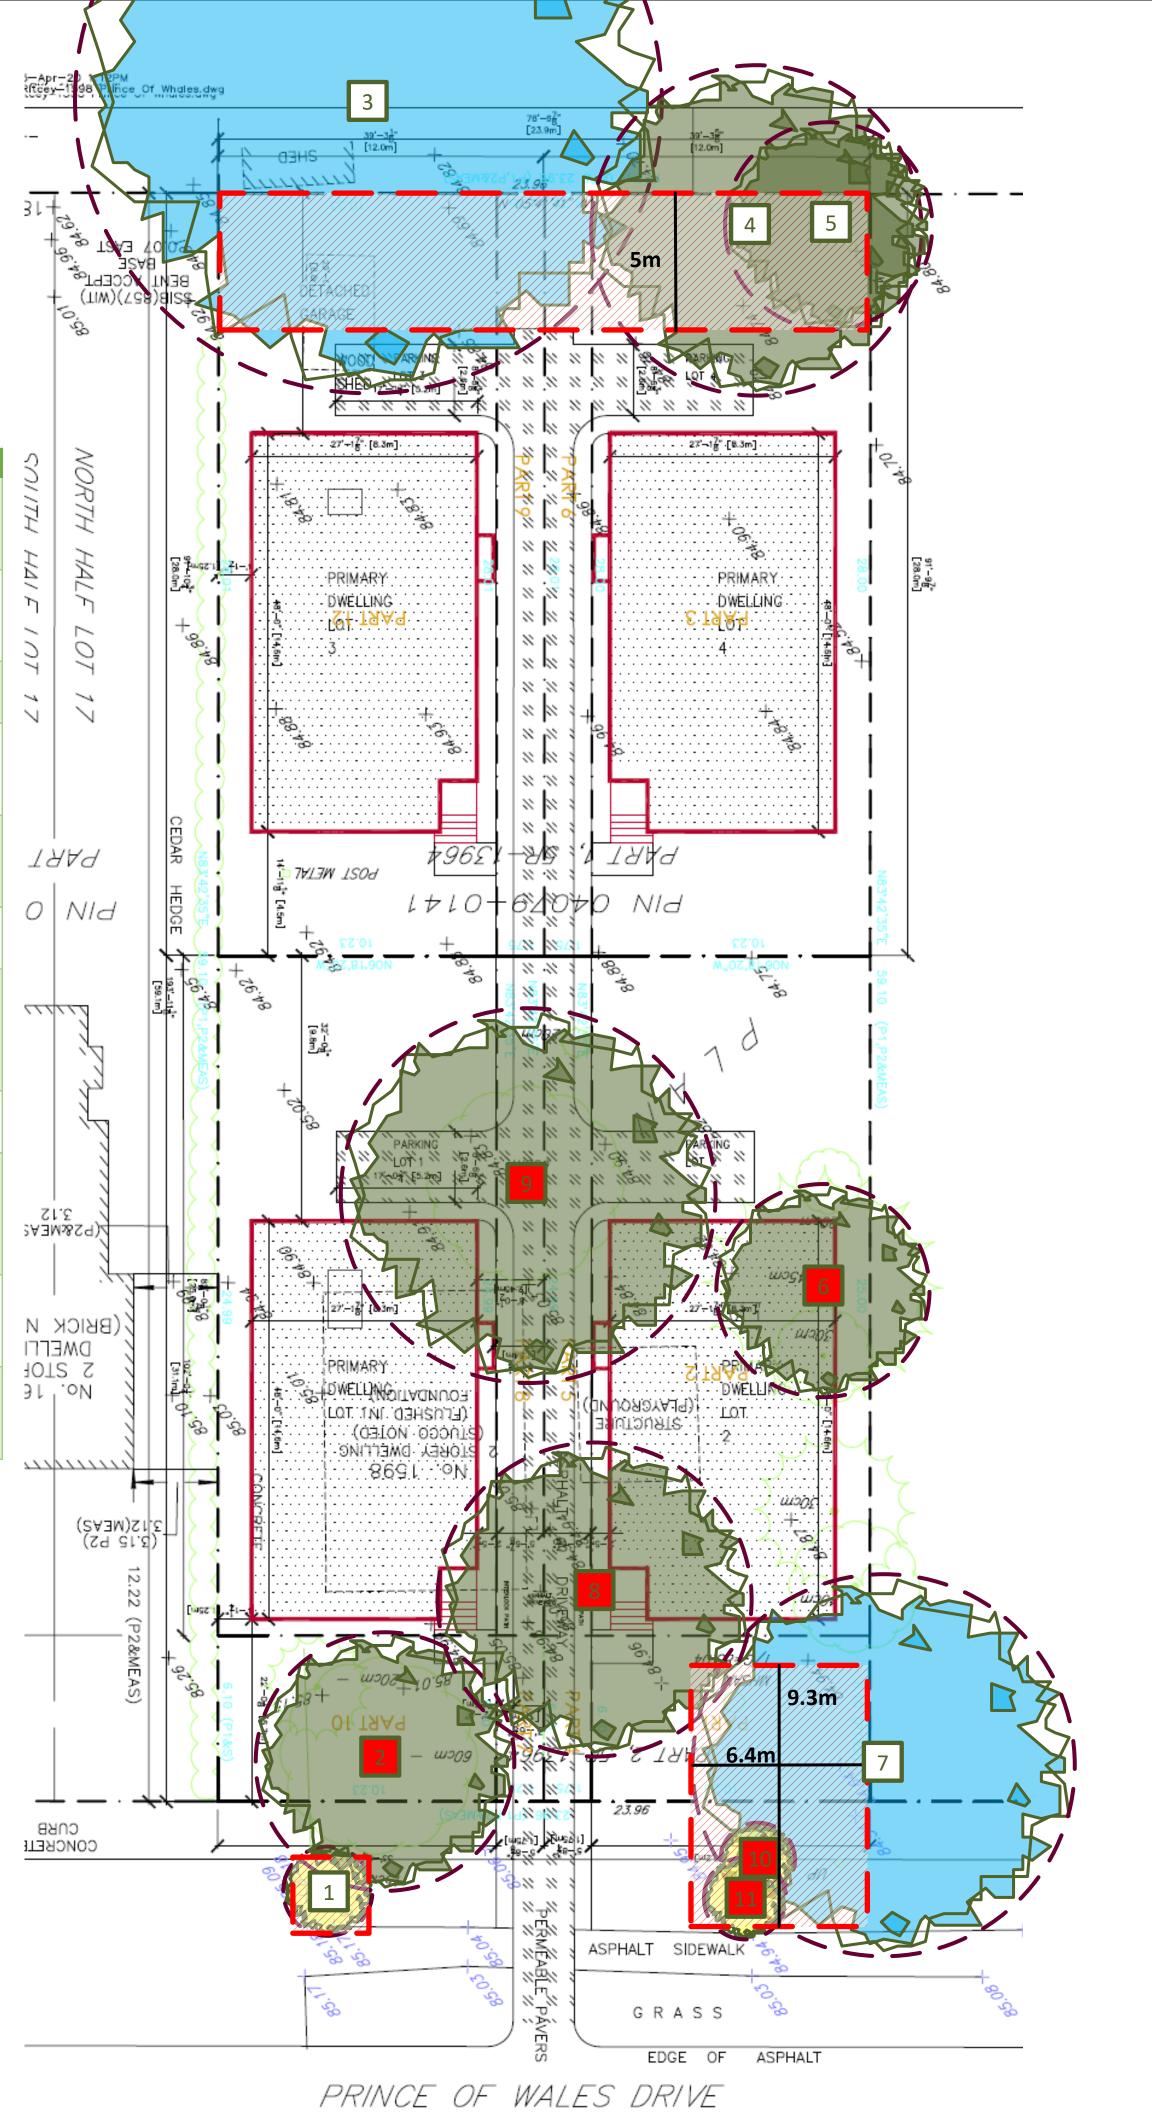
Note: the tree layer has been added to the original base layer supplied by the client in pdf format. This layer refers to the trees only, and the original base has not been altered in the process, although it may be cropped. Refer to the original plan for details as quality is lost when importing the plan into the software used to create the tree layer.
