October 12, 2021

**RE: TREE CONSERVATION REPORT FOR ST. THOMAS THE APOSTLE (2345 ALTA VISTA DRIVE)
AND ELLWOOD HOUSE (2270 BRAESIDE AVENUE), OTTAWA**

DRAWING: Tree Conservation Plan

PROJECT: ELWOOD HOUSE EXTENSION CITY OF OTTAWA

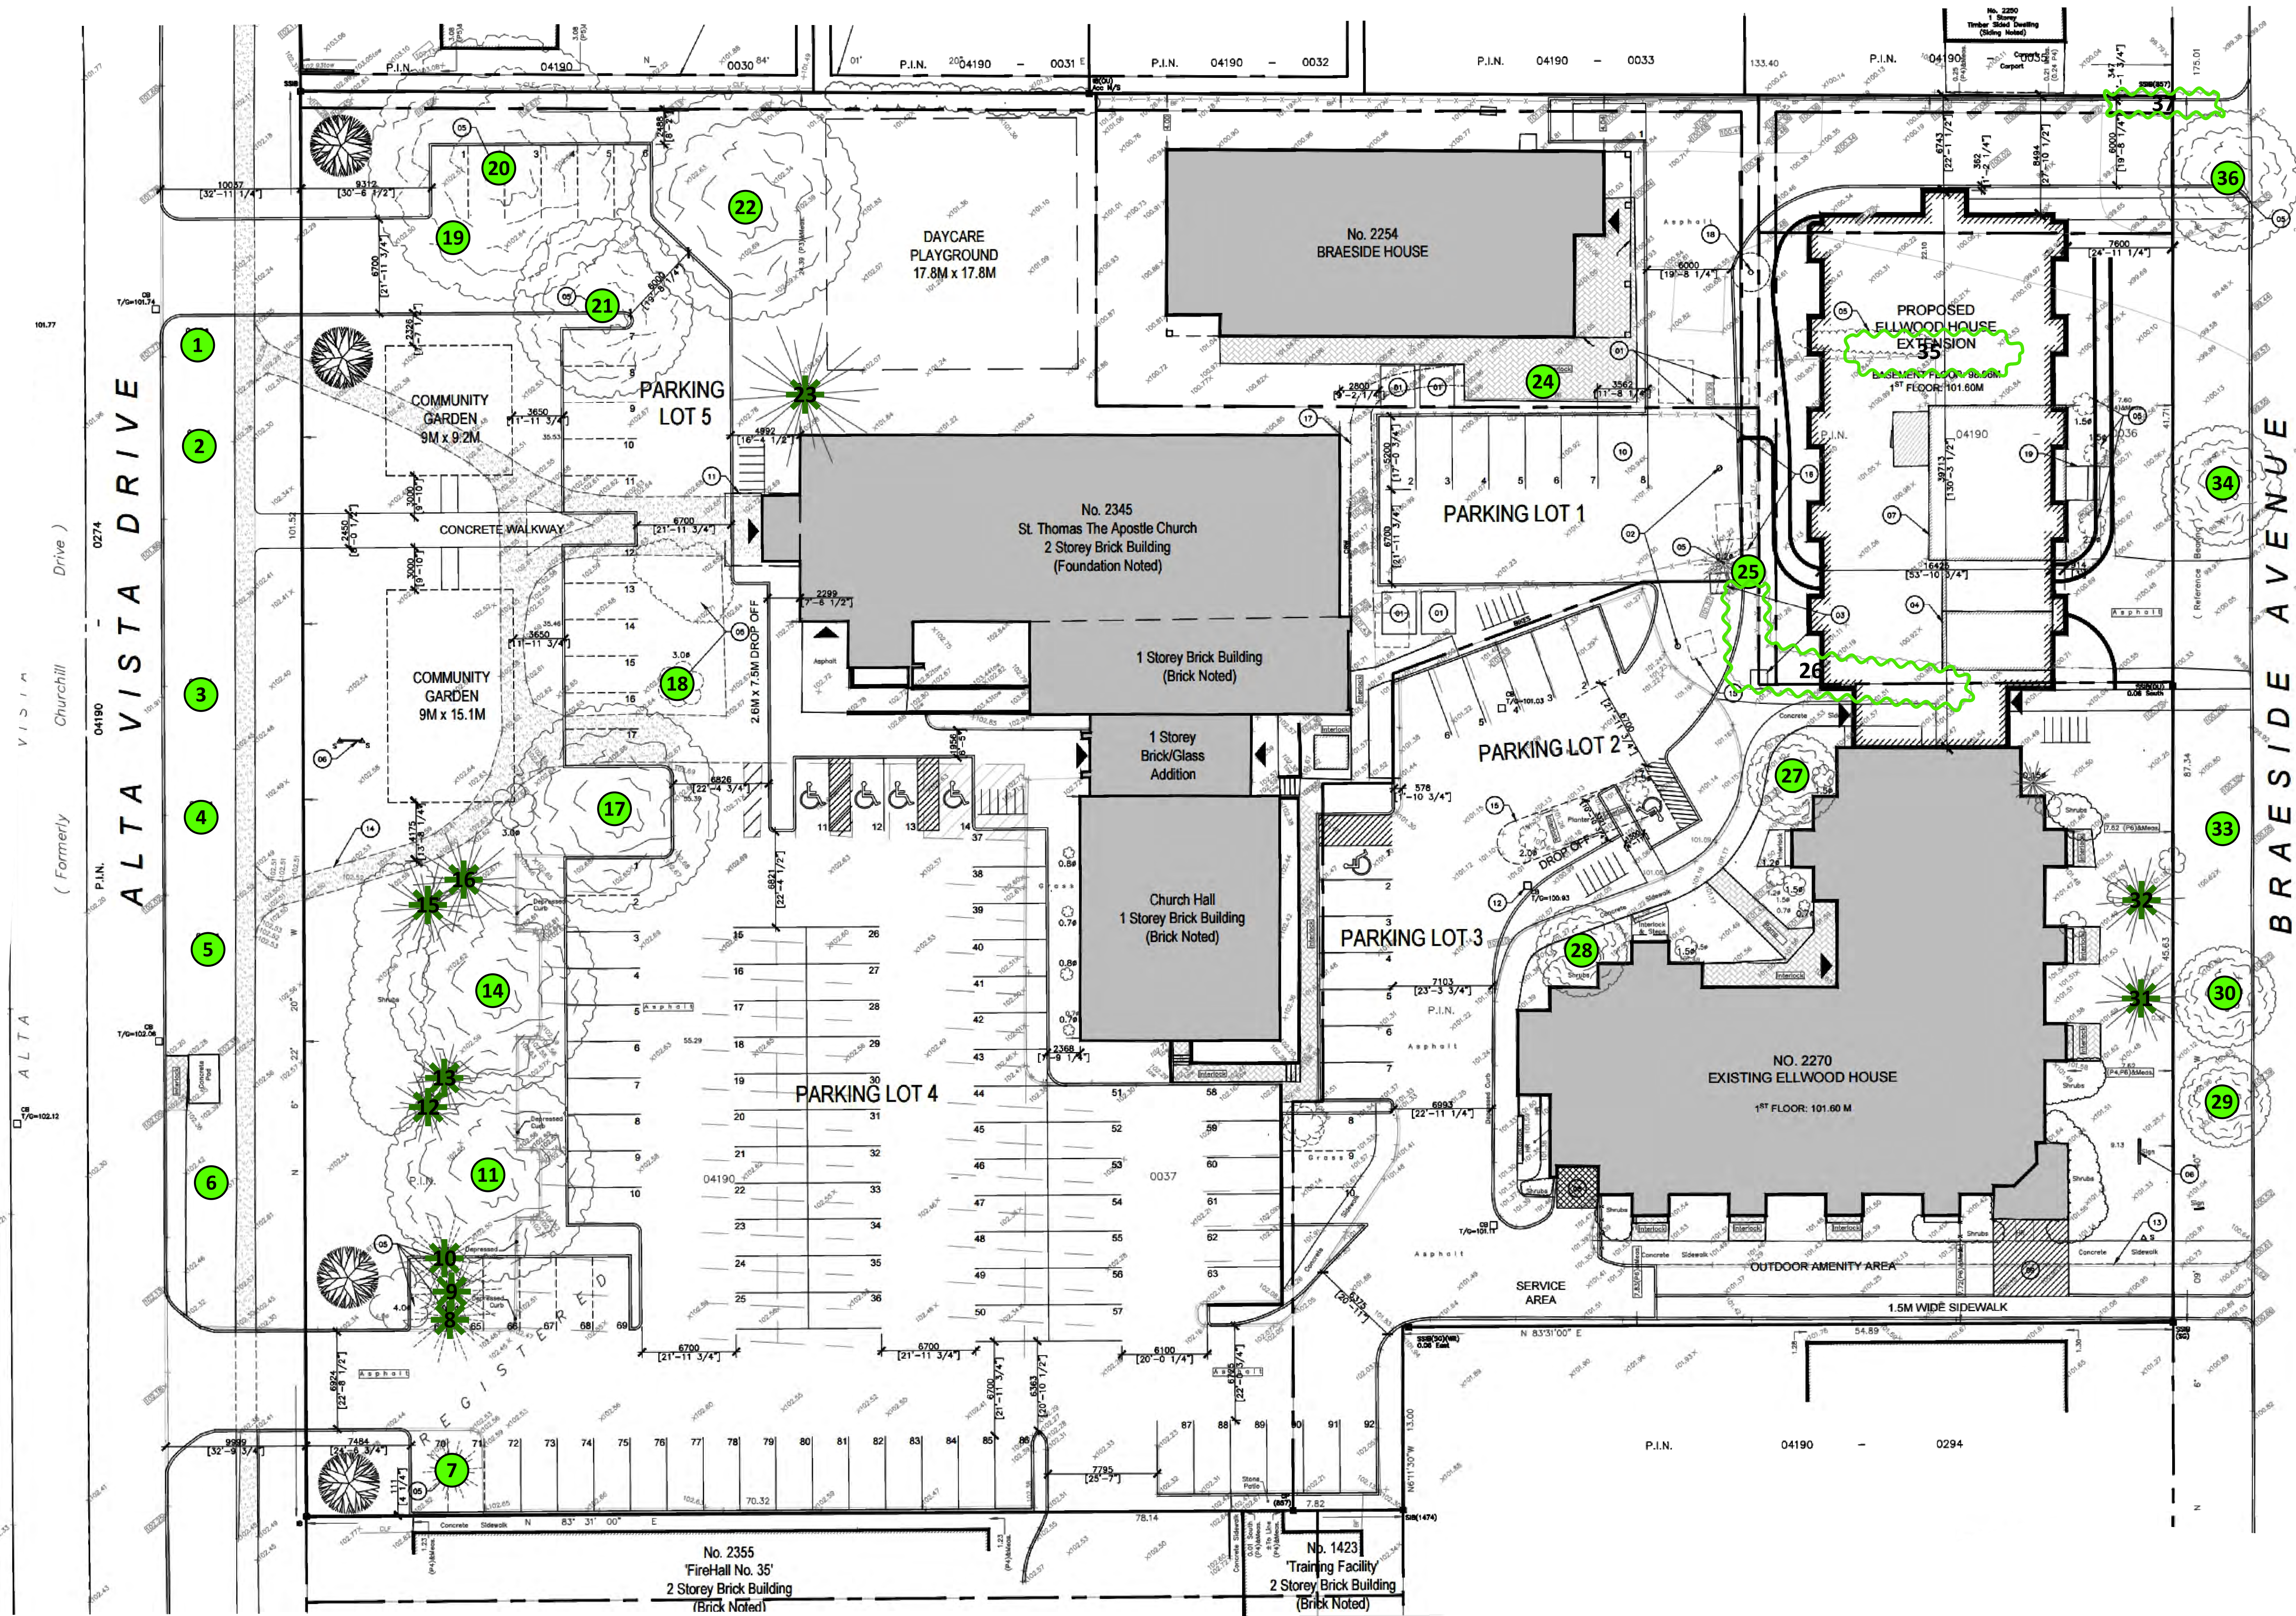
In terms of existing vegetation, there is a mixture of planted amenity trees and cedar hedges. Under the current site plan the majority of existing trees can be retained as the proposed layout of the extension is relatively small in relation to the overall property. The one area where tree retention will not be possible is the proposed new entranceway from Braeside Avenue. A mature city tree will be lost as a result of this conflict.

Preservation and protection measures intended to mitigate damage during construction will be applied for any trees to be preserved on and adjacent to the subject properties. The following measures are the minimum required by the City of Ottawa to ensure tree survival during and following construction:

1. Erect a fence at the critical root zone (CRZ¹) of trees;
2. Do not place any material or equipment within the CRZ of the tree;
3. Do not attach any signs, notices or posters to any tree;
4. Do not raise or lower the existing grade within the CRZ without approval;
5. Tunnel or bore when digging within the CRZ of a tree;
6. Do not damage the root system, trunk or branches of any tree;
7. Ensure that exhaust fumes from all equipment are NOT directed towards any tree's canopy.
