A CONSERVATION PLAN

CHAMPLAIN OIL COMPANY SERVICE STATION

70 RICHMOND ROAD OTTAWA, ONTARIO

FINAL April 30, 2022

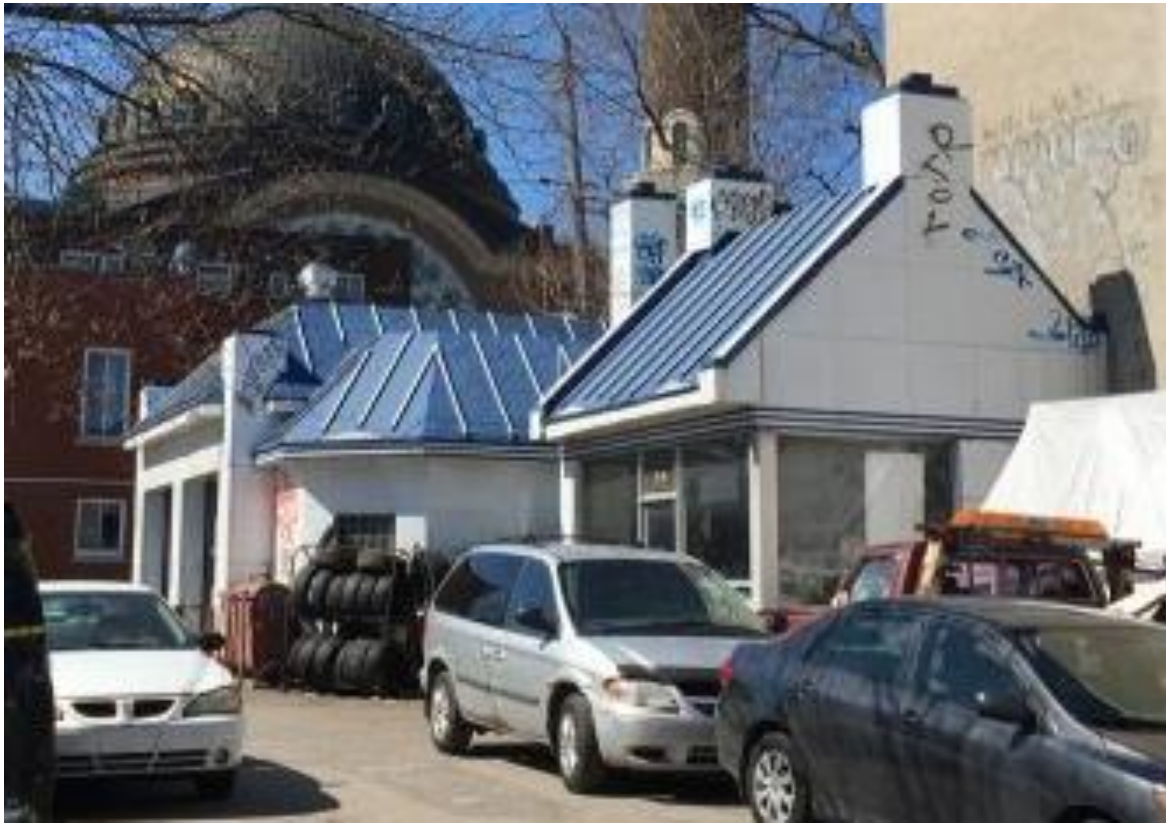
Figure 2: Former Champlain service station, 55 Saint-Viateur Street West Montreal is a mirror image of the Service Station at 70 Richmond Road. Source: [photo: Justin Bur 2017]

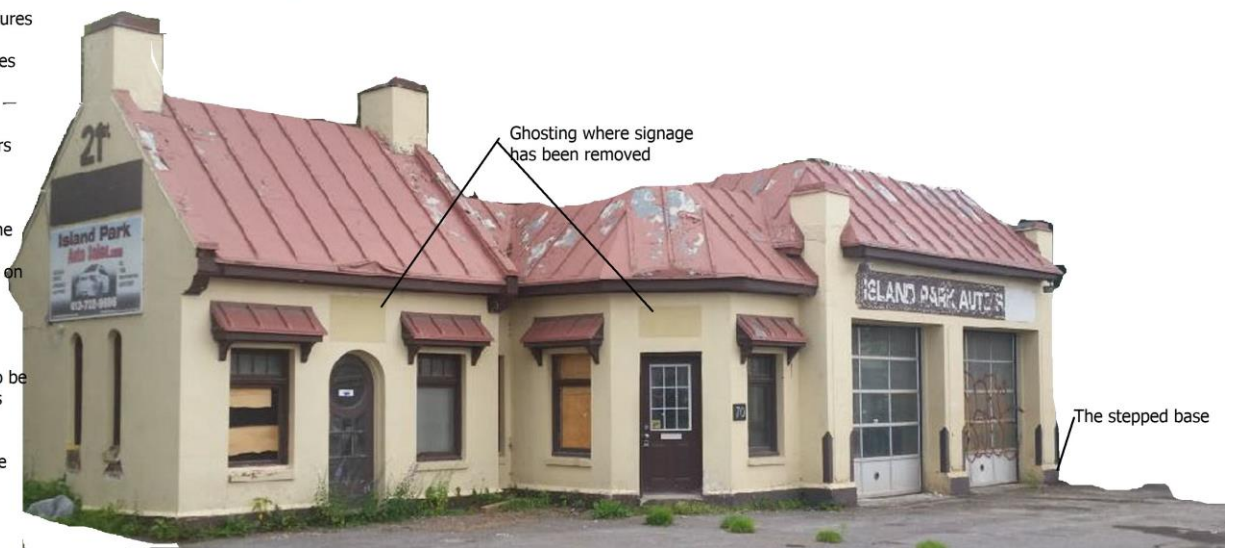
- Chimney's and Buttresses on either side of the Garage doors
- Metal Roof with diverters over each door.
- Window Hoods
- Windows with multi pane transoms
- Round Headed Window on the end Facade
- Cottage Door.
- Garage Doors appear to be replacements but needs confirmation.
- Signage over the garage doors

Figure 4: Annotated view of the Service Station highlighting the identified attributes. Source: Commonwealth

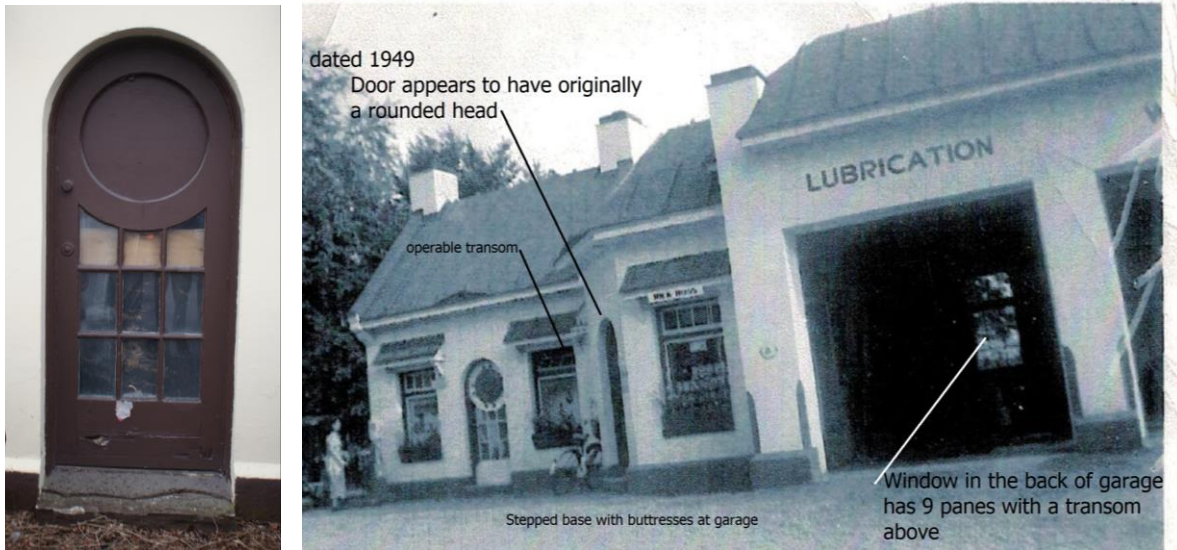
Figure 9 : Circa 1949 – 50. The historic view of the Service Station provides reference information supporting the conservation of the round headed doors at both entrances. Other features include the stepped foundation with chamfered treatment at the base of the service bay entrances. Over time, the scale of the stepped foundation has been reduced as grade was raised with the addition of asphalt. Source: Ottawa Archives, John Newcomb Collection.

The distinctive entrance door to the office will be retained and preserved, as will the awnings above the windows and doors. The round-headed door will be repaired as necessary and used as a model for the reconstruction of the second door, which had been altered at some time.

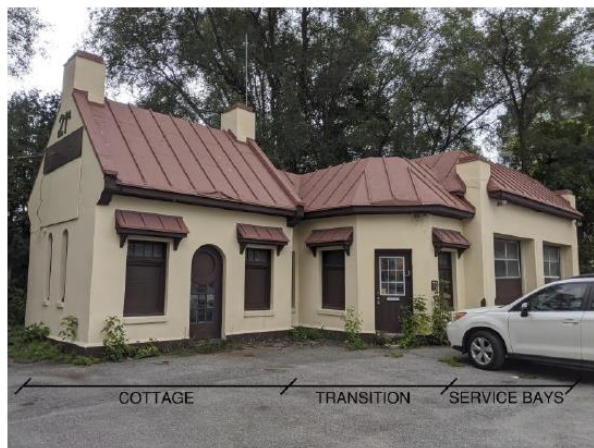
Photo 1: Overview of building [JCAL 2020]

In general there are three main spaces; the cottage, the transitional area and the service bays, see Photo 1. The transitional area and garage are divided by an interior loadbearing brick wall. The separation of these spaces is visible by the differing roof structures from the exterior.
