## Tree Information Report

Submitted as part of Committee of Adjustment Application to the City of Ottawa

**Date of Report:** January 21, 2025  
**Property Address:** 2544 Gravelle Crescent  
**Prepared for:** Chris Milburn, c/o Alison Clarke; [alison@tsgdi.ca](mailto:alison@tsgdi.ca)  
**Prepared by:** Kevin Myers, ISA Certified Arborist®; [kevin.myers@dendronforestry.ca](mailto:kevin.myers@dendronforestry.ca)  
**Date of Site Visit:** January 3, 2025

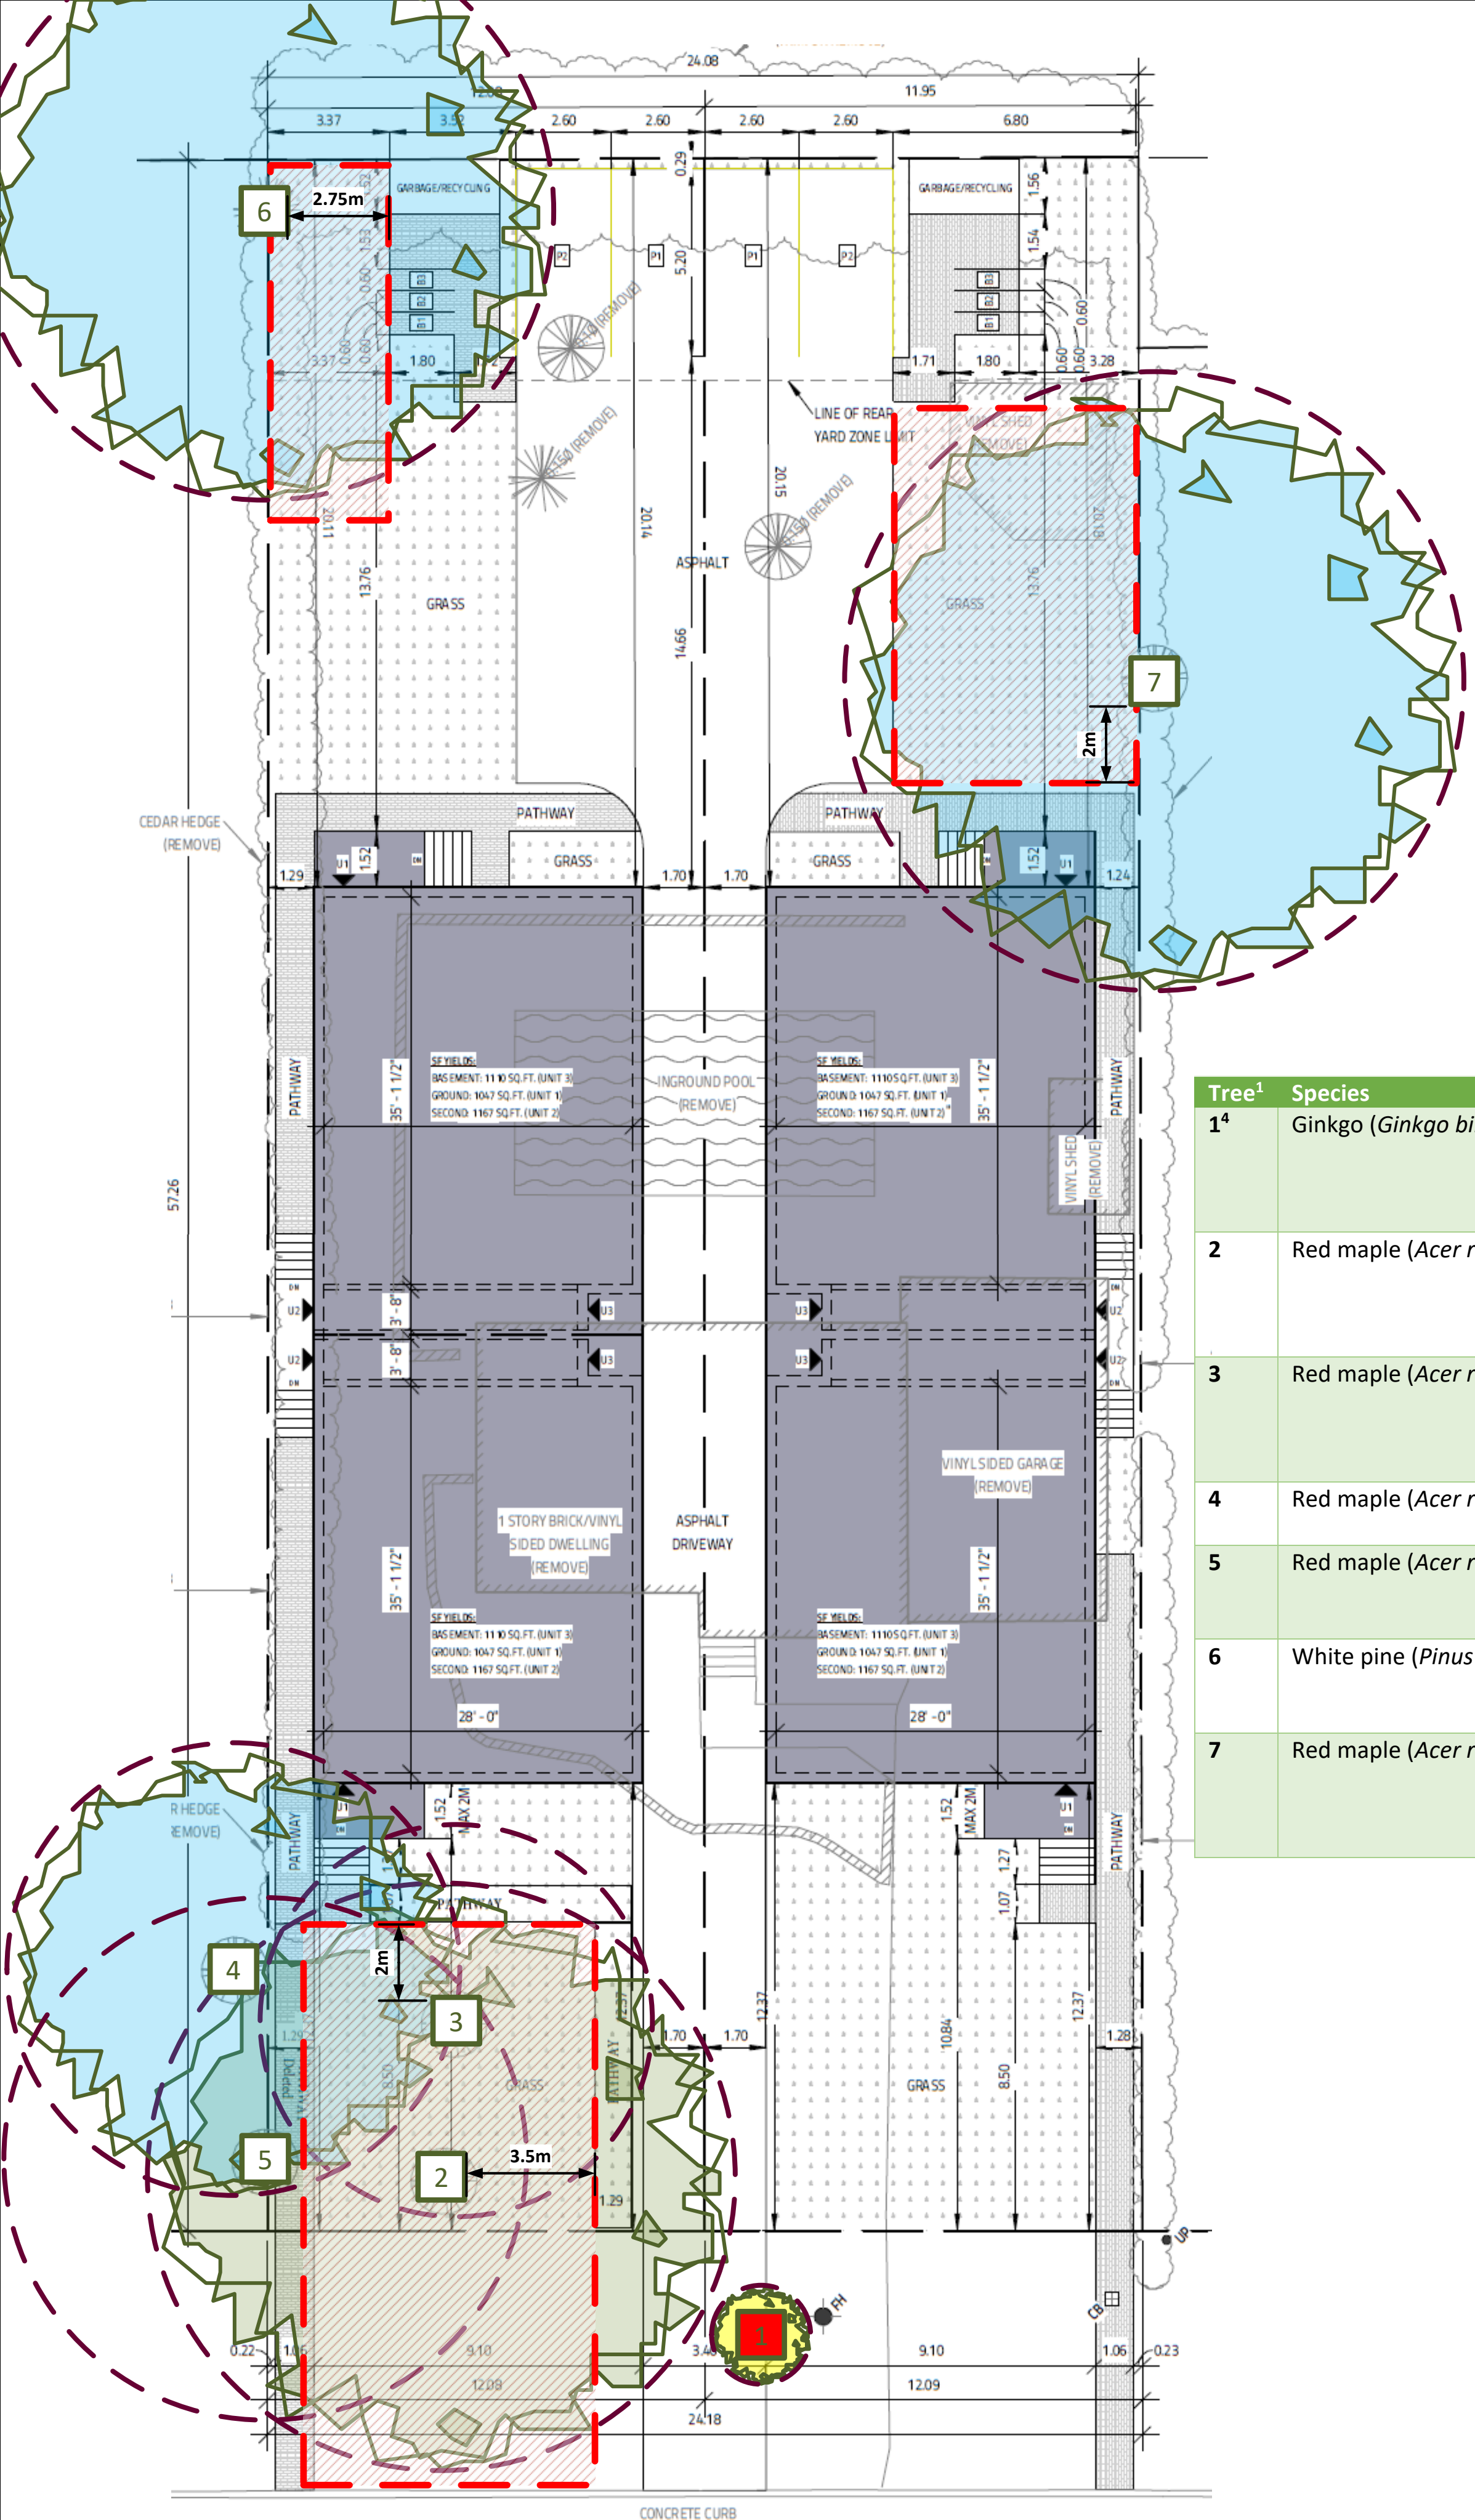
TIR Map – 2544 Gravelle Crescent		
Date	Version	Prepared By
21/01/2025	1	KM

Tree <sup>1</sup>	Species	DBH (cm)	Tree condition <sup>3</sup>	Forester recommendation
1 <sup>4</sup>	Ginkgo ( <i>Ginkgo biloba</i> )	5	Good	Remove. With proper planning, this tree could be transplanted to another point on the property. <b>Tree removal permit required for removal OR permission from city required to transplant.</b>
2	Red maple ( <i>Acer rubrum</i> )	74	Fair: some broken branches; small cavity at 2.5m – internal decay possible; trunk wound with decay beginning	Retain and protect as per the City of Ottawa Tree Protection Specifications (March 2021). Any roots encountered during installation of the path or front entryway are to be cleanly severed by hand.
3	Red maple ( <i>Acer rubrum</i> )	51	Fair/Good: codominant stems @2.5m with included bark; partly suppressed by Tree 2	Retain and protect as per the City of Ottawa Tree Protection Specifications (March 2021). Any roots encountered during installation of the path or front entryway are to be cleanly severed by hand.

4	Red maple ( <i>Acer rubrum</i> )	59	Fair/Poor: pruned around wires – poor structure; canker in canopy	Retain. Roots encountered during excavation for the front stairs are to be cleanly severed by hand.
5	Red maple ( <i>Acer rubrum</i> )	68	Fair: asymmetrical crown to the north; trunk is two large stems that have grown together – included bark and weak union very likely	Retain and protect as per the City of Ottawa Tree Protection Specifications (March 2021).
6	White pine ( <i>Pinus strobus</i> )	75 (estimate)	Good: some smaller broken branches; crown is slightly asymmetrical to the west	Retain and protect. Any roots encountered during installation of the rear yard garbage and bike storage area are to be cleanly severed by hand.
7	Red maple ( <i>Acer rubrum</i> )	55, 60	Fair/Poor: 60cm stem is in poor condition, with large cavities and decay @4m, dying branches; poor main union – wound and included bark; both stems have moderate leans	Retain. Roots along the line of excavation are to be revealed and cleanly severed by hand by a certified arborist prior to using a machine.
