254 ARGYLE AVENUE

Church Relocation Scenarios Analysis

Project Number: 2023-049-2

August 23, 2024

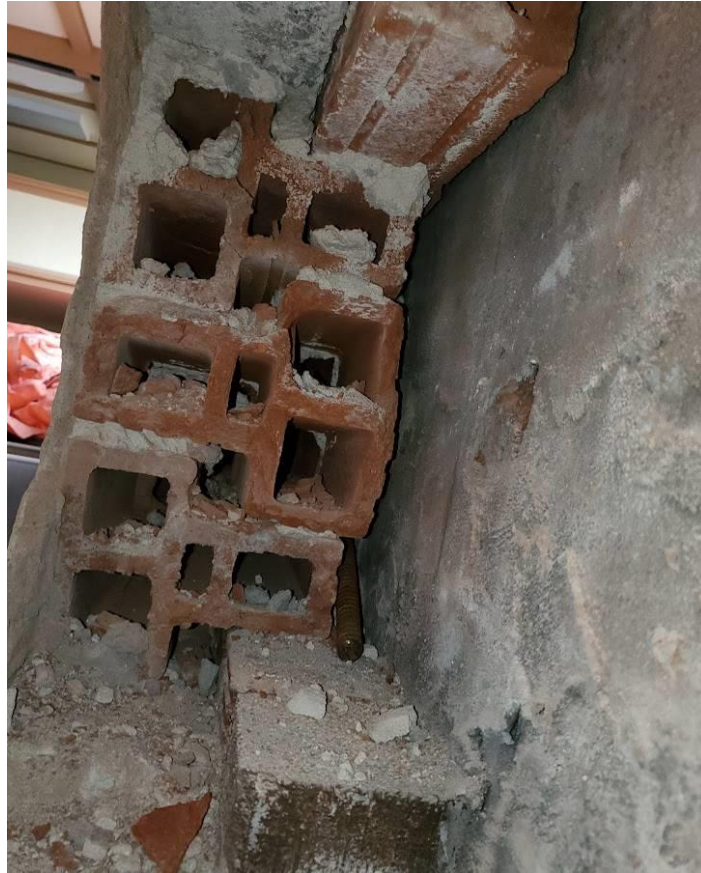
Figure 8: Wall Section

A 4' wide exploratory opening was made on the interior left-hand side wall (see Figure 8) and the following materials were found:

- **Material:** The brick veneer is made of clay.
- **Construction:** The brick veneer is a non-structural, decorative layer applied to the exterior of a building. On the back of the bricks is a uniform cementitious parging. The brick veneer is tied to the structural wall using brick headers every seventh course, following a pattern similar to a common bond, as shown in Figure 9 below. **It is important to note that the existing wall does not comply with current local building codes, which specify requirements for energy efficiency and structural integrity. This non-compliance may impact the future seismic performance of the entire project.**

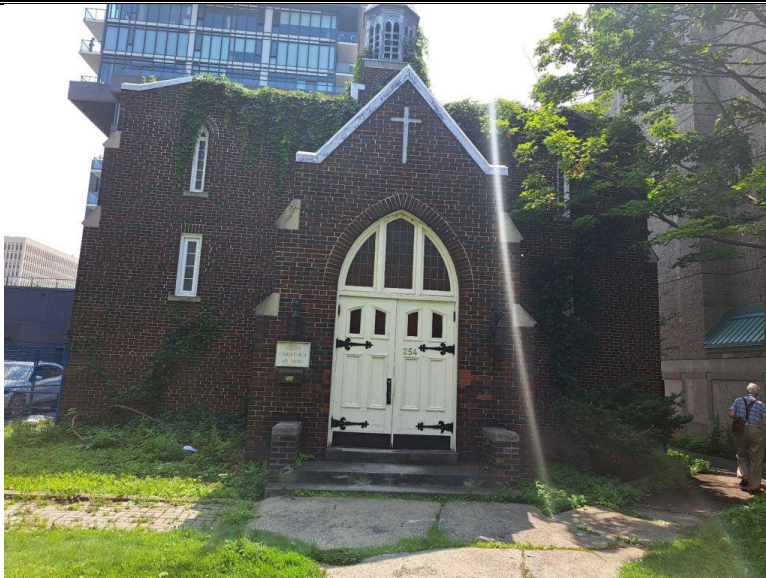
Photo 1
Front entrance (West side)

The concrete steps at the main entrance have deteriorated (see Photo 1). The main door is fabricated from painted wood (see Photo 2) and is in fair condition but requires maintenance (see Photo 3). The transom arch is made from glass panels and wood mullions. No ornaments were noted and most of the bricks are in good condition.

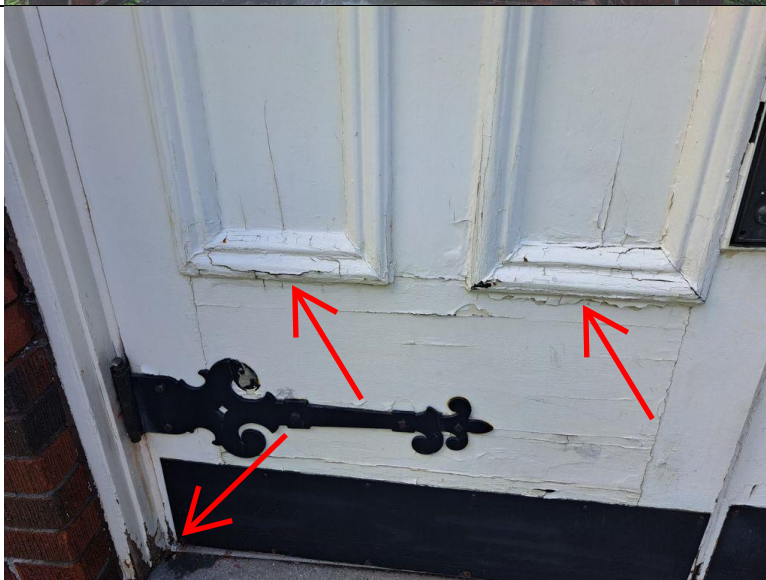
Photo 3
The main door needs intense maintenance work

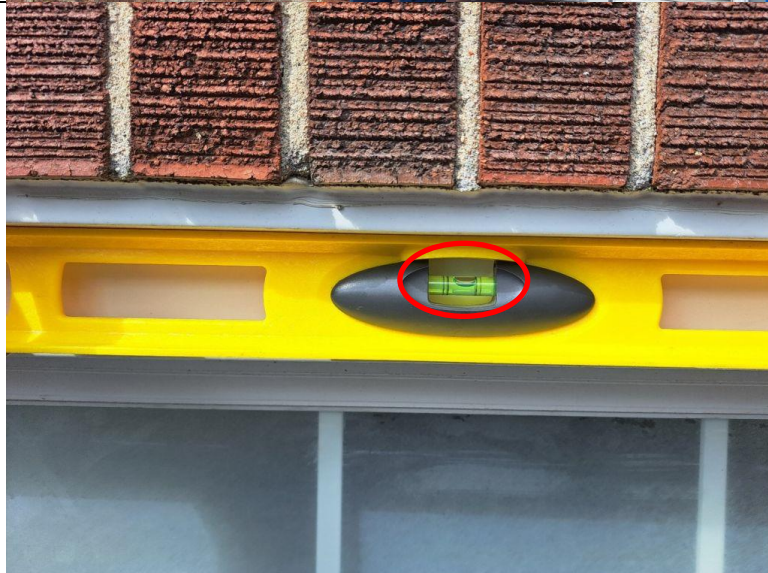
Photo 8

The building is tilted and there is noticeable settlement at the Southeast corner

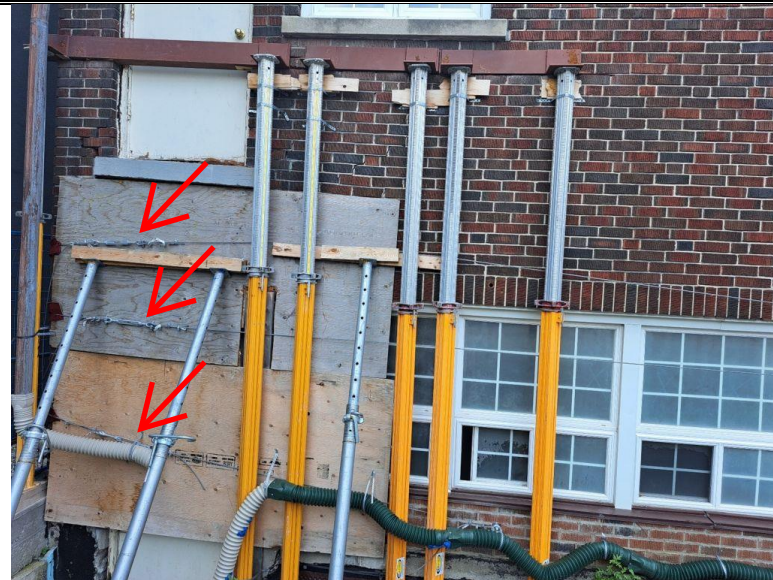
Photo 13

- Downspouts empty too close to the building, concentrating water against the foundation, a very likely source of basement water entry (see Photo 13).
- The staircase to the doorway on the main floor was removed (see Photo 13).

- Sheets of plywood are fastened to the brick cladding in the south-east corner with Tapcon fasteners at regularly spaced intervals to prevent further brick movement in that area. The plywood is secured tight to the building face by three cables (see Photos 11, 12, 13).

- Vertical supports are provided as temporary measures to prevent the whole south-east corner separating from left and back walls (see Photos 11, 13).
- The wall is leaning outwardly by 1cm for every meter (see Photos 15, 16).

The southeast corner is secured by fastening plywood to the brick and three cables

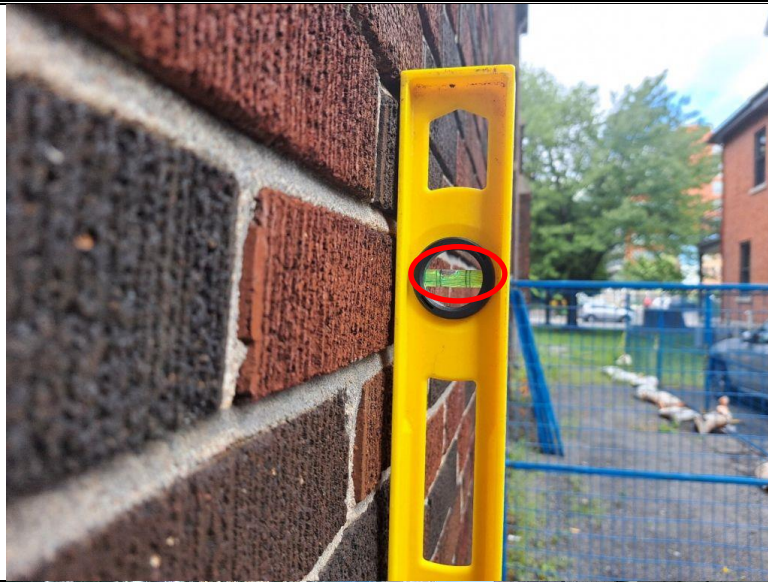
Photo 16
The South wall is leaning to the outside by 1cm for every meter

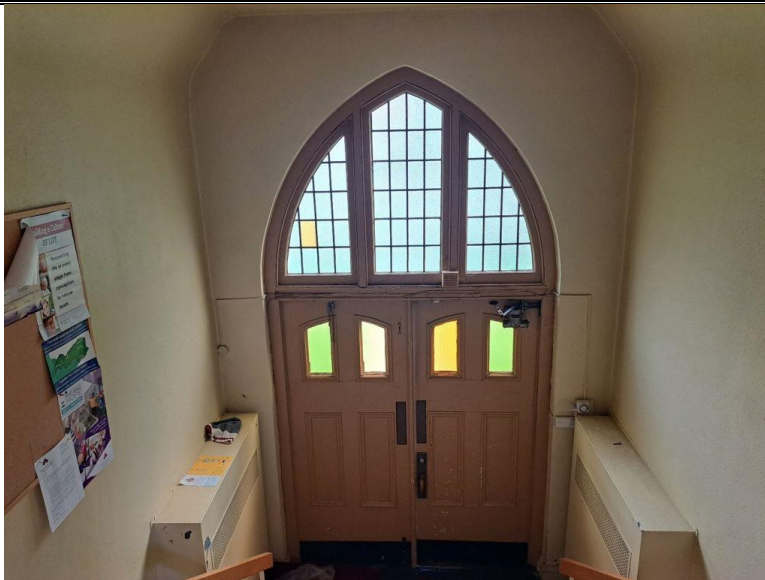
There are no severe cracks noted in this wall (see Photo 22) and the steps leading to the main floor are covered with ceramic tiles and are in fair condition (see Photo 23).

Photo 22
The entrance door from inside

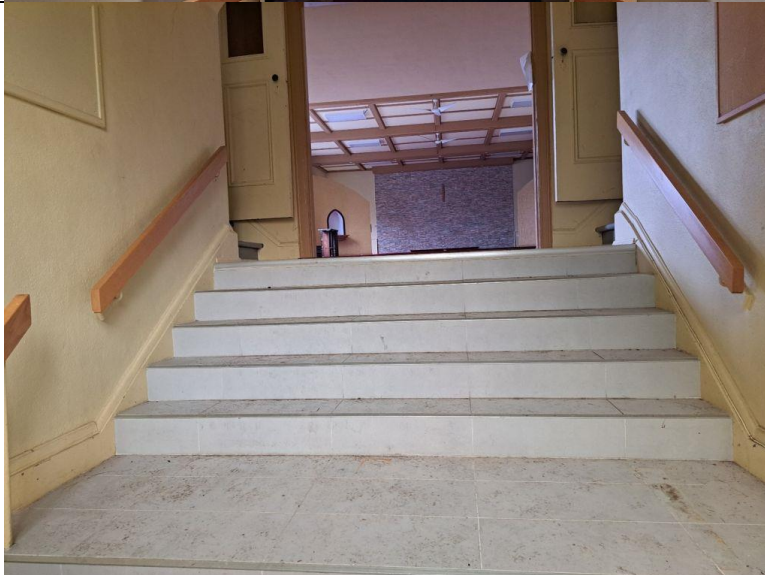
Photo 23
The internal steps are covered with ceramic tiles

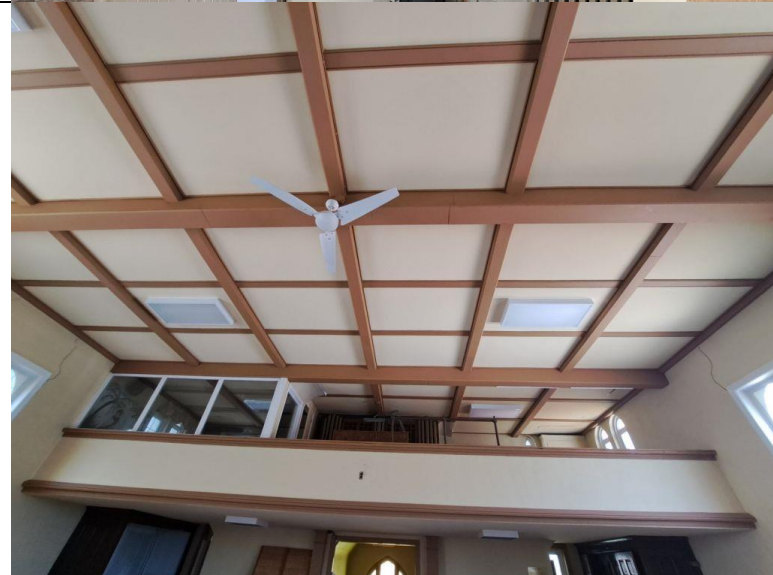
The ceiling does not suffer from any visible cracks, water stains, deflection, or peeling paint (see Photos 44, 45).

Photo 44
General view of the ceiling, no damage noted

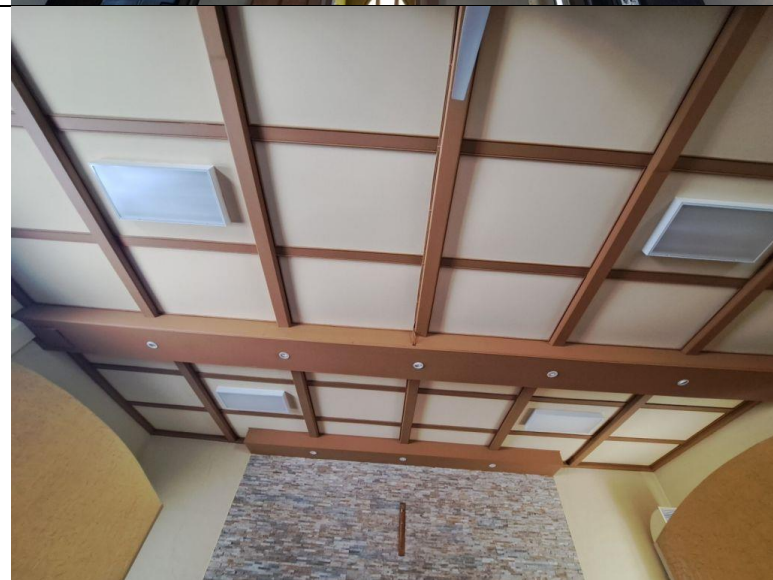
Photo 45
General view of the ceiling, no damage noted

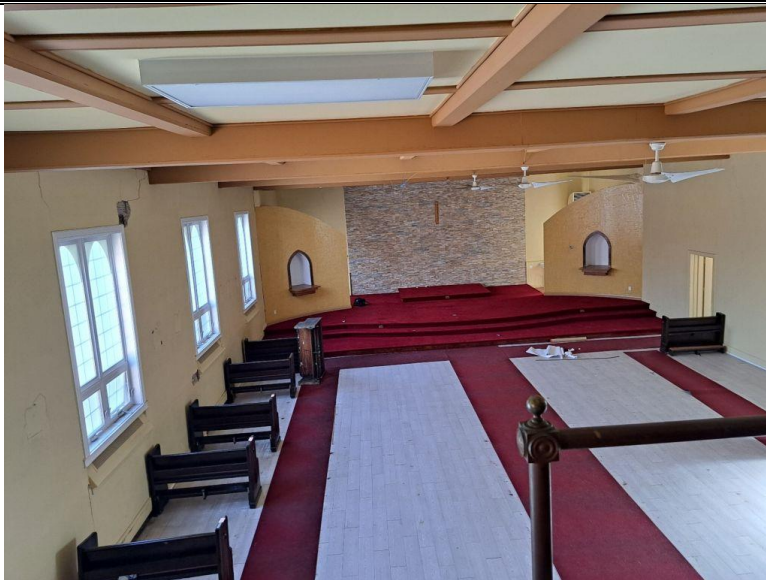
The carpet and laminated wood floor are in fair condition (see Photo 46). No structural concerns are present.

Photo 46
General view of the floor, the floor is laminated wood planks and carpet

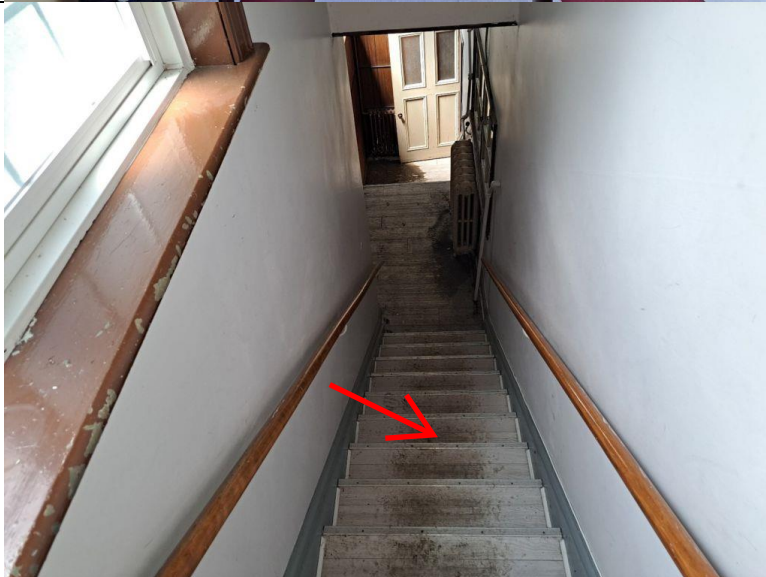
The stairs are covered with laminated wood boards of poor quality which were wet and dirty at the time of the inspection. A side door to exit at the right side of the building is located at the landing between the main floor and the basement (see Photos 47, 48).

Photo 47
Staircase to the basement, covered with laminated wood

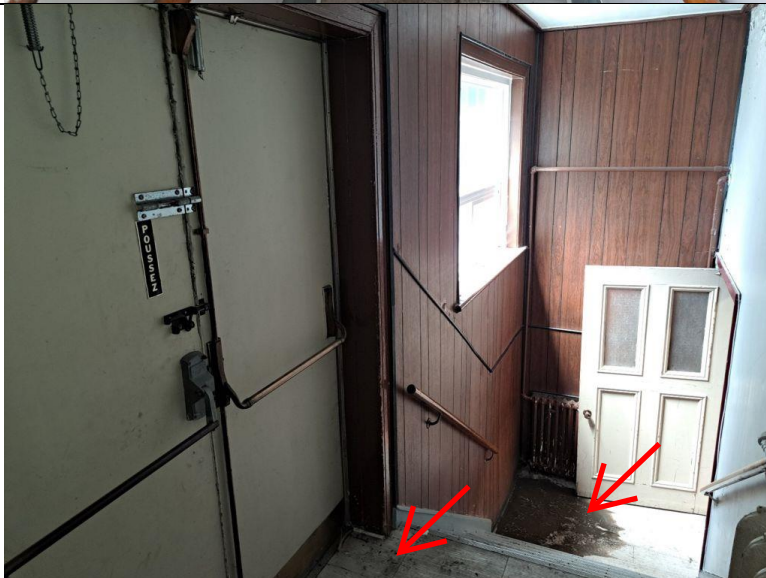
Photo 48
The side door is at the landing level

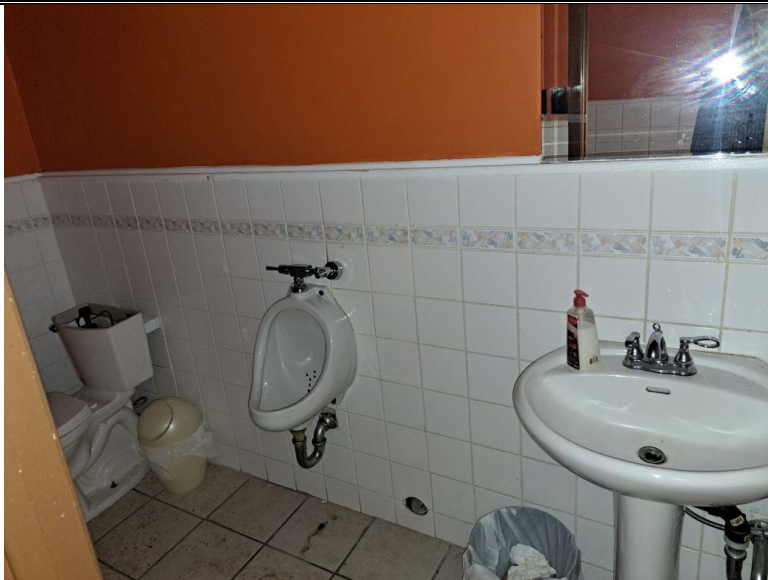
Photo 64

The washroom area is neglected and needs lots of maintenance. The water was disconnected at the time of inspection (see Photo 64).

Room view of the washroom, water was disconnected at the time of inspection, and the washroom was dirty and not maintained

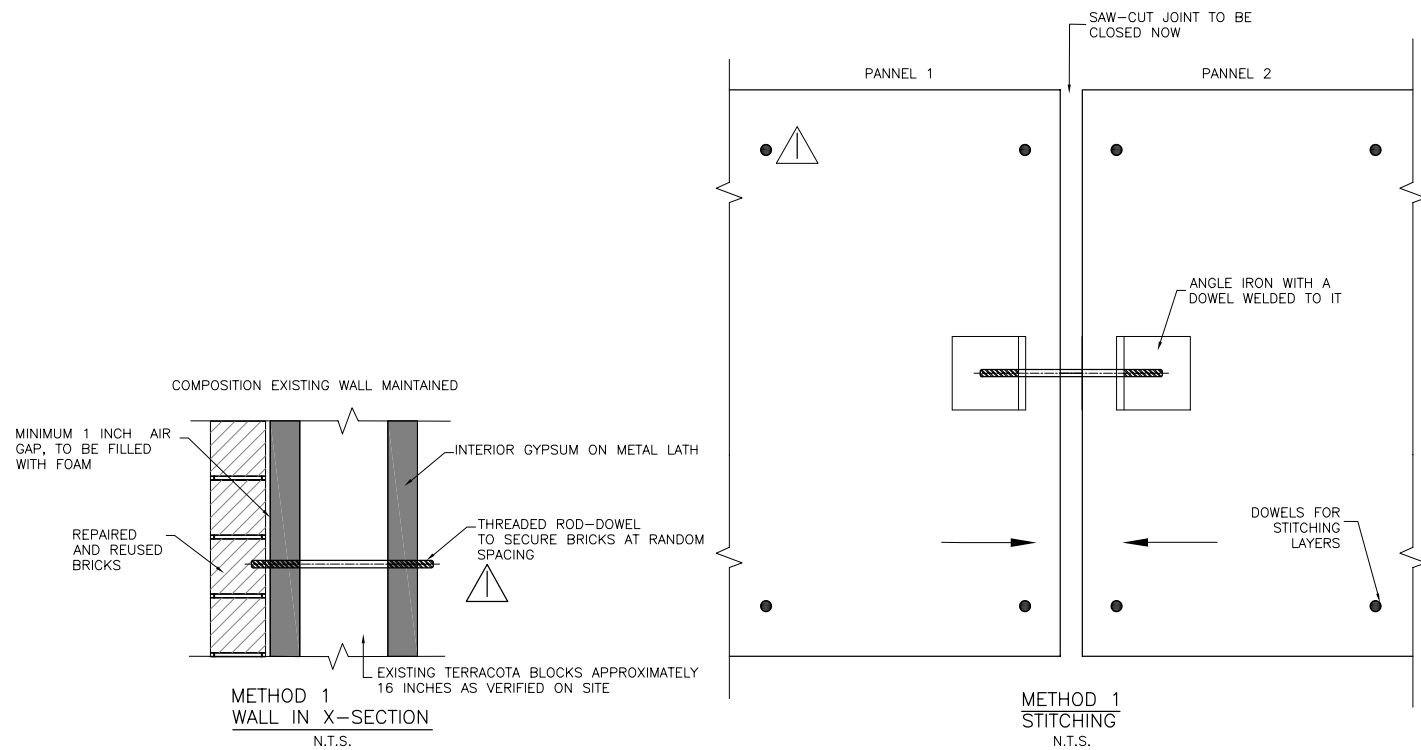
EXISTING WALL COMPOSITION:

- BRICK VENEER
- AIR GAP
- TERRACOTTA BLOCKS

NEW DOWELS/CINTEC ANCHORS OR EQUIVALENT TO TIE BRICK VENEER TO OLD TERRACOTTA WALL. SPACING TO BE DETERMINED.
