CONSERVATION PLAN

254 ARGYLE AVE, OTTAWA, ON
L'ÉGLISE CHRIST-ROI (CHRIST THE KING CHAPEL)

PREPARED BY: Emily B. Leonoff, MAC, CAHP

DATE: September 27, 2024

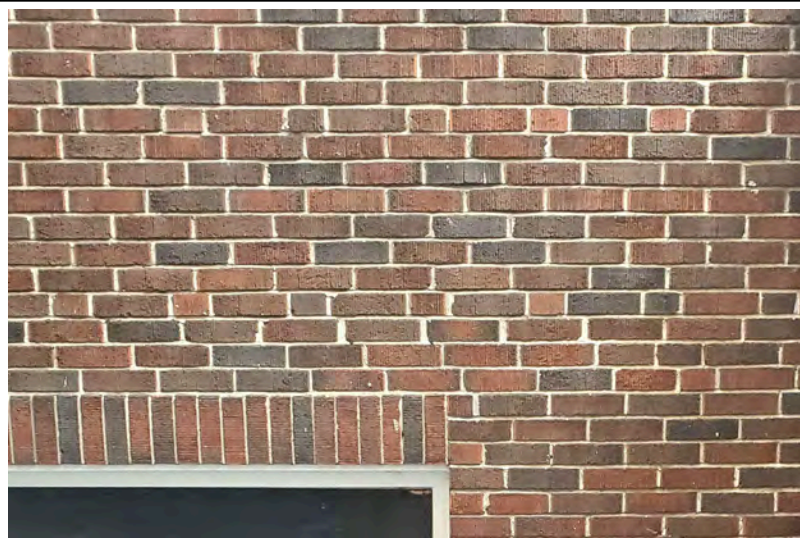
Fig. 6: An overall view of the randomized brick pattern on the east elevation of the building.

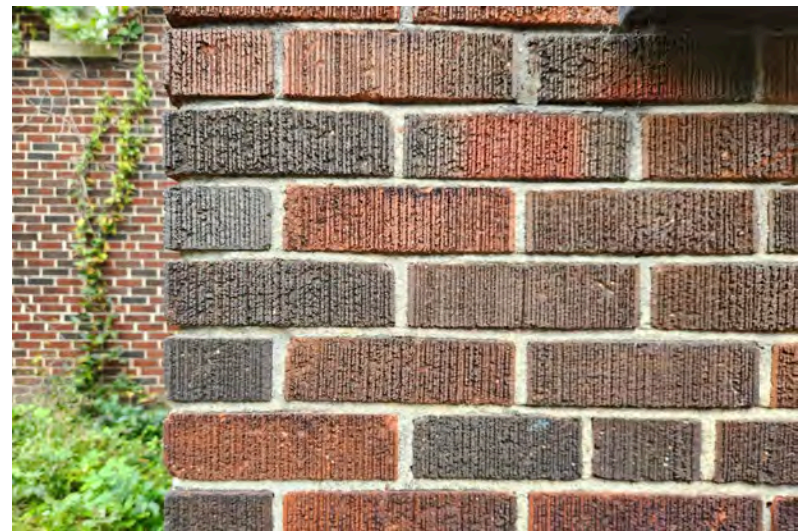
Fig. 7: A view of a section of the brick pattern on the north elevation.

The bricks are an extruded clay brick with a textured, 'combed' finish.

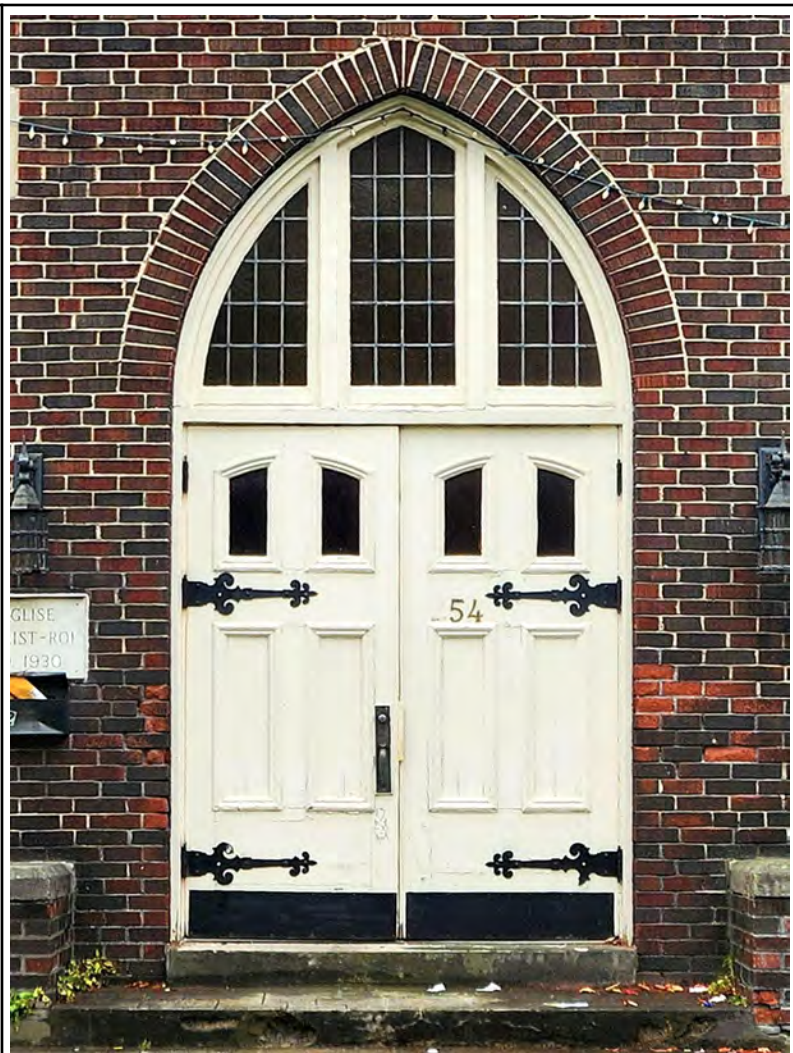
Fig. 12: The bottom of the left door leaf showing existing heavy paint layers failing and corrosion around the metal decorative hinges.

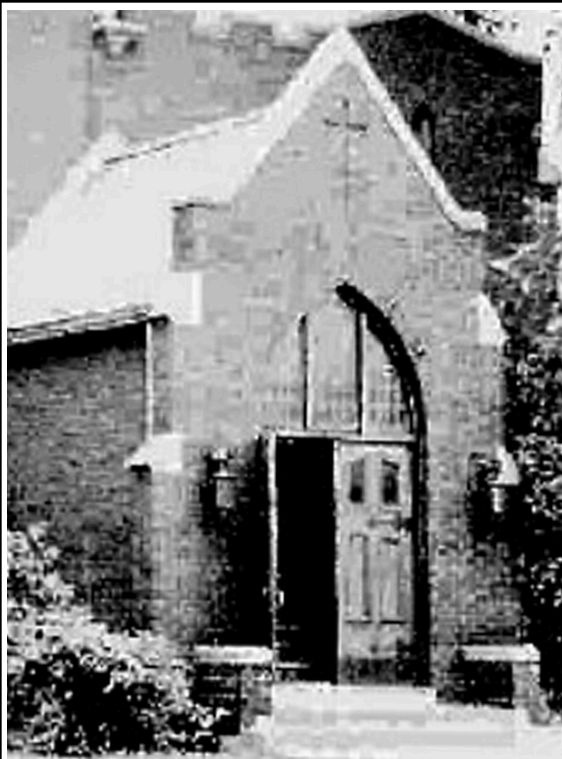
Fig. 14: A detail from a photograph titled, "1929-30 Church Under Construction" showing the main doors and transom. Though it is currently thought that the assembly is non-original, historical evidence shows nearly identical doors, hardware included, implying otherwise. *Source: Bibliothèque et Archives nationales du Québec.*

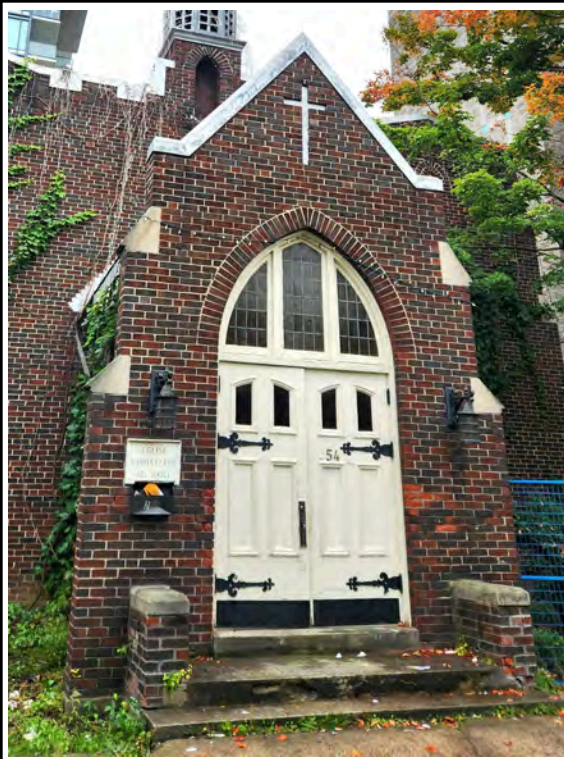
Fig. 15: A September 2024 image of the main doors of the church which strongly resemble those seen in historical images and the building's original blueprints (see Fig. 16). The main difference between this image and the historical image appears to be the transom which is showing wider and more robust mullions and surrounding frame. It is possible that the transom frame has been modified at some point.

A full examination of the doors and frame and its construction details should provide an answer.

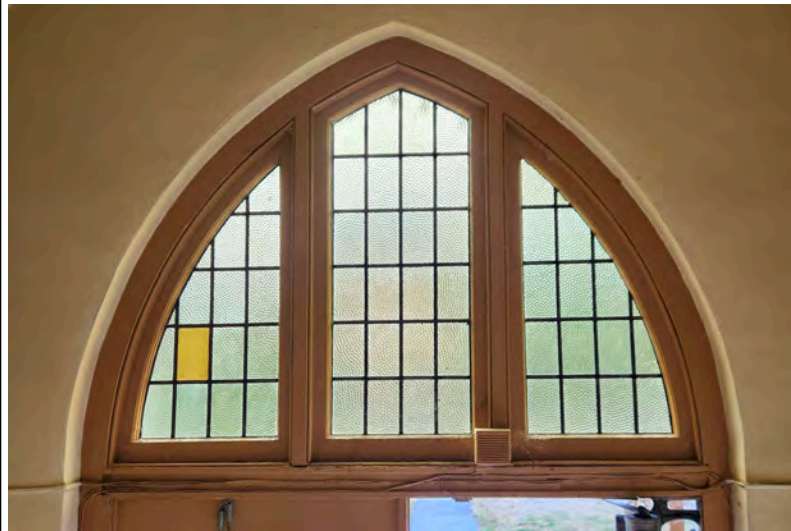
Fig. 20: The interior face of the Georgian patterned stained and leaded glass transom above the main doors.

Note the one yellow replacement pane in the lower left of the image.

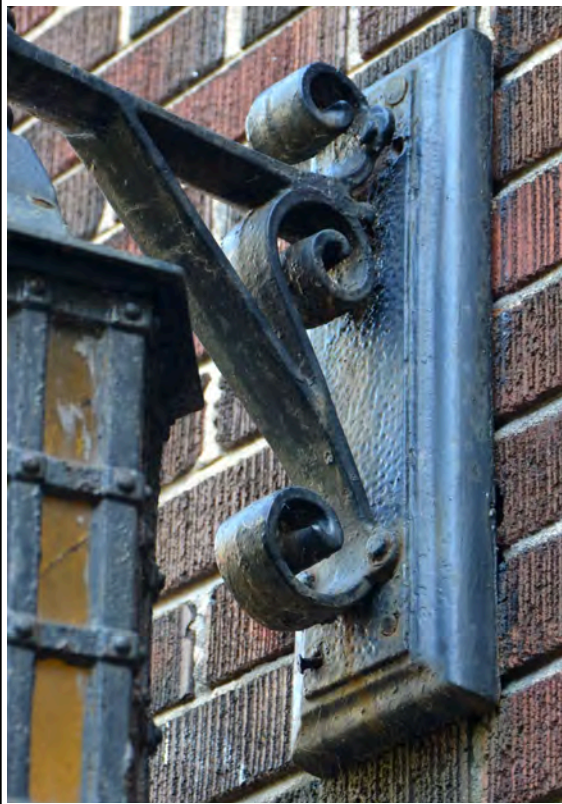
Fig. 28: A view of the cast iron face plate affixed to the brick.

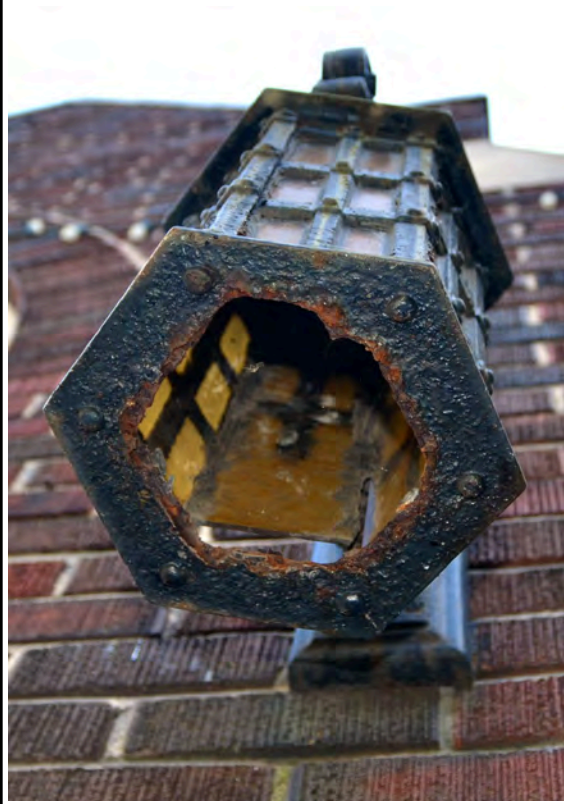
Fig. 29: A view looking up into the interior of one of the two lanterns.
