HERITAGE IMPACT ASSESSMENT & CONSERVATION PLAN*

168 -174 MURRAY STREET, OTTAWA

Owner: David Yoo
Address: 168 – 174 Murray Street, Ottawa, Ontario

Revised March 2025

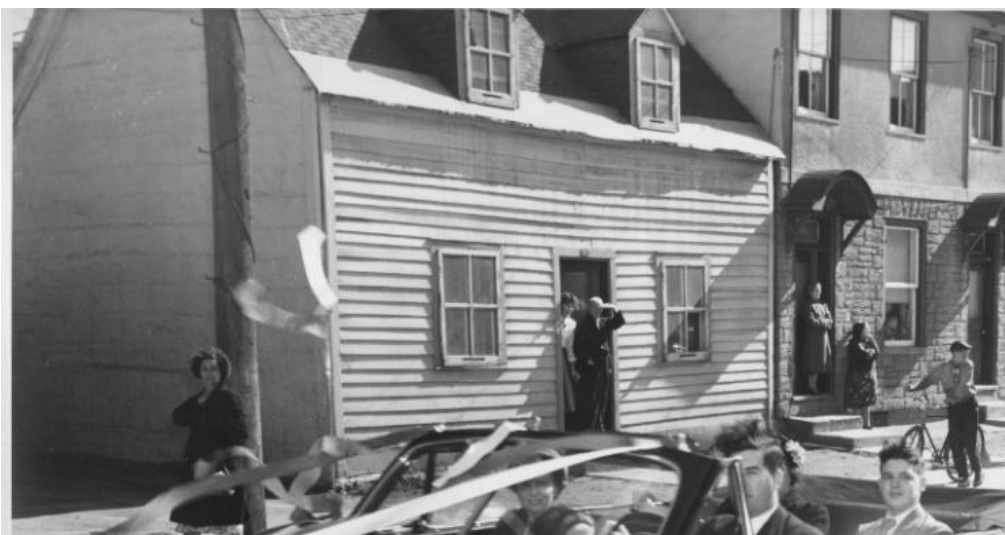
Figure 38: The house at 168 Murray appears in the background of the c.1949 parade. The house is a 1.5 storey side gable with two dormers facing the street, a centre front door with no canopy, horizontal siding on the front and squared timber chinked and whitewashed on the gabled side elevation.

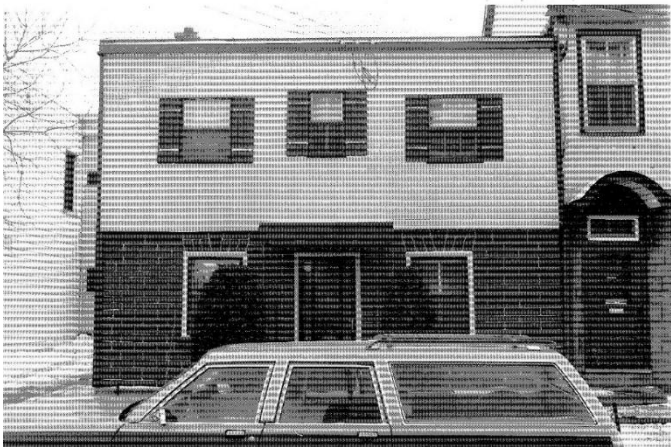
Figure 4: A 1991 view of the house documents the substantive alteration from its original one-and-one half storey side gable roof with gabled dormers facing the street. The house has been remodelled with a flat roof, a second floor added, and three windows replacing the dormers. The exterior was reclad in an angel stone on the ground floor and aluminum siding on the upper floor. A canopy over the front door has been added. Source: City of Ottawa Heritage Survey Forms 1991.

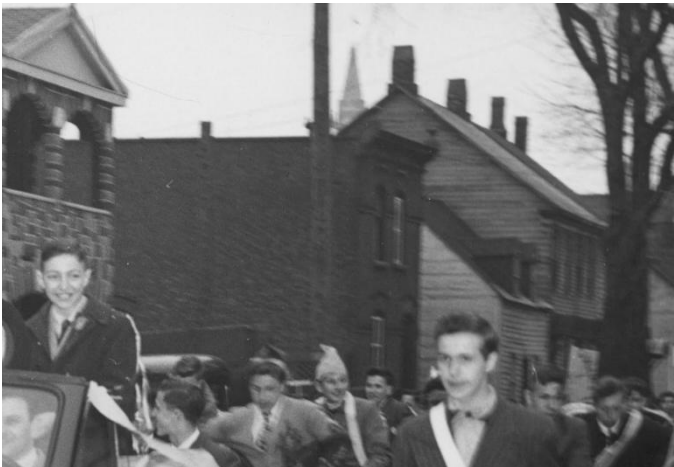
Figure 41: A c.1949 picture with the two houses in the background clearly documents the brick siding of 174 Murray Street and the cottage form of the neighbouring 168 Murray. Source: Marc Aubin’s collection

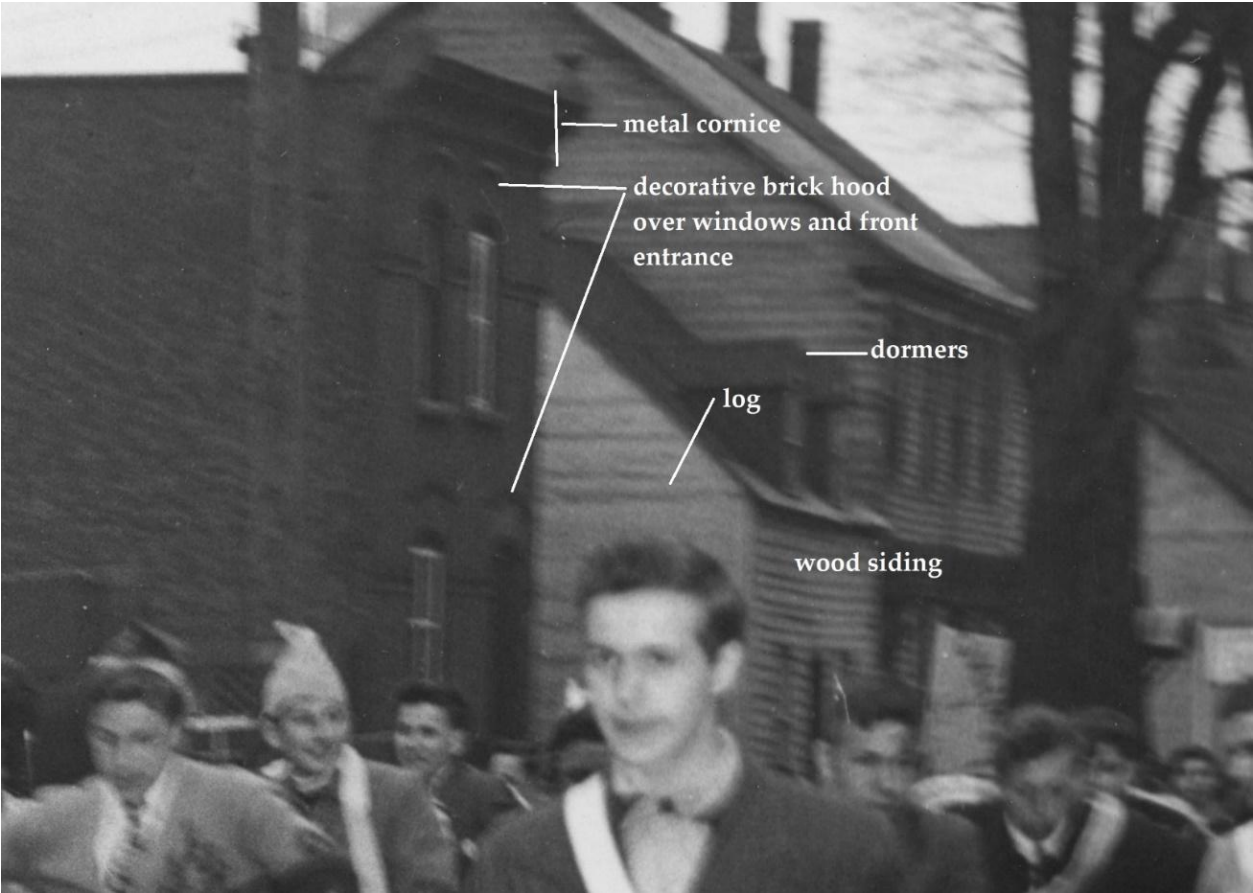
Figure 44: A c.1949 photograph clearly documents the 2-storey brick siding of 174 Murray Street with its off-set door and decorative arched headers over the door and windows. The cottage form of the neighbouring 168 Murray with the textured log sidewall of squared log. The log has been covered over on the front façade with a horizontal siding. Source: Marc Aubin’s collection
