Tree Information Report v2.0

Date of Report: April 22, 2025
Property Address: 15 Deerfox Drive
Prepared for: Antilia Homes c/o Ravi Shanghavi; ravi@antiliahomes.com
Prepared by: Kevin Myers, ISA Certified Arborist®; kevin.myers@dendronforestry.ca
Date of Site Visit: March 20, 2024

TIR Map – 15 Deerfox Drive
Tree layer prepared by
Dendron Forestry Services
Version 2.0, April 22, 2025
For more information, please contact: info@dendronforestry.ca

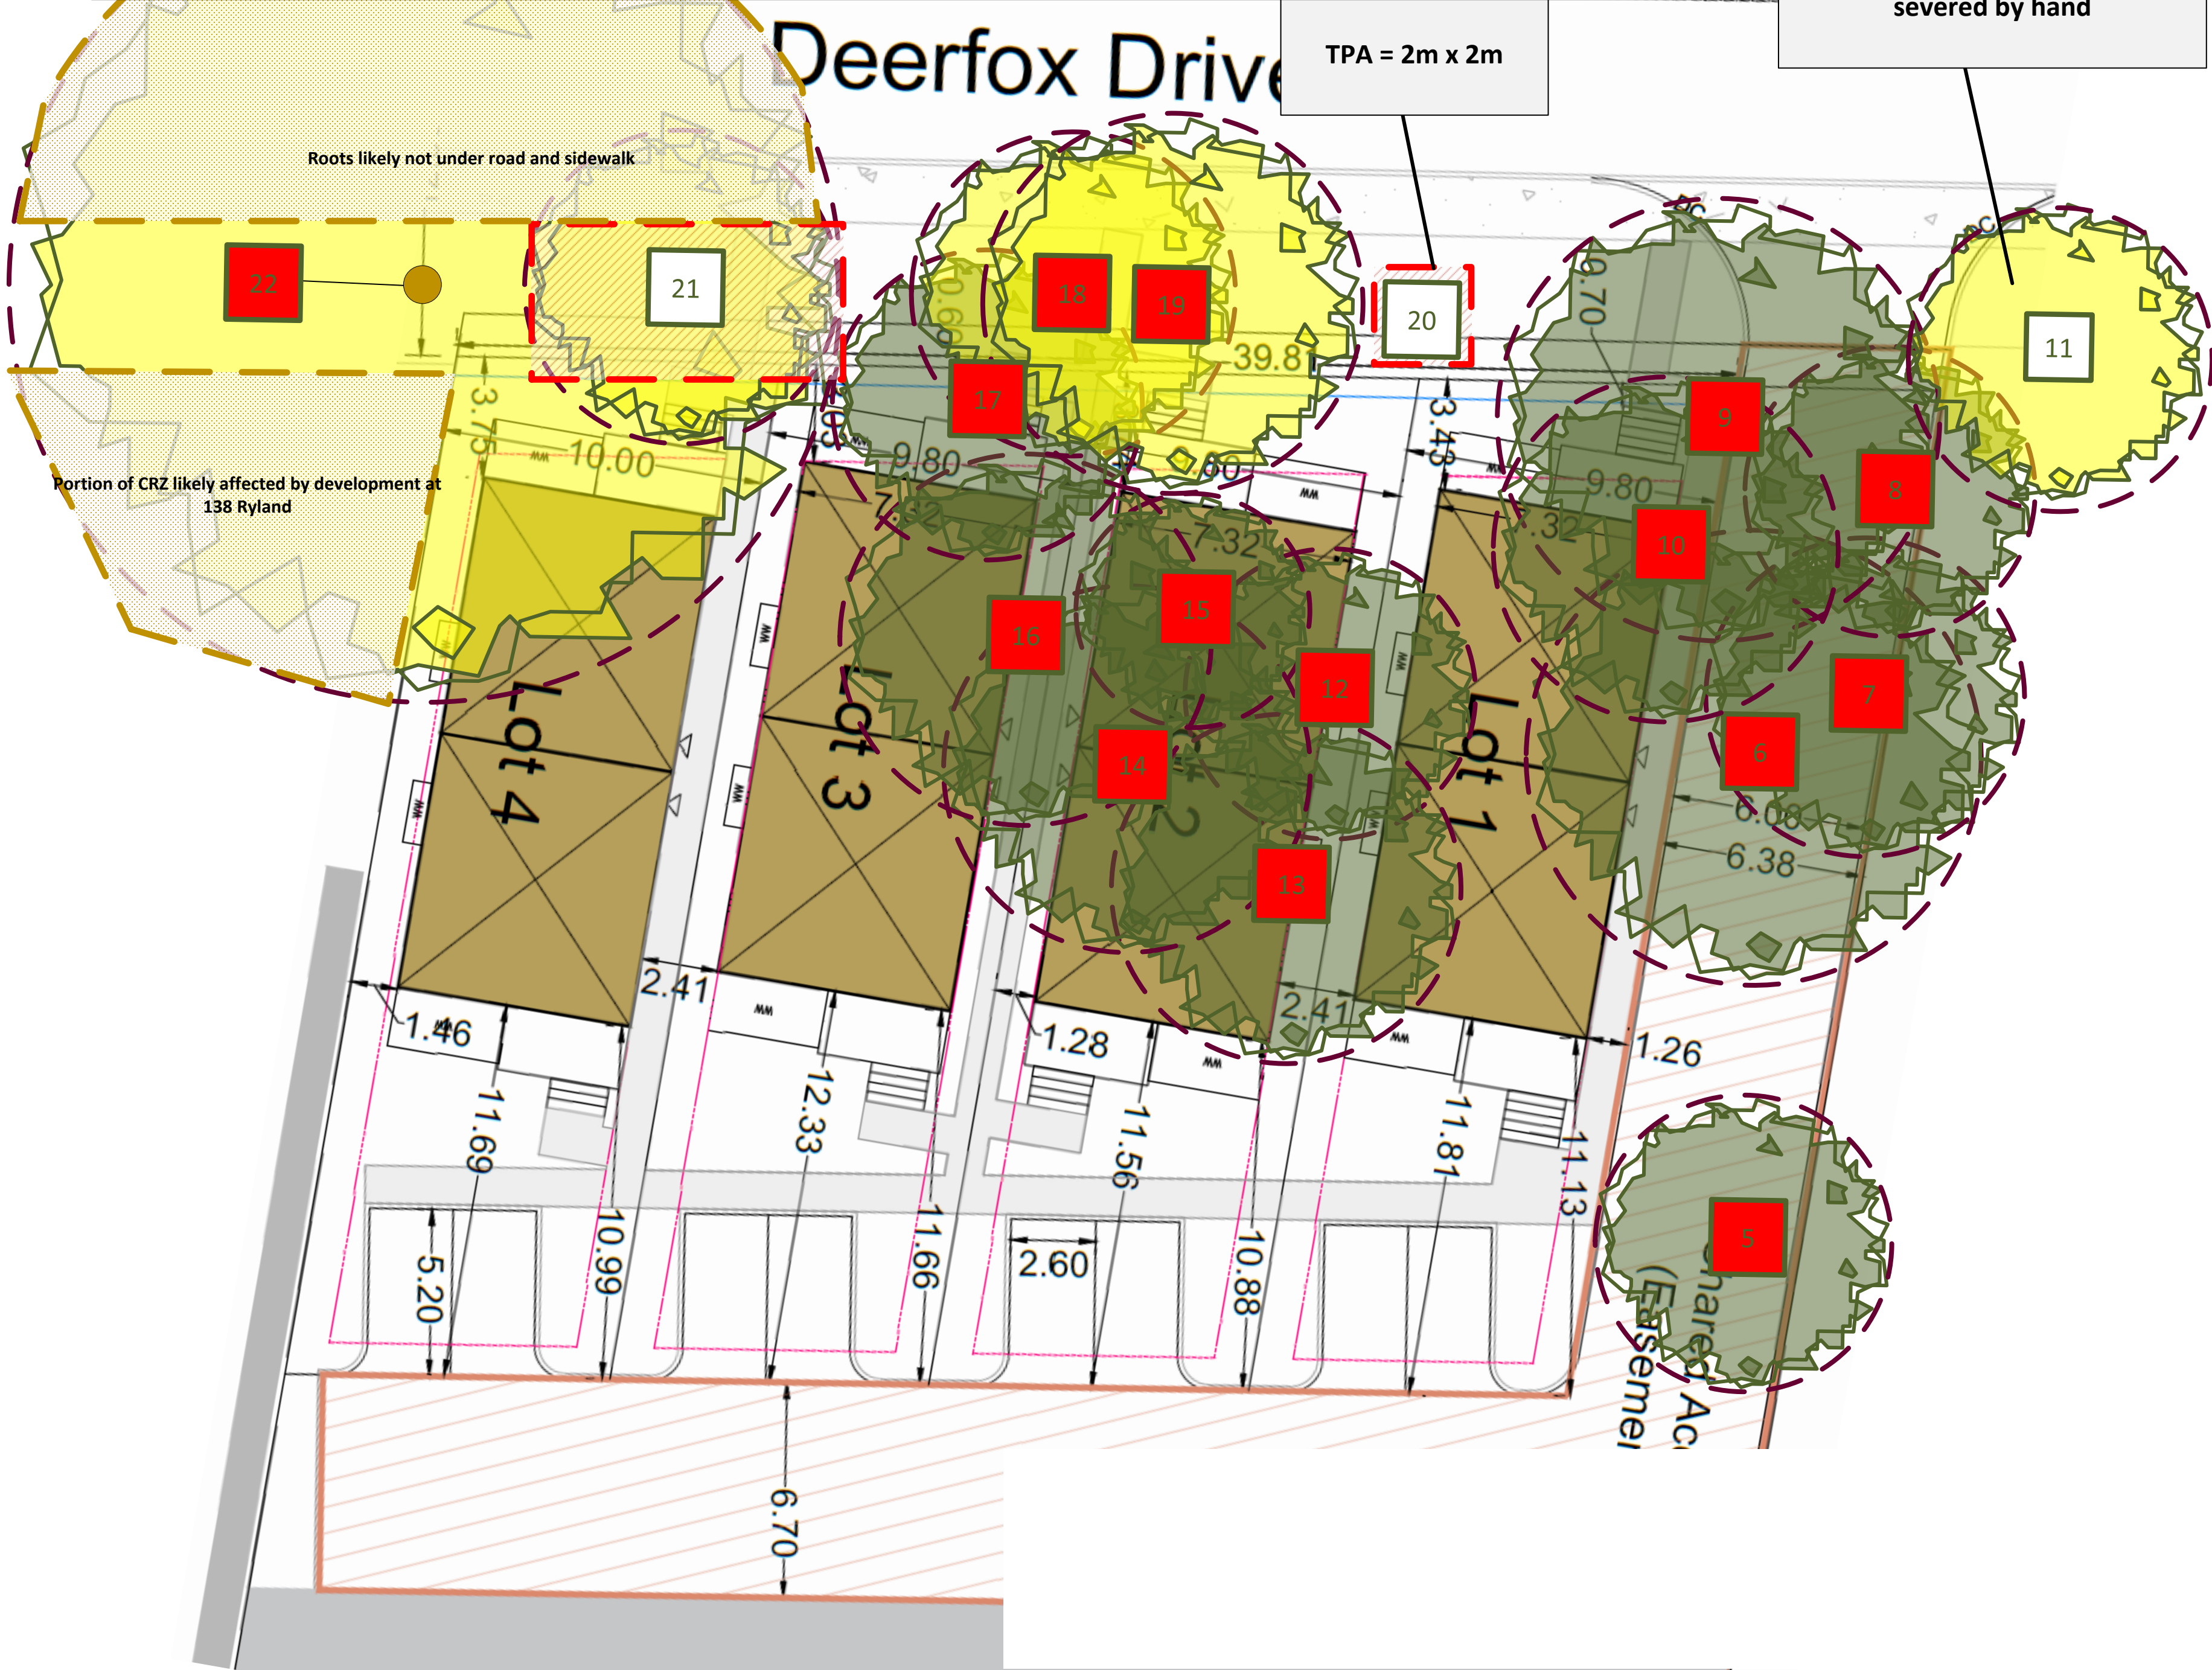
Tree ¹	Species	DBH (cm)	Tree condition	Approximate distance to excavation (m)	Forester recommendation
5	Colorado spruce (<i>Picea pungens</i>)	42	Fair/Good: tridominant stems at 7m; some dead branches; ~10% defoliation	Driveway: 0	Remove: in line with driveway. Tree permit required for removal.
6	Sugar maple (<i>Acer saccharum</i>)	65 @ 1.1m	Good: some branches rubbing against trunk; large burl	Driveway: 0	Remove: in line with driveway. Tree permit required for removal.
7	Sugar maple (<i>Acer saccharum</i>)	45	Fair: top is broken off – growth correcting; suppressed/asymmetrical crown	Driveway: 0	Remove: in line with driveway. Tree permit required for removal.
8	Black maple (<i>Acer nigrum</i>)	42	Good: codominant stems at 8m	Driveway: 0	Remove: in line with driveway. Tree permit required for removal.
9	Sugar maple (<i>Acer saccharum</i>)	63	Fair/Poor: decay probable – woodpecker activity; top has poor form	Driveway: 0	Remove: in line with driveway. Tree permit required for removal.

10	Sugar maple (<i>Acer saccharum</i>)	49.5	Fair: large crook at top – likely broken off years ago	Driveway: 0	Remove: in line with driveway. Tree permit required for removal.
11	Sugar maple (<i>Acer saccharum</i>)	35, 36	Fair/Poor: cavities with decay in canopy; codominant stems with included bark at base	Driveway: 2	Retain. Roots to be revealed along the line of excavation and cleanly severed by hand prior to excavation with heavy equipment.
12	Beech (<i>Fagus grandifolia</i>)	43	Good/Fair: crooks; scale insect	0	Remove: within area of excavation. Tree permit required for removal.
13	Beech (<i>Fagus grandifolia</i>)	49.3	Poor: scale insect; top broken; large cavity at top; fungal bodies at base	0	Remove: within area of excavation. Tree permit required for removal.
14	Beech (<i>Fagus grandifolia</i>)	52	Good: Slight lean; epicormic shoots	0	Remove: within area of excavation. Tree permit required for removal.

15	Black maple (<i>Acer nigrum</i>)	33	Poor: large cavity at top; debarking at base – low vigor	0	Remove: within area of excavation. Tree permit required for removal.
16	Beech (<i>Fagus grandifolia</i>)	54	Poor: large cavity at top; bark disease	0	Remove: within area of excavation. Tree permit required for removal.
17	Sugar maple (<i>Acer saccharum</i>)	44	Fair/Poor: decay in large wound at top	< 1	Remove due to proximity of excavation. Tree permit required for removal.
18	Sugar maple (<i>Acer saccharum</i>)	46	Fair: epicormics turning into	Walkway: 0	Remove: in line with proposed walkway. Tree permit required for removal.
19	Sugar maple (<i>Acer saccharum</i>)	54	Fair/Poor: top dead	Walkway: < 1	Remove due to proximity of excavation. Tree permit required for removal.
20 ⁴	Sugar maple (<i>Acer saccharum</i>)	7	Good	House: 3.5	Retain and protect as per the City of Ottawa Tree Protection Specifications (March 2021).

21	Cedar hedge (<i>Thuja occidentalis</i>)	7 stems 14-22	Fair: 15' tall	3.5	Retain and protect as per the City of Ottawa Tree Protection Specifications (March 2021).
22	Willow (<i>Salix spp.</i>)	119	Fair: large cavity at base – approx. 1/3 diameter deep; decay and woodpecker activity on trunk (small area); large branches pruned off – epicormic shoots at wounds and on trunk	House: 4 Porch: 3 Walkway: < 1	Remove due to impacts from previous construction, combined with proposed walkway and site works. Tree permit required for removal.
