Tree Information Report Version 3.0

Submitted as part of Building Permit Application for the City of Ottawa

Address: 844 Connaught

Date: December 21, 2023

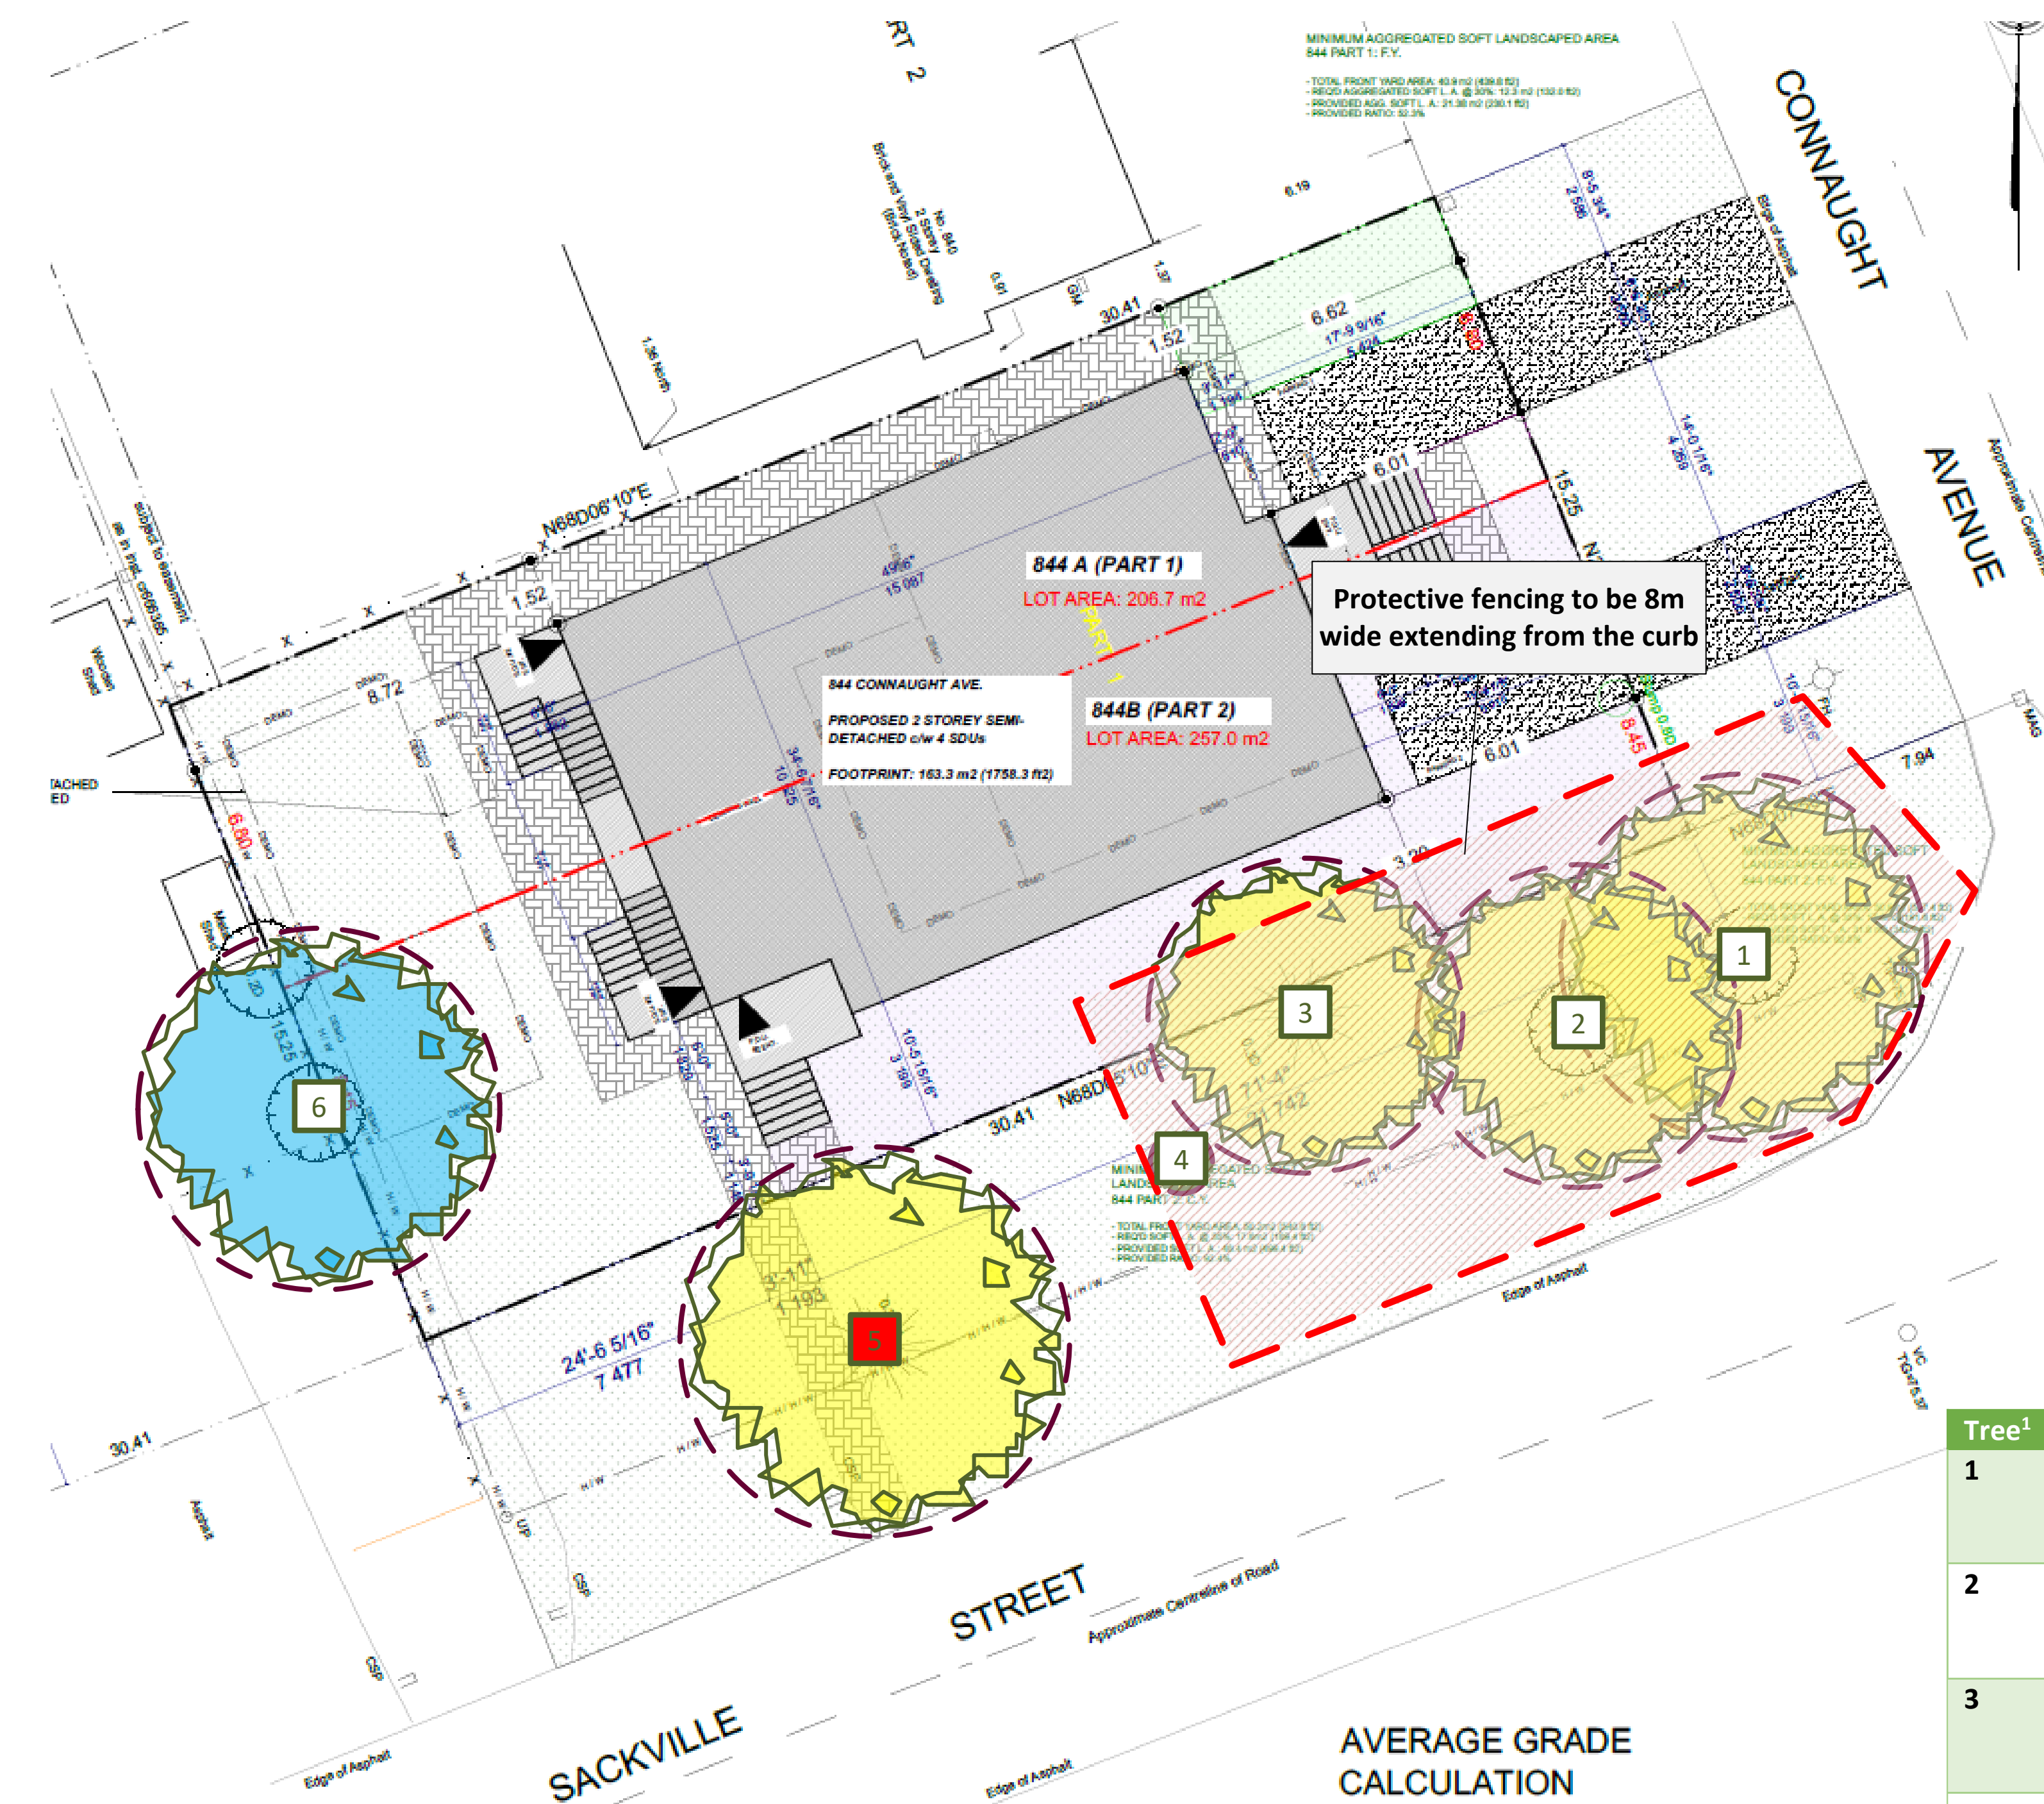
Tree Protection Area (TPA)

Tree ¹	Species	DBH (cm)	Condition	Recommendations
1	Norway maple (<i>Acer platanoides</i>)	41 cm	Fair/poor; large canker (35X50) at base of tree, leaning in opposite direction, pruned by hydro	Retain and protect with fencing as per specifications in report, City should monitor regularly for stability
2	Norway maple (<i>Acer platanoides</i>)	36 cm	Fair/good; 2 from hydro lines, significant hydro pruning but has adapted well	Retain and protect with fencing as per specifications in report
3	White spruce (<i>Picea glauca</i>)	35 cm	Good/fair; sweep at base, some hydro pruning, possible root girdling on underside of lean	Retain and protect with fencing as per specifications in report
4	Viburnum (<i>Viburnum lentago</i>)	5 cm	Good	Retain and protect with fencing as per specifications in report
5	White spruce (<i>Picea glauca</i>)	39 cm	Poor; topped by hydro	Remove based on health and potential impact of construction; better option is to replace with a new tree post construction

Prior to any site works, fencing should be installed around the TPA as indicated in this Map and maintained until all construction on site has been completed as per the **City of Ottawa Tree Protection Specifications (March 2021)**. Within the fenced area, the following tree protection guidelines should be applied:

- Do not change the grade
- Do not store construction material
- Do not operate machinery
- Do not convert to hard surface or change the landscaping
- Do not excavate unless it is a method that has been pre-approved by the City
- Do not place signs, notices or posters to any tree
- Do not damage the root system, trunk, or branches of any tree
- Direct the exhaust away from the tree

The tree protection fencing must be 1.2 m in height and constructed of a rigid or framed material (e.g. modulus – steel, plywood hoarding, or snow fence on a 2”X4” wood frame) with posts 2.4 m apart such that the fence location cannot be altered. All supports must be placed outside of the CRZ and installation must minimize damage to existing roots.
