Tree Information Report – 6719 Barsona Place, Ottawa

This Tree Information Report is being submitted as a partial requirement for the development of this property. A site visit was conducted by Chris McIntyre, Certified Arborist ON-1219A, on December 18, 2025.

6719 BARSONA PLACE
 OTTAWA ONTARIO
 TREE INFORMATION REPORT

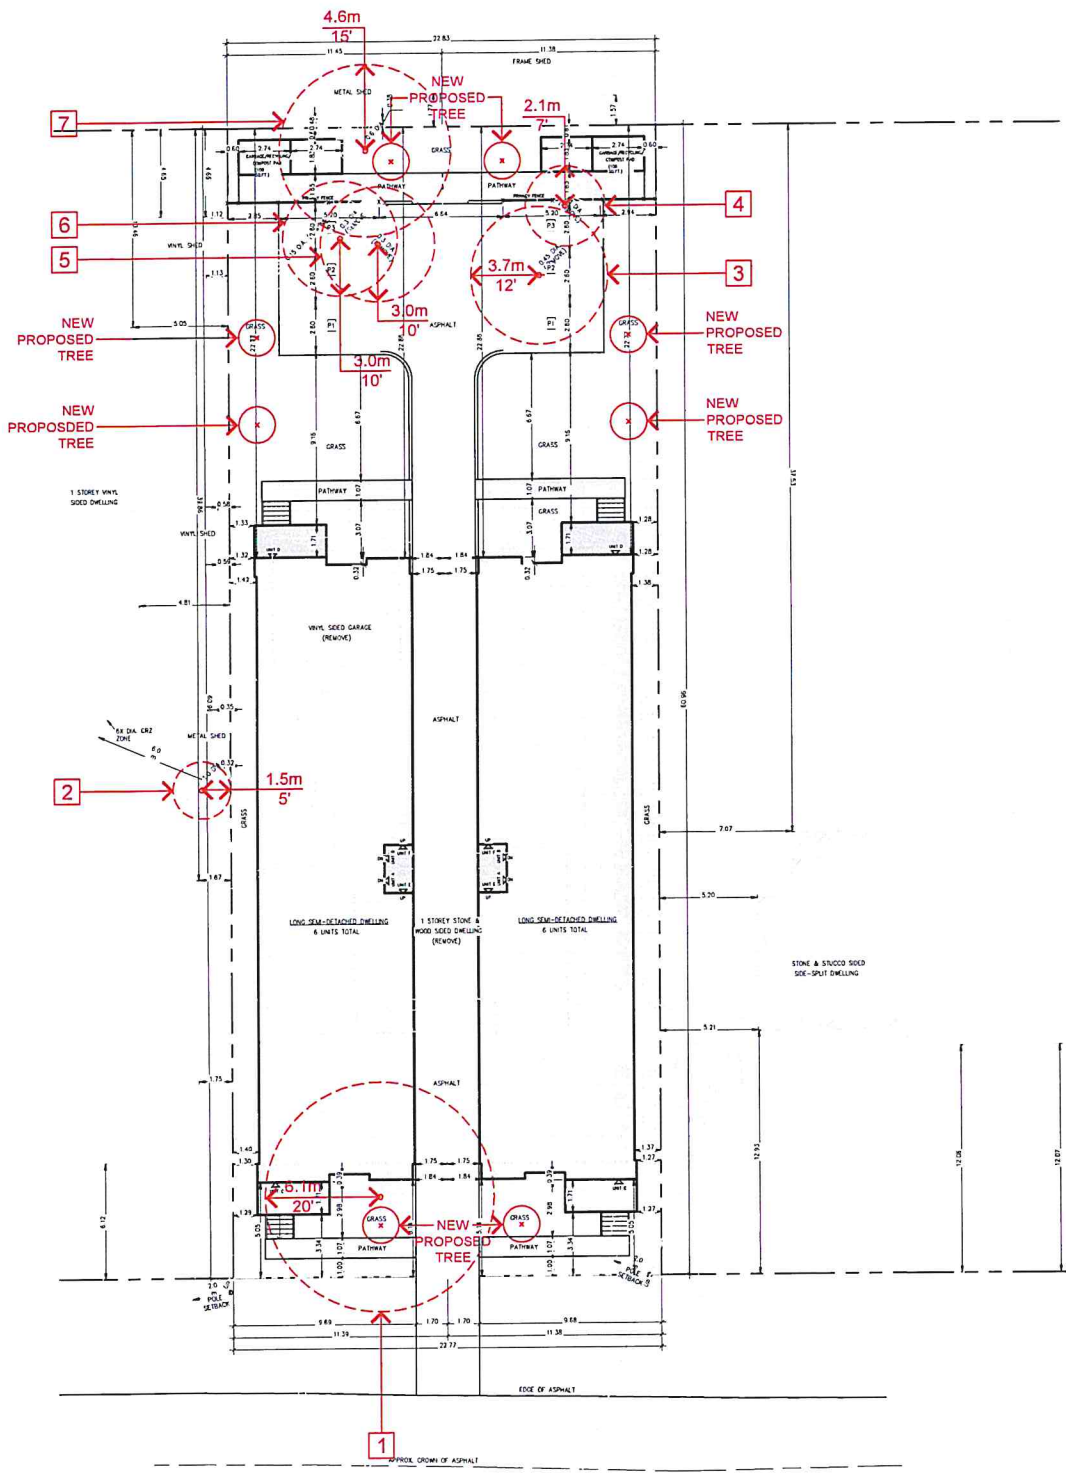
Tree 5

5	Manitoba maple	26	Private	Tree health and vigor are fair, structure is poor.	Within footprint of development.	Remove. Tree is not viable long term. Conflict with construction.
6	Manitoba maple	32	Private	Tree health, vigor and structure are all considered fair.	Within footprint of development.	Remove. Conflict with construction.
7	Manitoba maple	46	Private	Tree health, vigor and structure are all considered poor. Extensive decay present due to crown failure.	Within footprint of development.	Remove - Safety.
<p>Tree Protection Measures for Retained Trees.</p> <p>The following are measures to be implemented prior and during the construction process.</p> <ul style="list-style-type: none"> -Critical root zone of retained trees must be protected as outlined above. Snow or metal fencing must be erected around the CRZ and signage should be installed to identify tree is being protected. -Pruning must be performed prior to construction to ensure tree limbs will not be in conflict with equipment and construction. Permission must be obtained to prune Municipal or neighbors trees. (performed by Certified Arborist). -No material or equipment is permitted within any CRZ. -No signs, notices or posters may be attached to the tree. -No grade changes within any CRZ. -Ensure exhaust fumes from equipment are not directed towards tree canopy's. -After excavation is complete exposed and damaged roots should be pruned (performed by Certified Arborist).
