## TREE CONSERVATION REPORT

65 and 85 Gemini Way

Tree Conservation Report submitted as Partial  
Requirements for a Site Plan Control  
Application, November 28, 2024 and Application  
for Severance for 65 Gemini Way

**Date of Report:** November 28, 2024

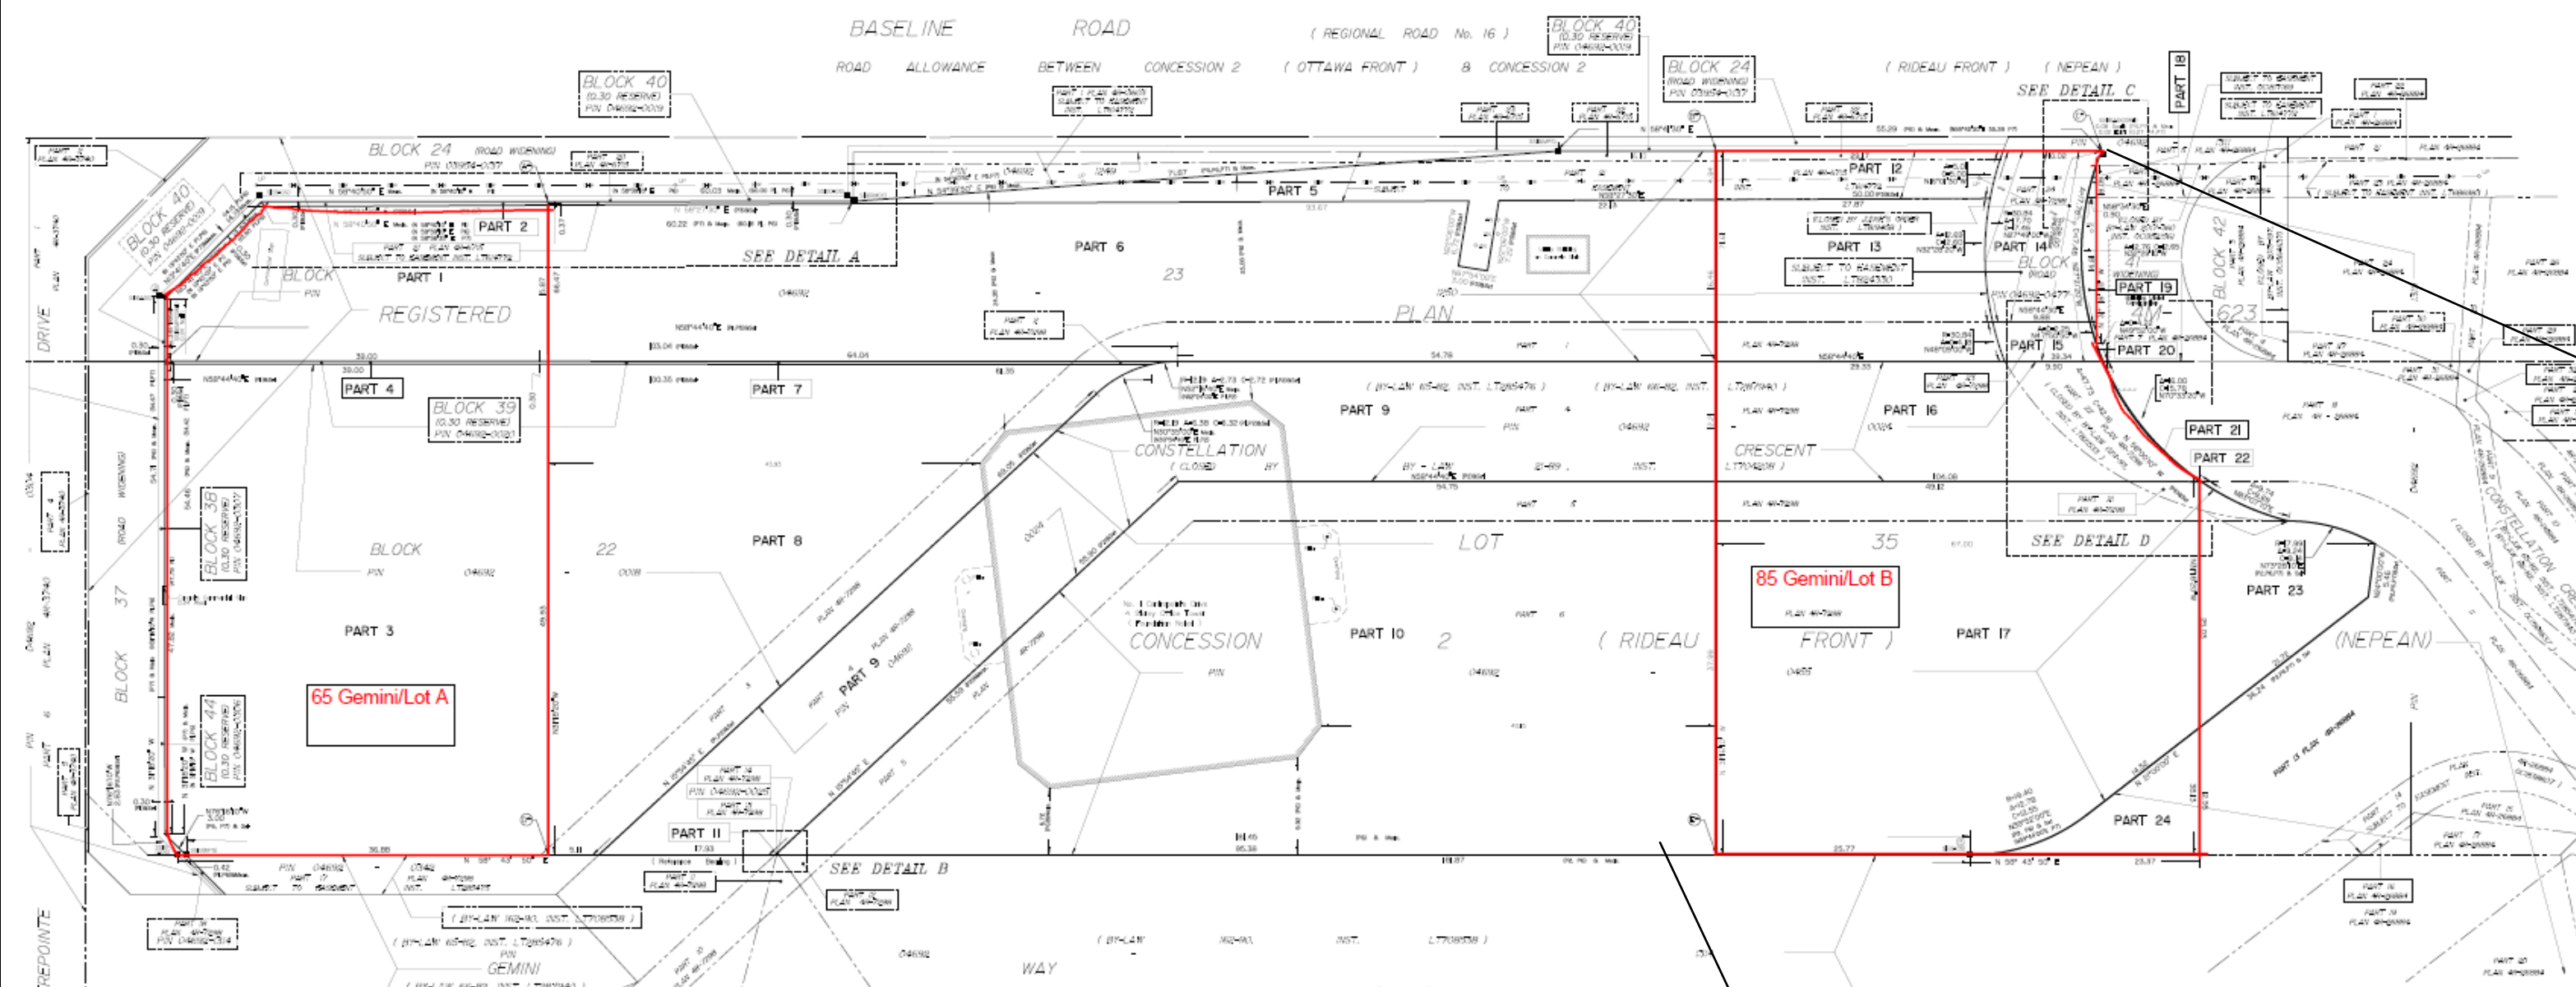
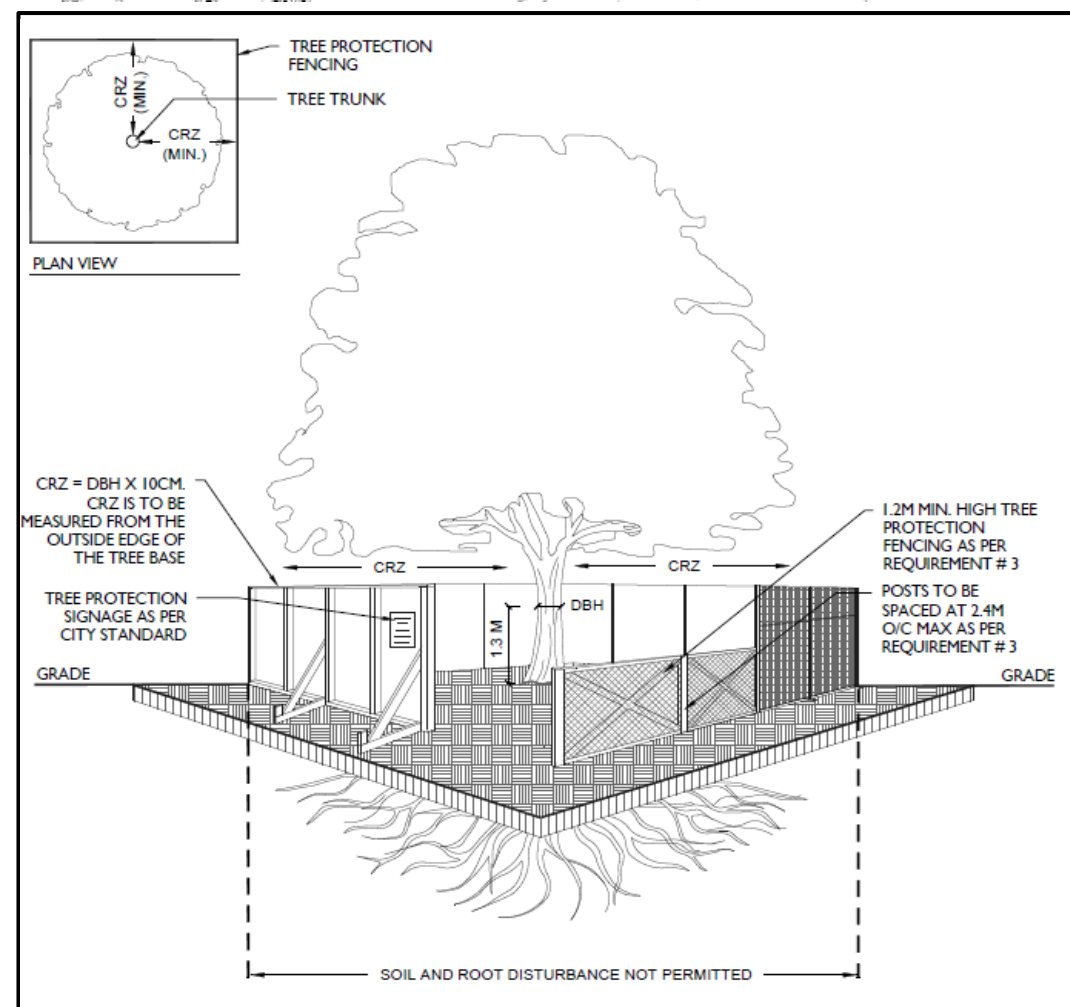
Tree Conservation Reprt – 85 Gemini Way  
 Map #2 – Proposed Development  
 Version 1.0, November 28, 2024  
 For more information, please contact [info@dendronforestry.ca](mailto:info@dendronforestry.ca)

The proposed building will include underground parking. The three protected trees in this area of the 1 Centrepointe property are recommended for removal based on the intensity of excavation required to install the parking and build the tower.

**Tree 3** is an oak in good condition. A Tree Protection Area should be installed to ensure that the tree's rooting space is protected to the greatest extent possible.

- TREE PROTECTION REQUIREMENTS:**
- PRIOR TO ANY WORK ACTIVITY WITHIN THE CRITICAL ROOT ZONE (CRZ = 10 X DIAMETER) OF A TREE, TREE PROTECTION FENCING MUST BE INSTALLED SURROUNDING THE CRITICAL ROOT ZONE, AND REMAIN IN PLACE UNTIL THE WORK IS COMPLETE.

- UNLESS PLANS ARE APPROVED BY CITY FORESTRY STAFF, FOR WORK WITHIN THE CRZ:
    - DO NOT PLACE ANY MATERIAL OR EQUIPMENT - INCLUDING OUTHOUSES;
    - DO NOT ATTACH ANY SIGNS, NOTICES OR POSTERS TO ANY TREE;
