May 30, 2013

OEI File: N009-002

RE: Heritage Structural Review of 197 and 201 Wilbrod Street, Ottawa

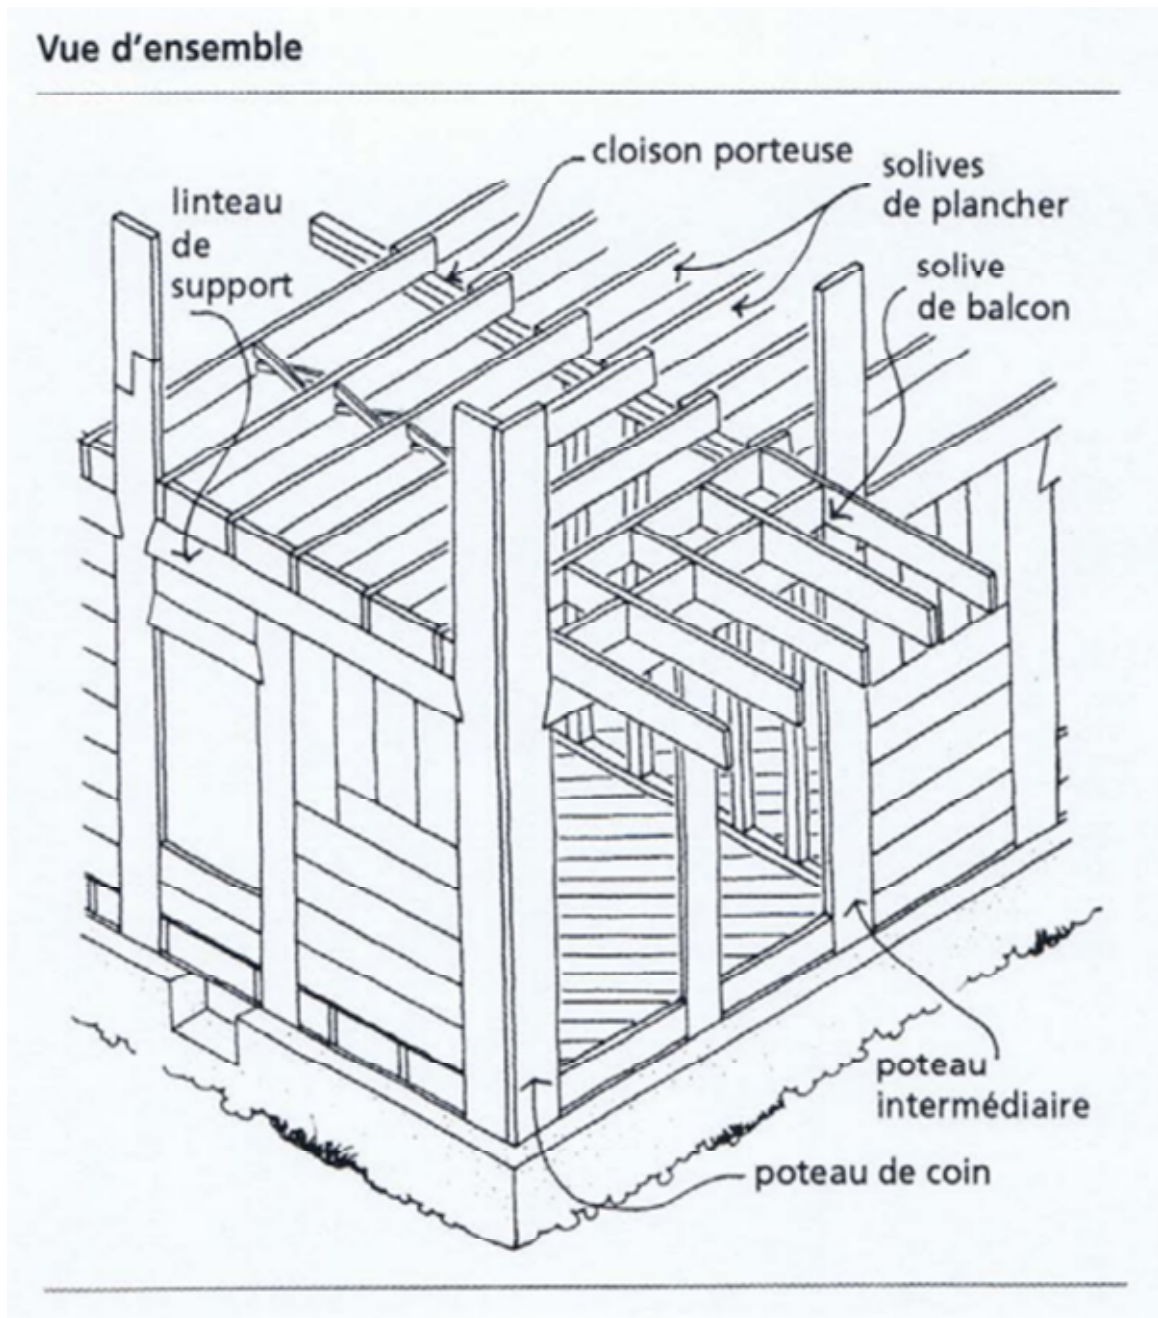
We performed a limited literature search about the plank framing system. A sketch from the book “Guide de renovation, reparation, isolation, entretien d’une maison”, by Jules Auger, 1979 is copied here without permission (Figure 2). The sketch shows a classic plank framing system with corner posts and dovetailed inserts of the horizontal planks. The framing of the buildings on Wilbrod is a variation of this approach. The corners are

overlapped and nailed, and the vertical strapping appears to be an integral part of keeping the horizontal planks in line.

Figure 2. Typical Plank Framing System
