A CONSERVATION PLAN

CHAMPLAIN OIL COMPANY SERVICE STATION

70 RICHMOND ROAD OTTAWA, ONTARIO

PREPARED BY: JOHN STEWART, COMMONWEALTH HISTORIC RESOURCE MANAGEMENT

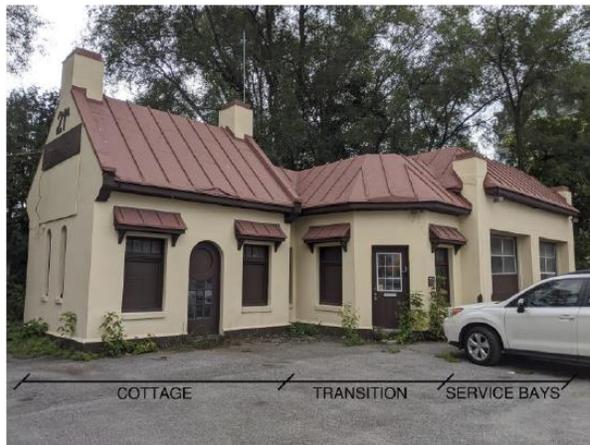
Photo 1: Overview of building [JCAL 2020]

In general there are three main spaces; the cottage, the transitional area and the service bays, see Photo 1. The transitional area and garage are divided by an interior loadbearing brick wall. The separation of these spaces is visible by the differing roof structures from the exterior.
