DILLON
CONSULTING

May 2019

CITY OF OTTAWA

Long-Term Strategy Review and Decommissioning Impact Study Porters Island Pedestrian Bridge (SN013260)

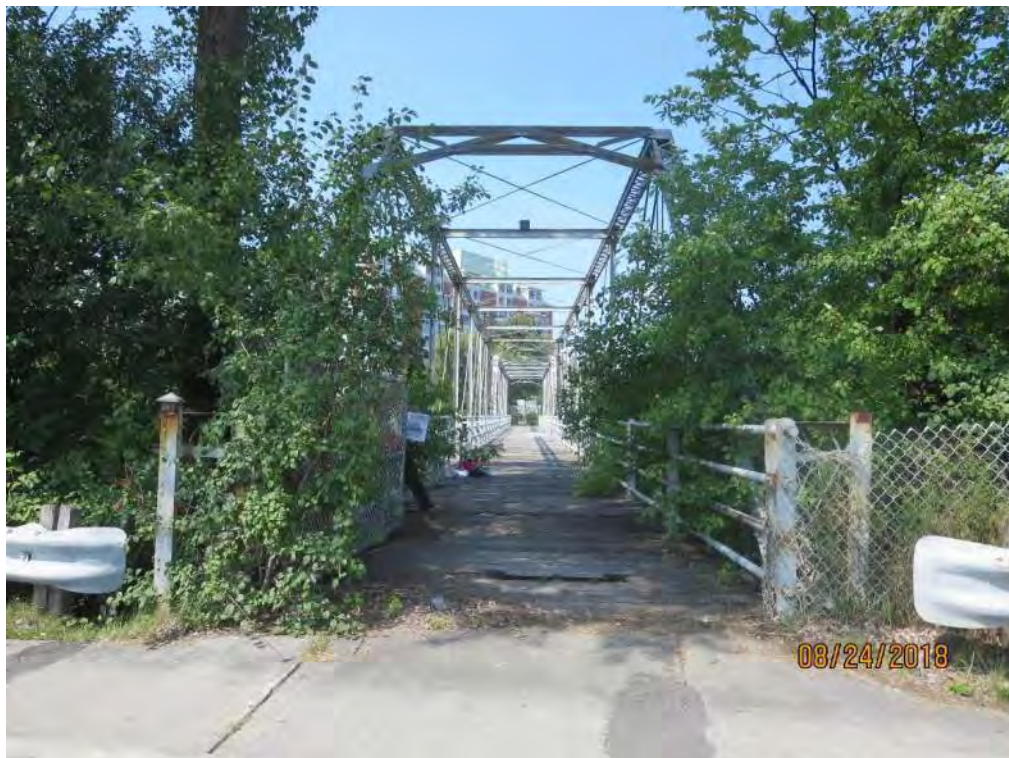
Photograph 2: South Entrance from St. Patrick Street

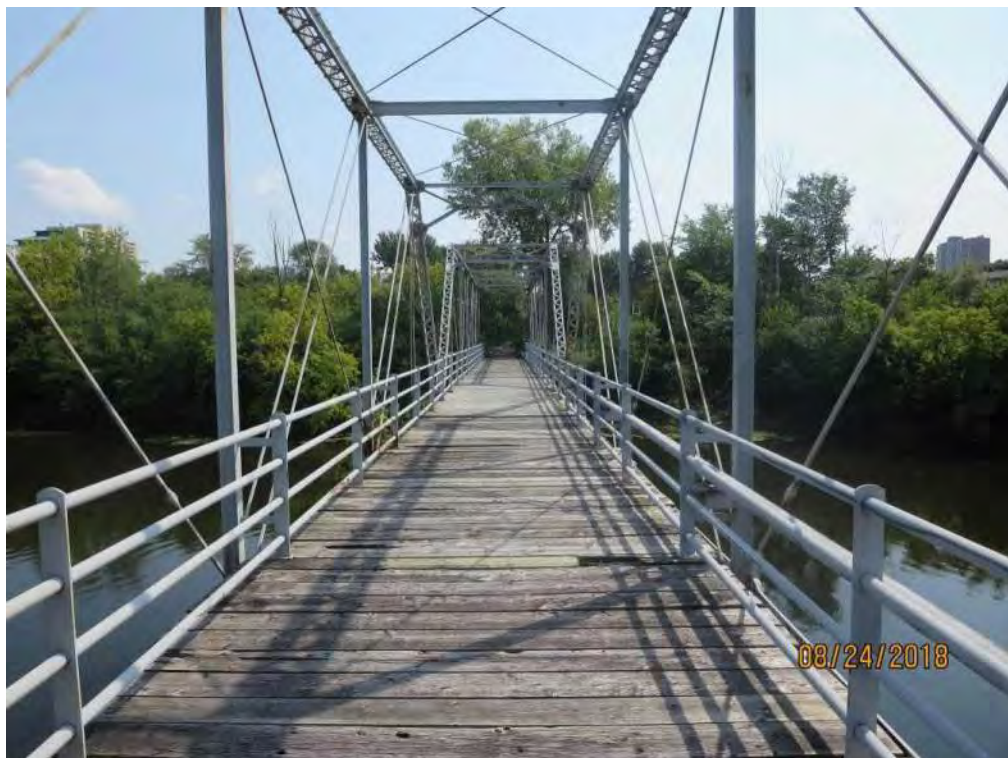
Photograph 4: Cross section of structure looking south at the pier.

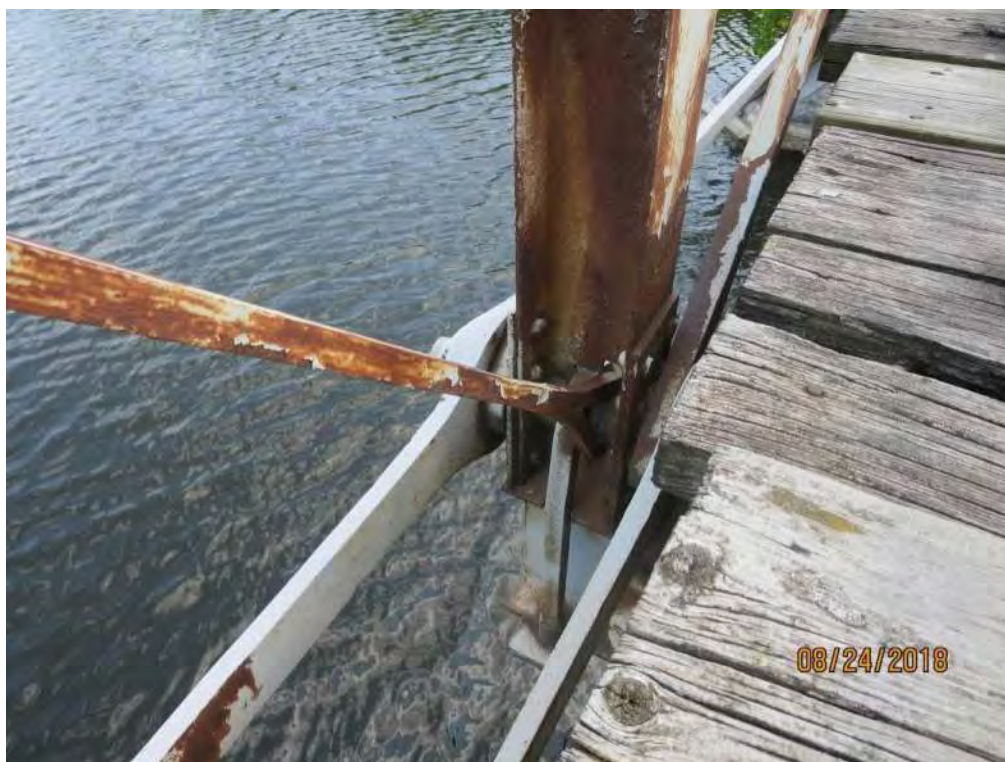
Photograph 16: Severe flaking of coating on interior panel vertical at middle of North span.

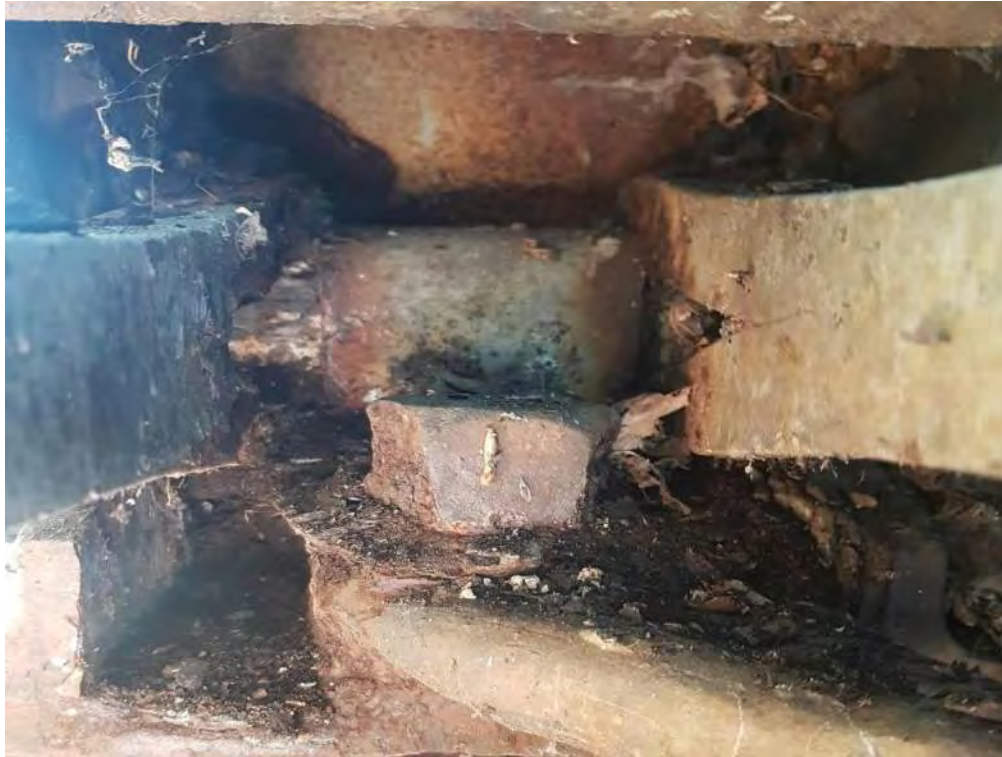
Photograph 21: Bottom chord connection at South Abutment (east side).

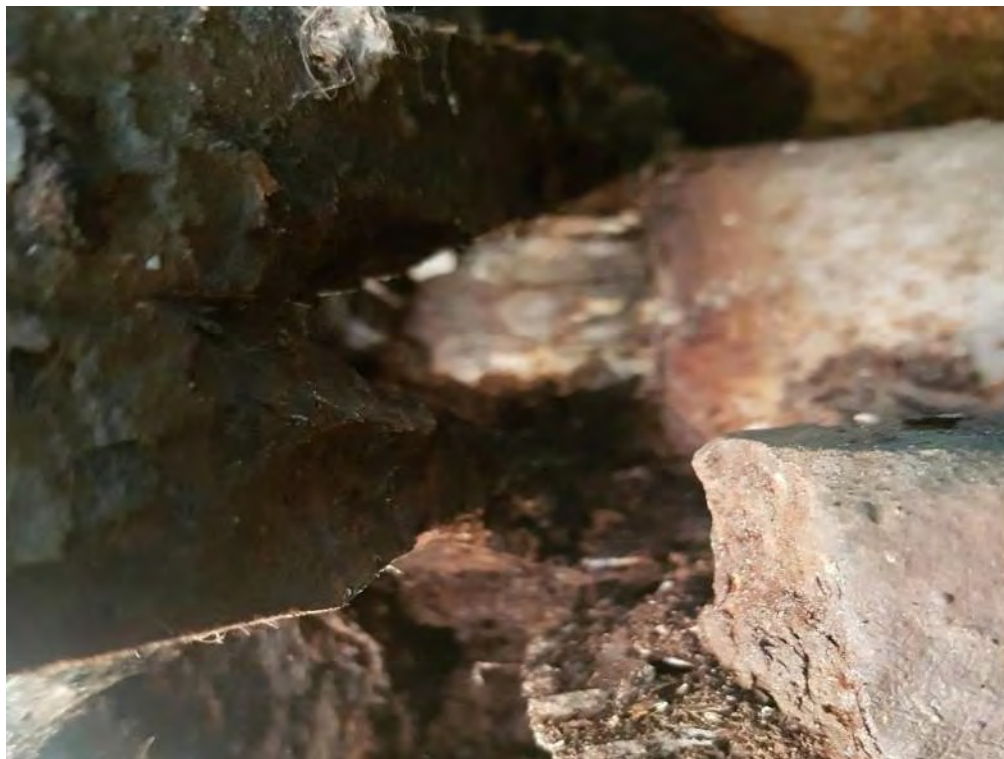
Photograph 22: Close up of Photograph 21. Note approximately 50% section loss of one of the rods.

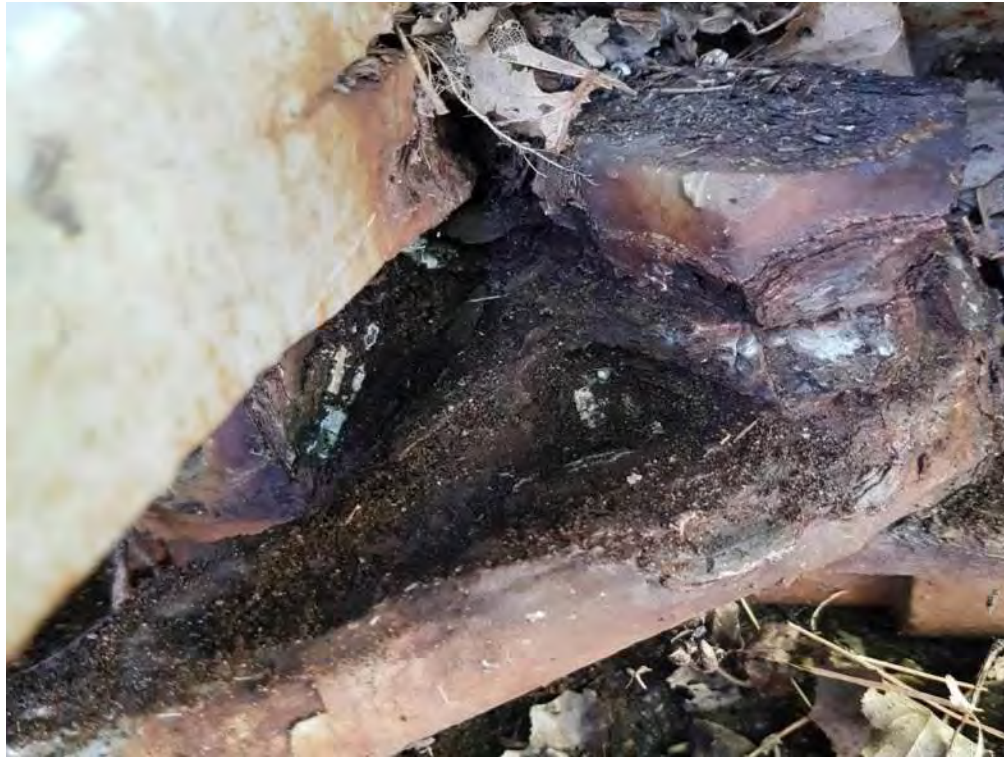
Photograph 35: Severe (> 25%) section loss of cross brace at South Abutment.

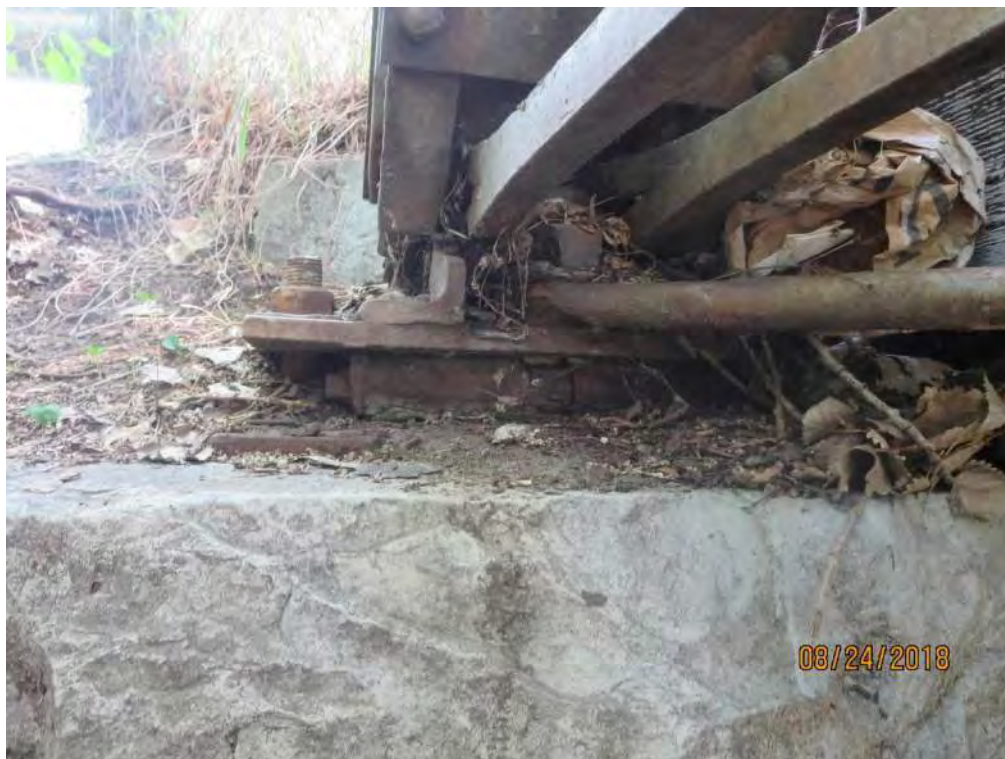
Photograph 36: Typical abutment roller bearing. Southeast bearing shown. Bearings are suspected to be seized.

- Due to the condition of the structure, it is recommended that the abutment bearing seats be cleaned to allow for proper inspection and monitoring of the structure. It is recommended that the structure be observed in cold weather to increase understanding of structure behaviour. Revisiting the current frequency of structure inspections may also be warranted (biennial instead of the current 5 year interval).

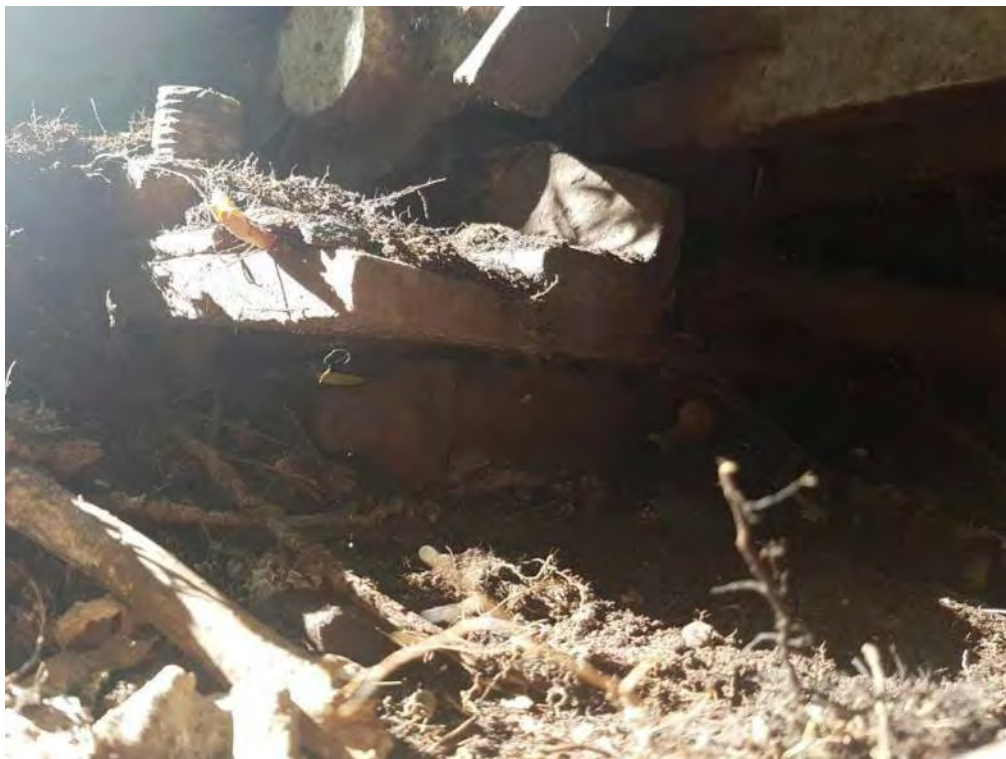
Photograph 37: Close up of Photograph 36.

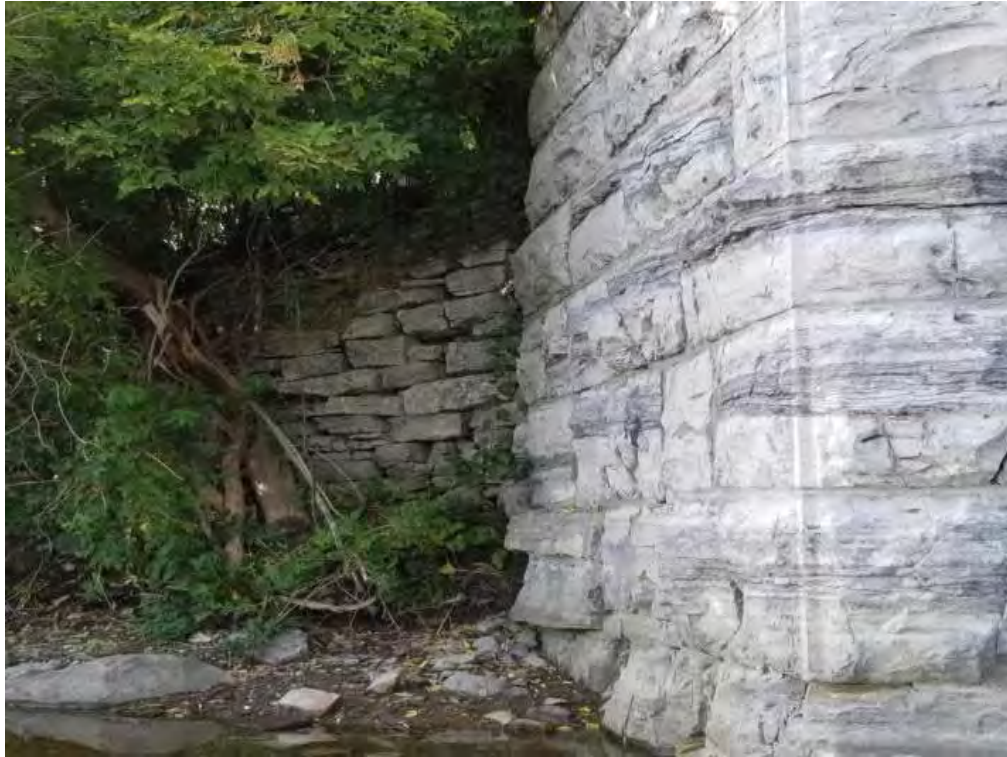
- Dry stone retaining wall noted at northwest quadrant was in poor condition.

Photograph 43: West wingwall and dry stone masonry retaining wall at the North Abutment.

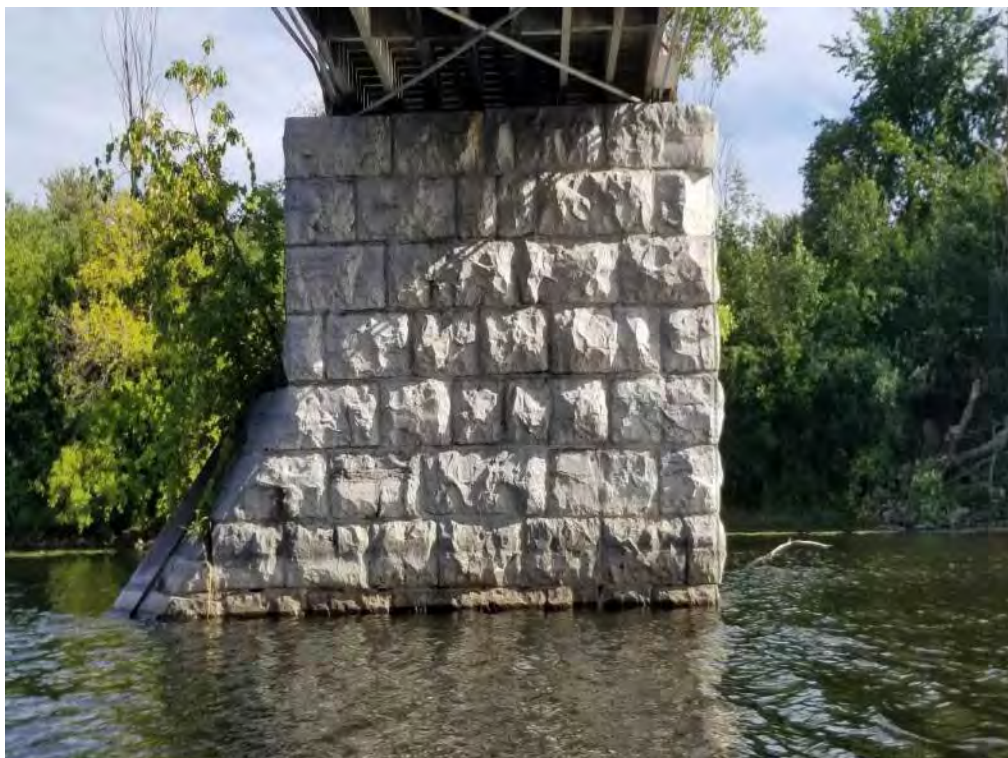
Photograph 46: North face of Pier.

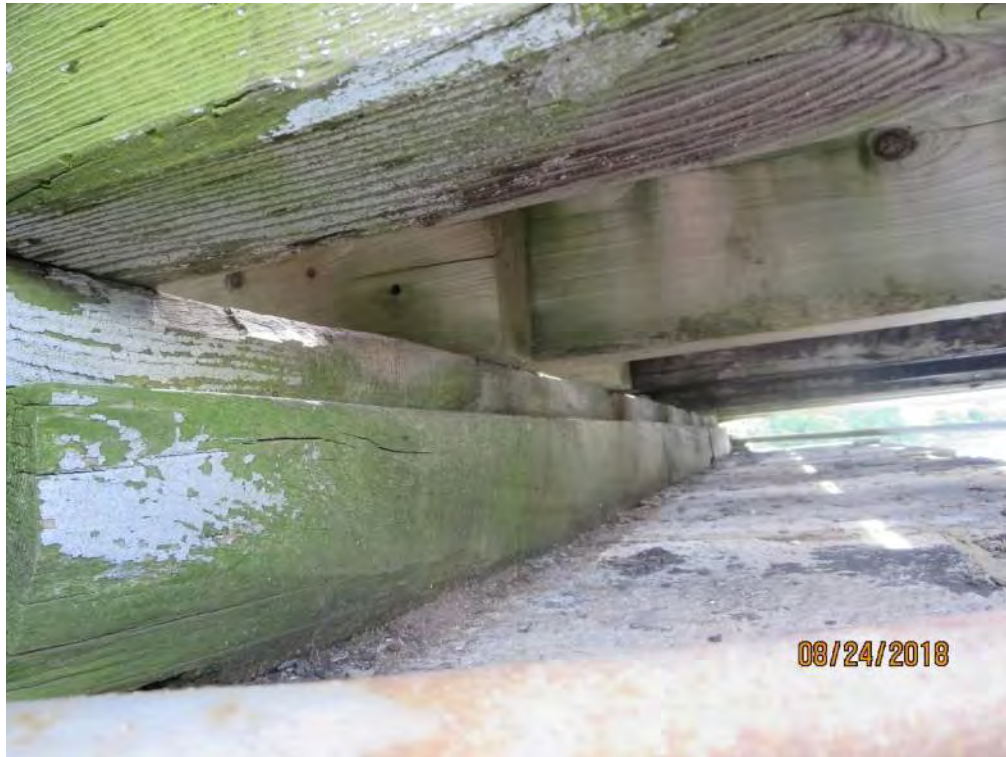
Photograph 47: Pier bearing seat.

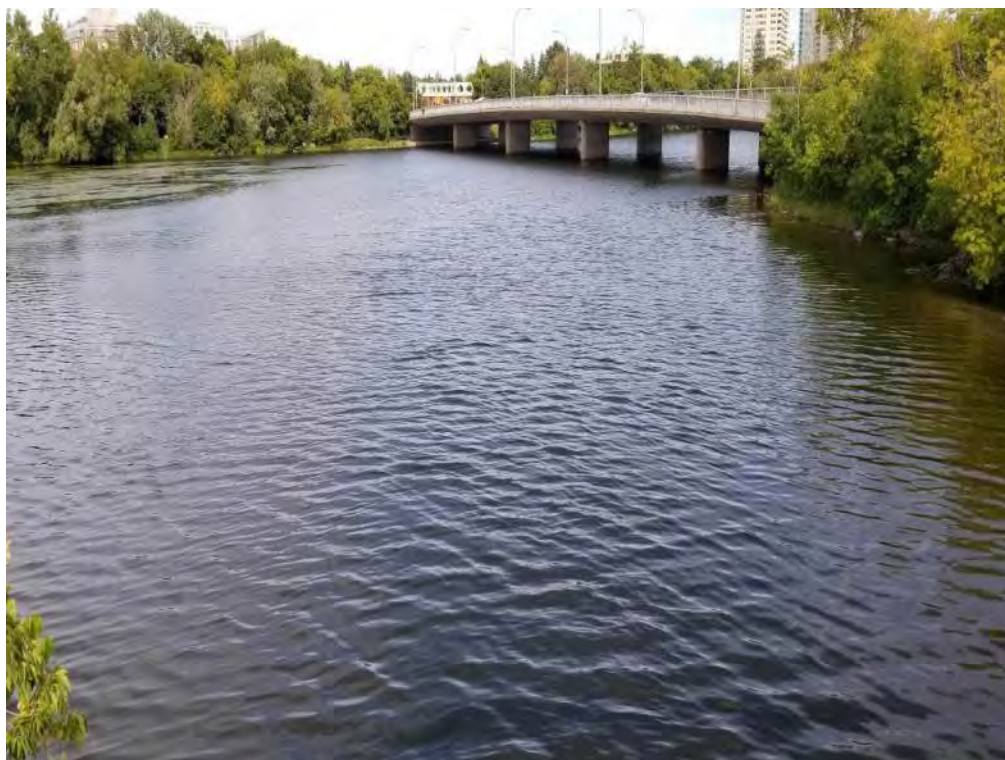
Photograph 50: General view looking east on structure.

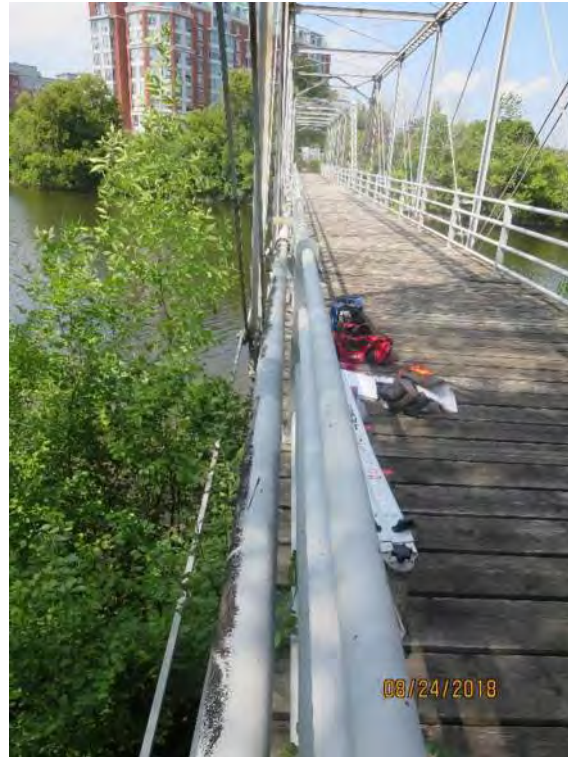
Photograph 51: Gas line on west side of deck.

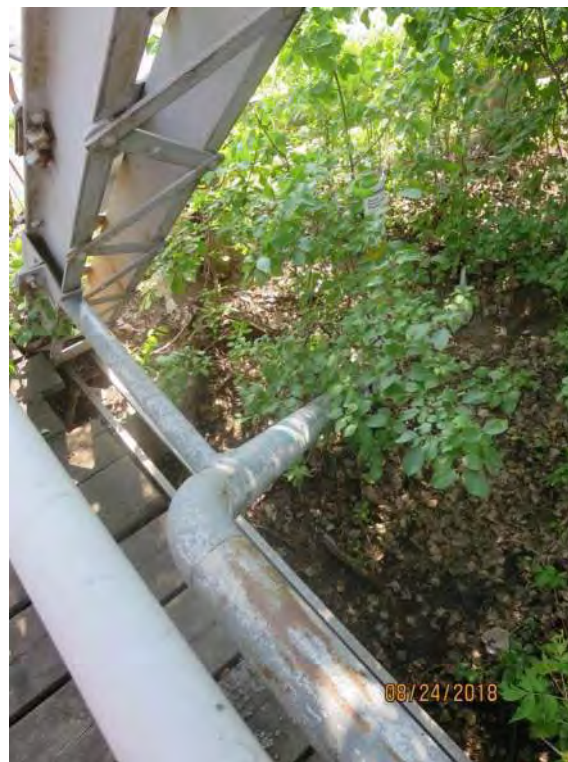
Photograph 52: Start of gas line at south end.
