A CULTURAL HERITAGE IMPACT STATEMENT

234 O'Connor Street, Ottawa, Ontario

**SUBMITTED TO: Gemstone Development Ltd.
PREPARED BY: COMMONWEALTH RESOURCE MANAGEMENT**

August 2016

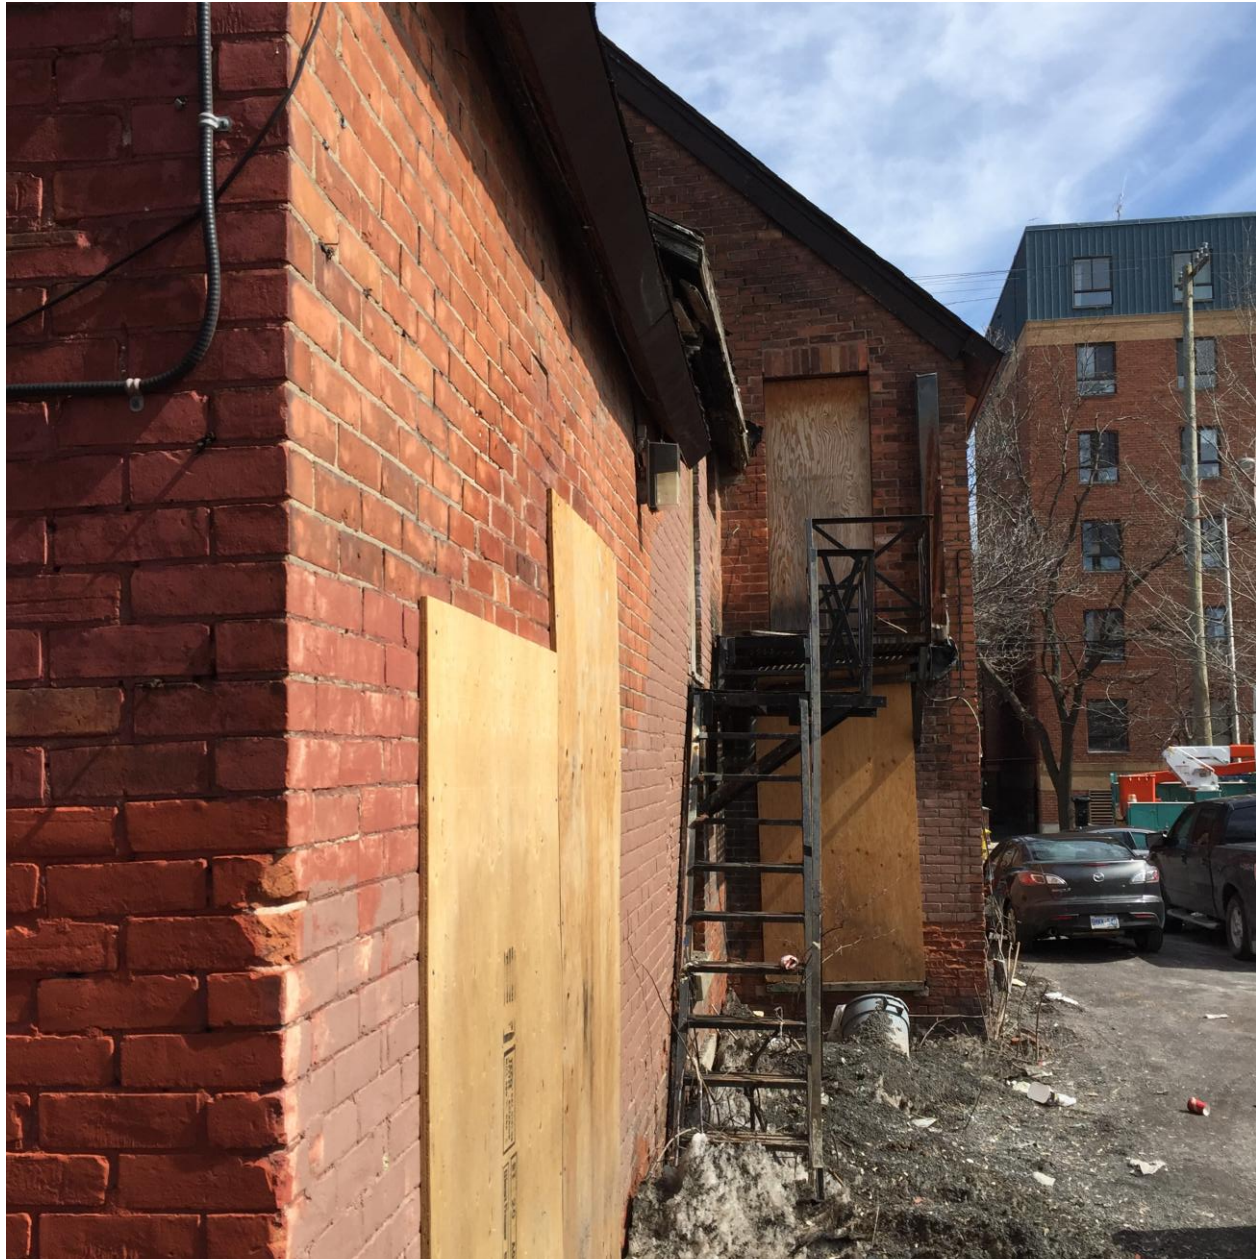
Figure 13: View of south side of the rear wing of the building. Credit: Neil Zaret 2016.

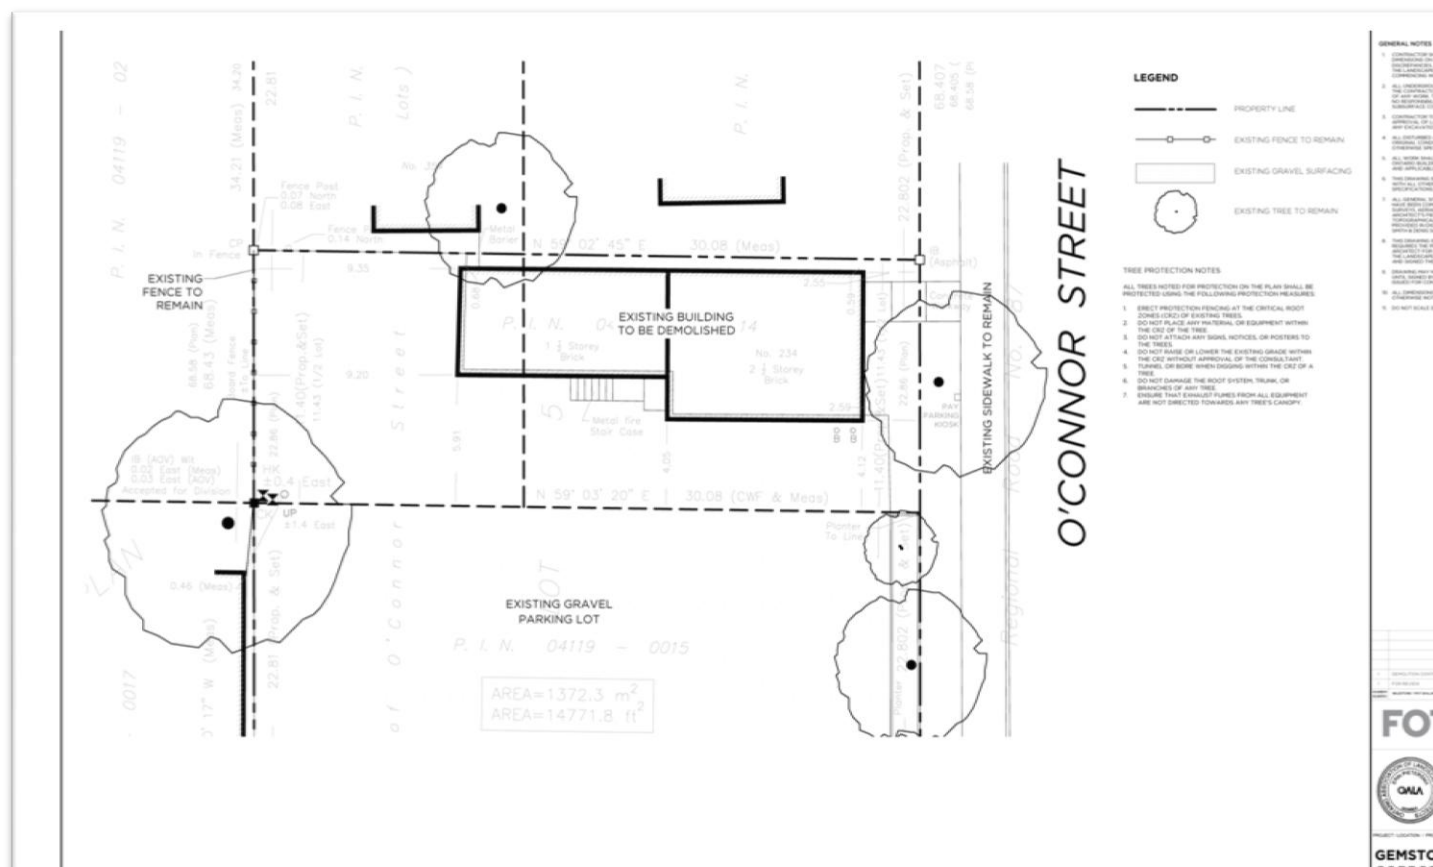
The proposal is to demolish the building due to its poor condition and landscape the lot (Figure 18). The lot will be leveled, top-dressed with soil and planted with a native meadow mix to provide ground cover. The existing fence along the west property line will be retained. The south and east (sidewalk) property lines will be lined with armour stone set in a band of stone dust. The site will be planted with a variety of trees and shrubs.

Figure 18: Demolition plan for the site at 234 O'Connor Street. Credit: Fotenn Consultants 2016.

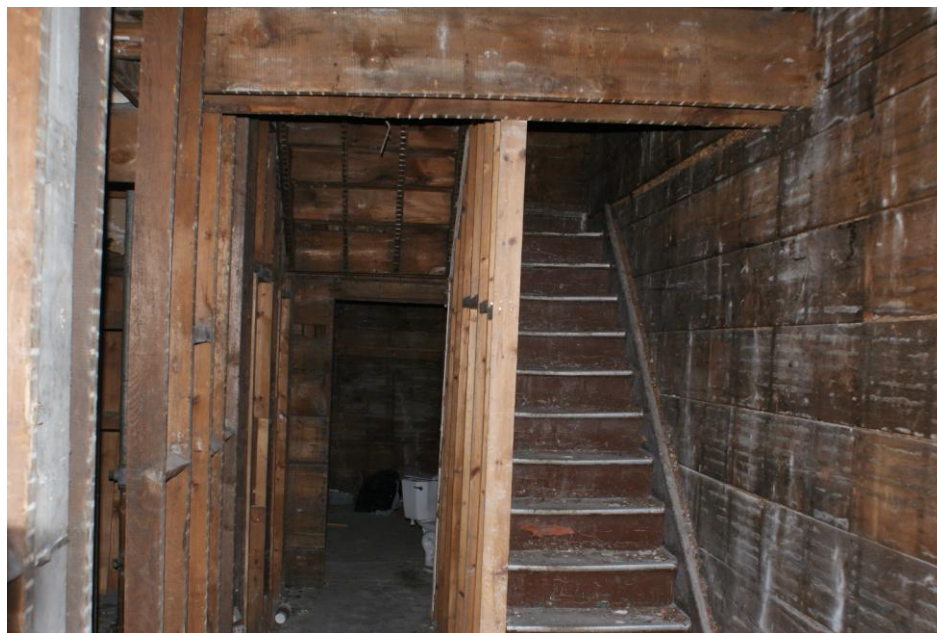
Figure 2: View of the interior stair. Note the horizontal board sheathing applied to the interior walls.

The building has a small footprint (1,126 sq.ft.) with no windows on the north and south side of the front portion of the building. The interior detailing specifically the remaining stair is simple in detail (Figure 2). A garage abutted the north side of the building as is evident by the ghosting of the roof on the brickwork. It would also appear that another structure possibly a porch abutted the south wall of the rear portion of the building as evidenced by the second storey doors and the lack of windows along the south façade other than a window in the foundation wall (Figure 3).

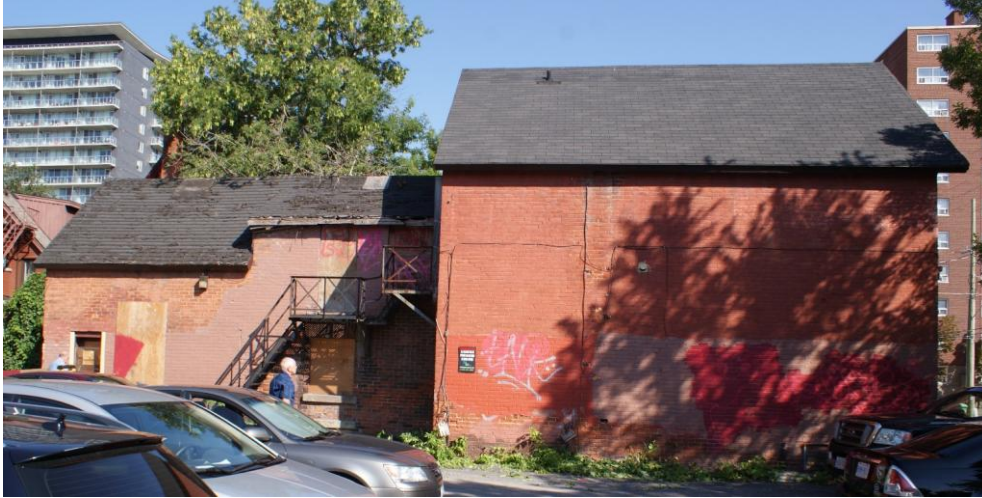
Figure 3: View of the south wall of the main building and rear wing. Note the lack of windows in the south wall.
