June 21, 2016

OEI File: N009-003

RE: Heritage Structural Review of 352 Somerset St. W., Ottawa

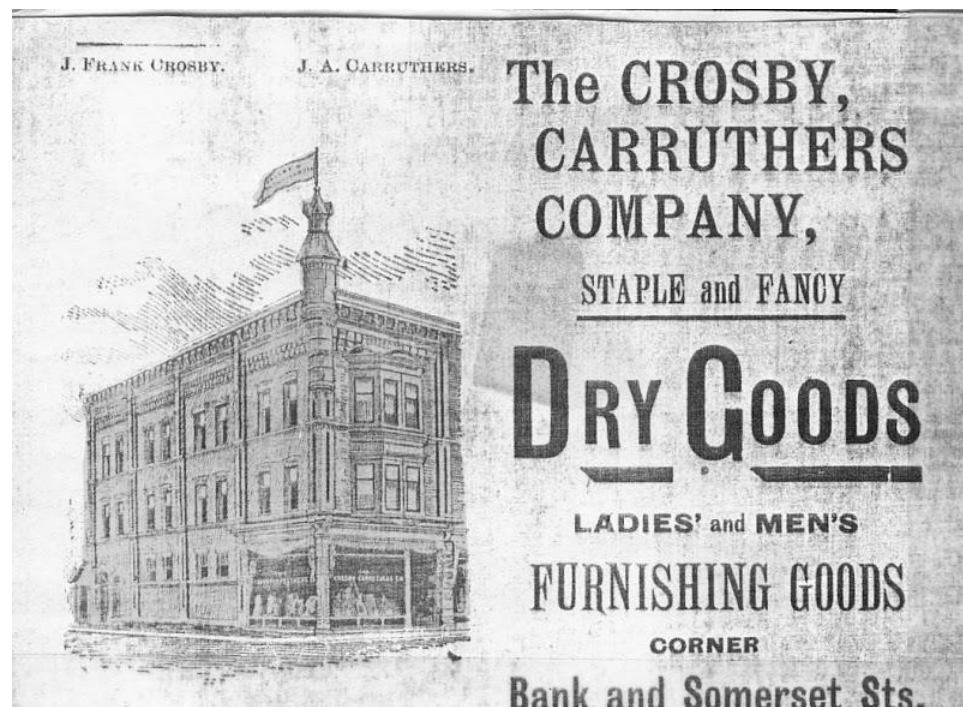
Figure 1. Original three storey building. Reproduced without permission from <http://urbsite.blogspot.ca/2012/10/the-haunted-hotel-somerset-ritz.html>

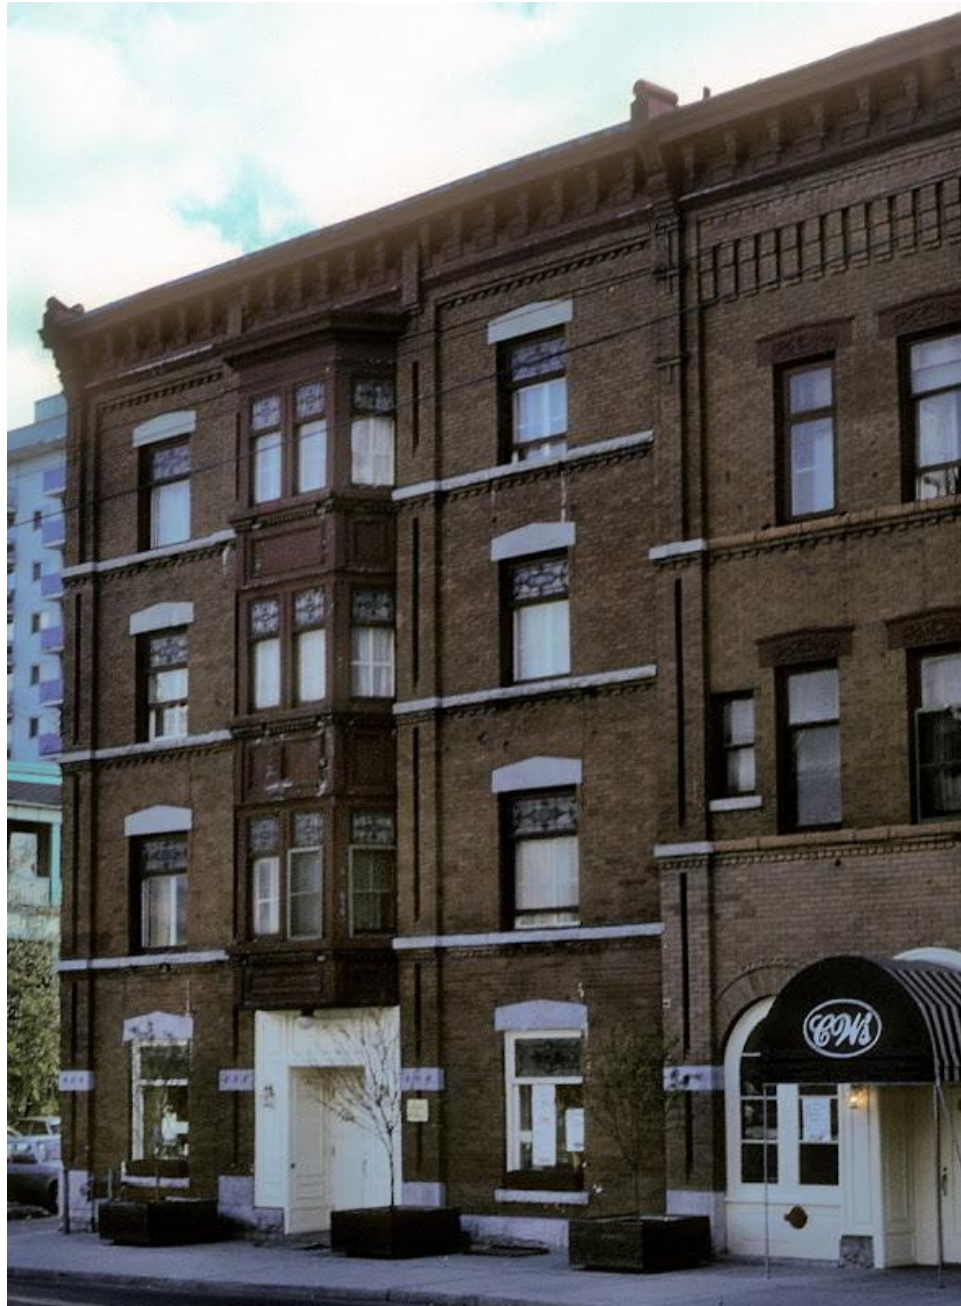
Figure 2. Four storey addition to the east. Reproduced without permission from <http://urbsite.blogspot.ca/2012/10/the-haunted-hotel-somerset-ritz.html>
