THE MATERIAL CONSERVATION PLAN 100 ARGYLE AVENUE, OTTAWA

COMMONWEALTH HISTORIC RESOURCE MANAGEMENT

REVISED NOVEMBER 2020

THE MATERIAL CONSERVATION PLAN

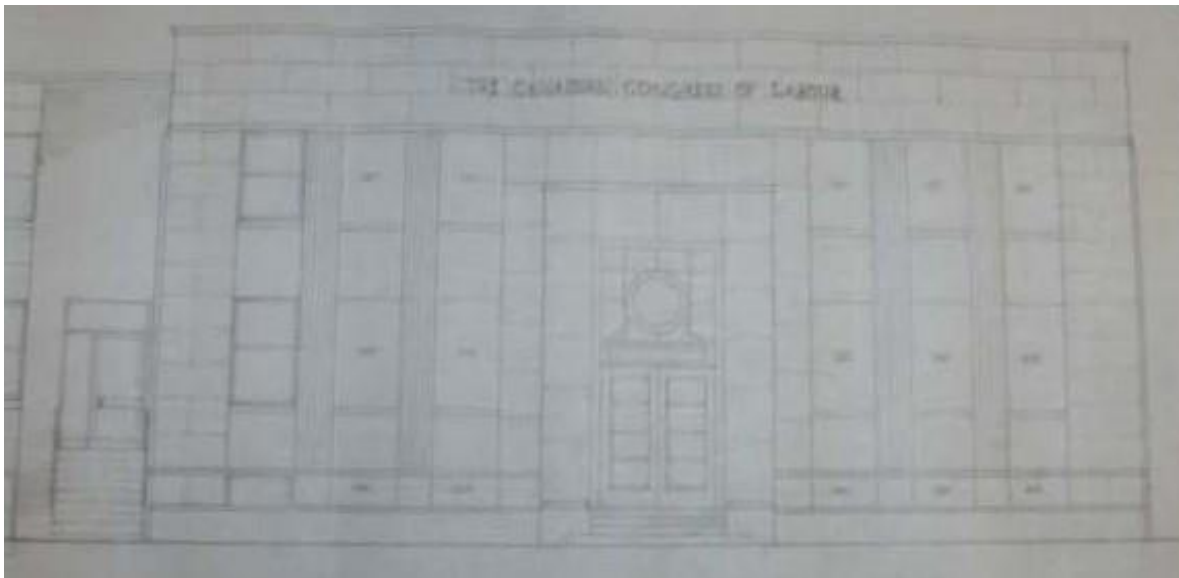
Figure 2: Elevation drawing from the 1959 set of drawings for the addition illustrating the original entrance configuration. Attributed to James Strutt. Source: Library & Archives Canada.

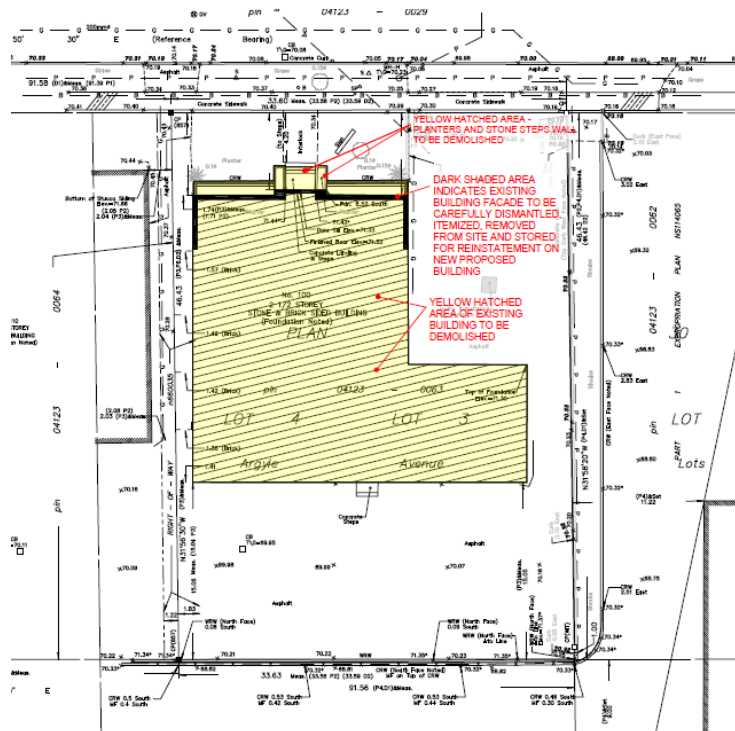
Figure 5: Survey Plan of the existing building indicating the portion of the building to be demolished shown in yellow hatch with the black outline indicating the front façade to be dismantled.

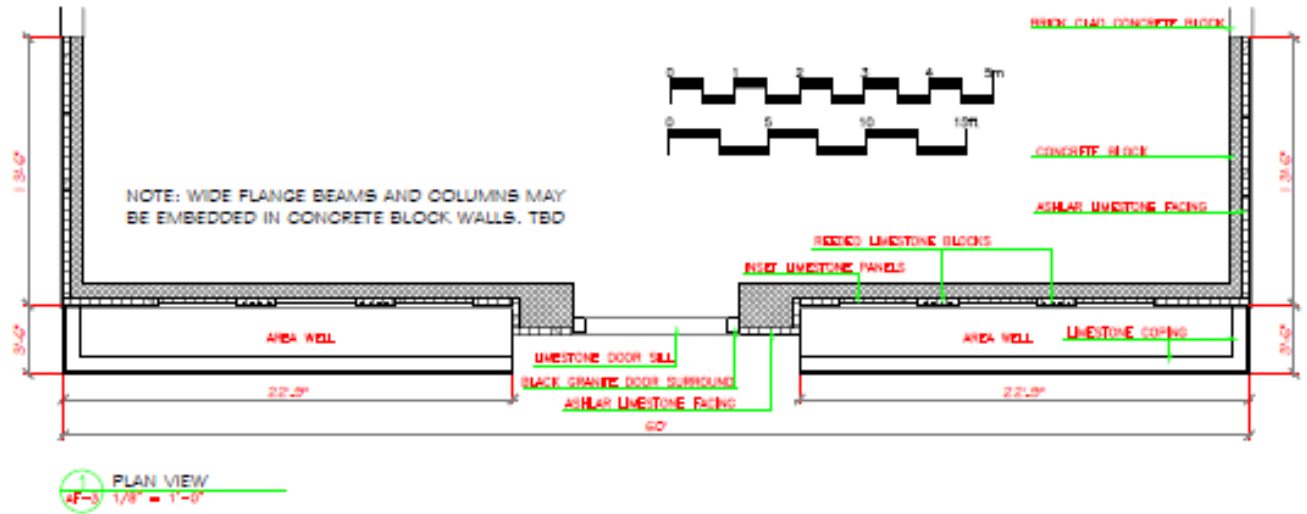
Figure 6: Plan As-Found drawing AF3.

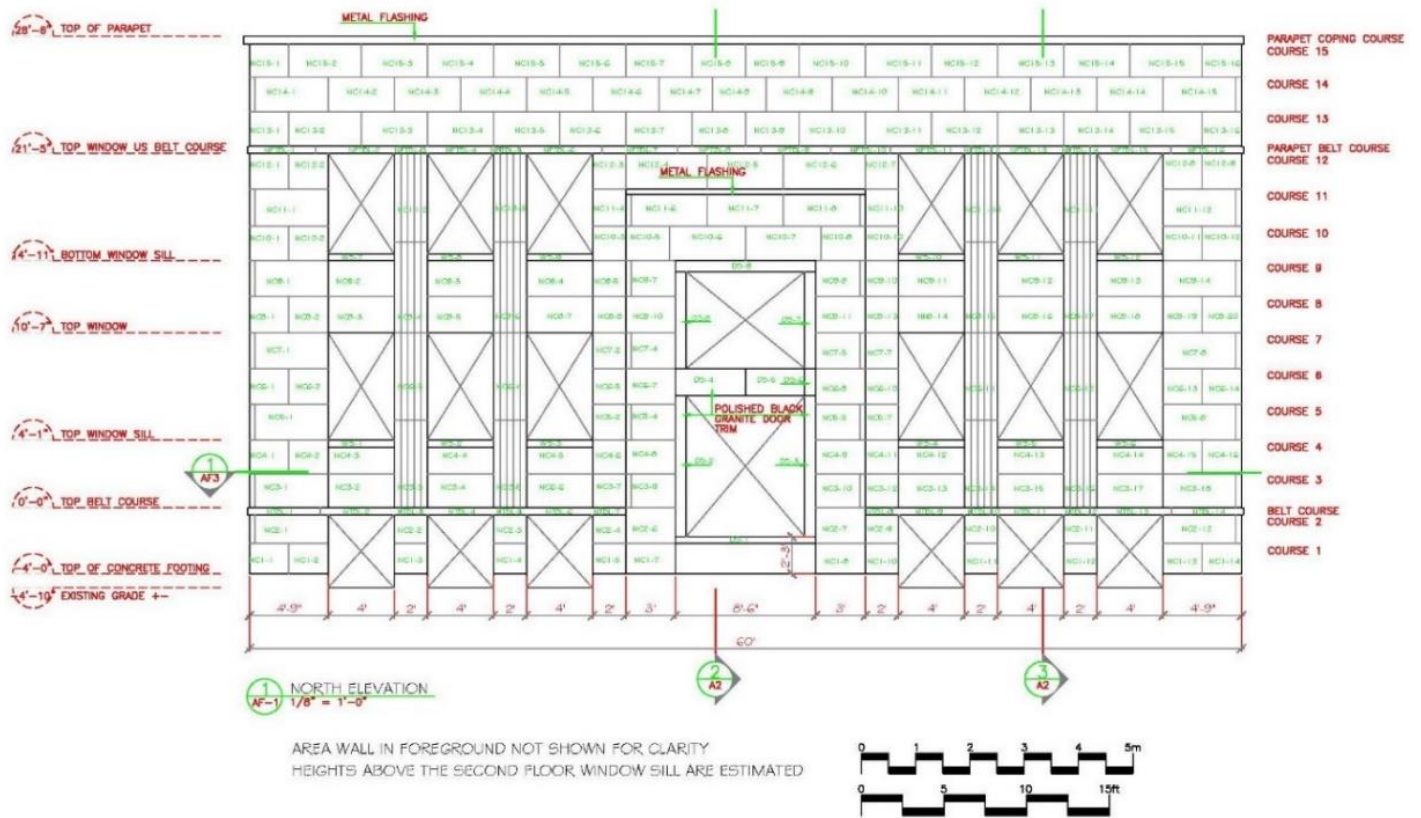
Figure 7: Front Elevation As-Found drawing AF1 and AF2. Source Commonwealth

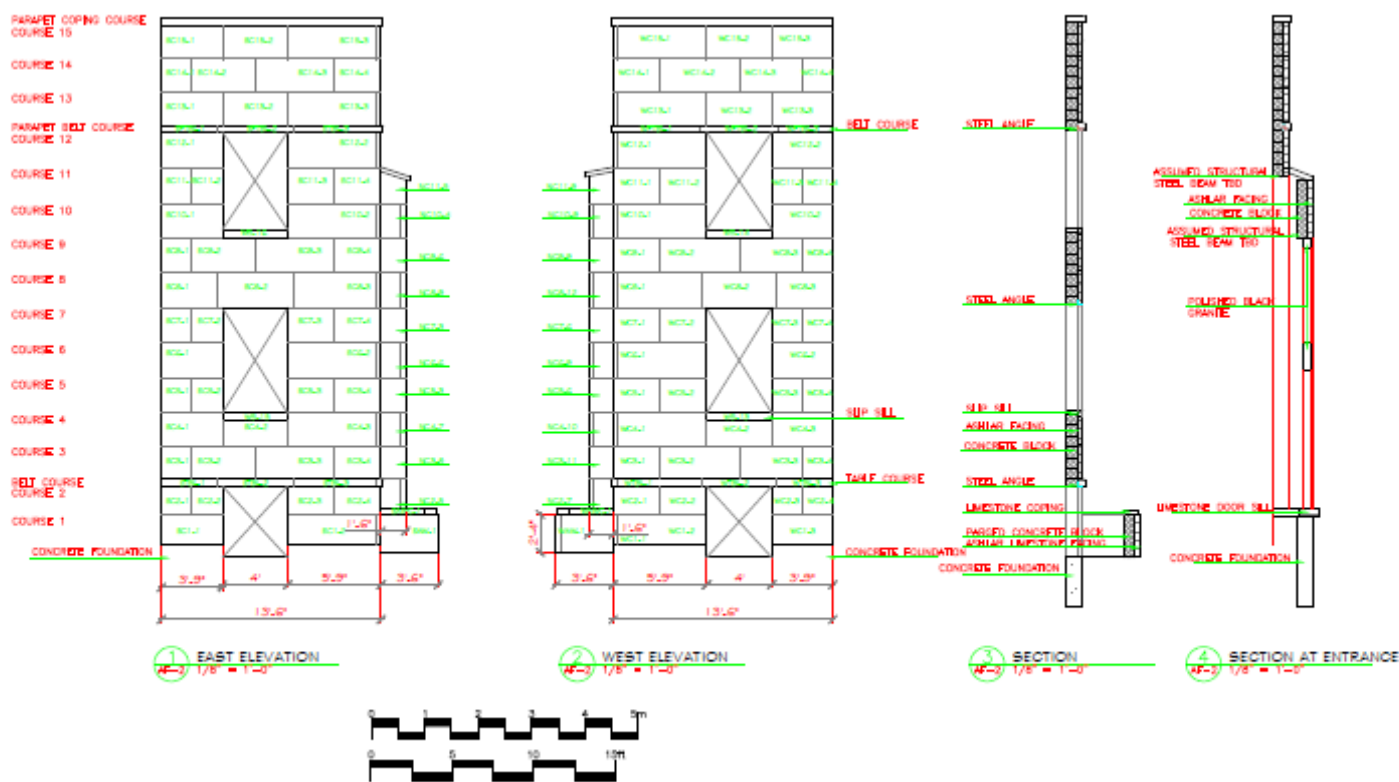
Figure 8: Side Elevations As-Found drawing AF1 and AF2. Source Commonwealth

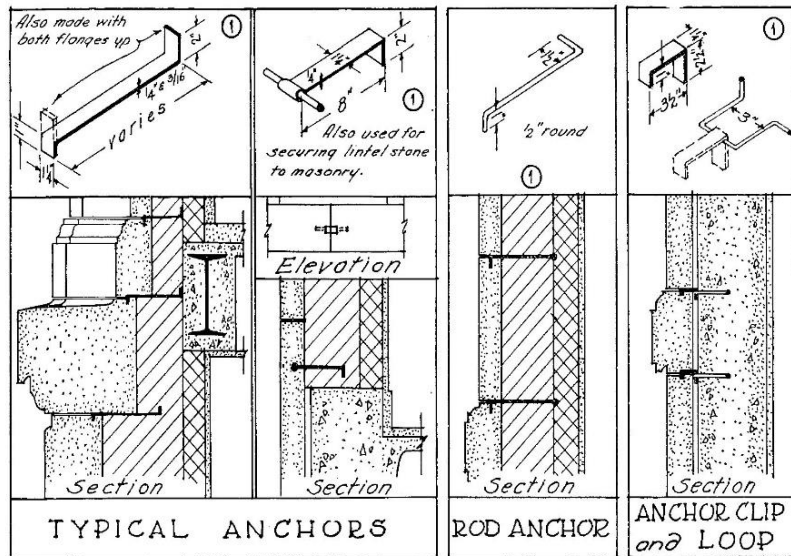
Figure 7: Typical anchors used to secure cut stone facing to an assortment of back-up walls. The flat steel bar with upturned or downturned ends to the left the image, and the rod anchor would both be suitable to the relatively simple stone application on the facades. Source: *Traditional Details for Building Restoration, Renovation, and Rehabilitation. 1932-1951 Editions Architectural Graphic Standards* pg. 63. Ramsey Sleeper. John Wiley and Sons Inc.

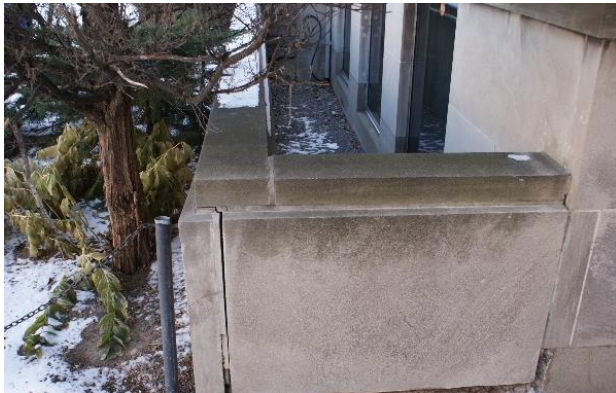
Figure 13: View of limestone clad area wall and coping. Note that the basement windows are set into the foundation wall.

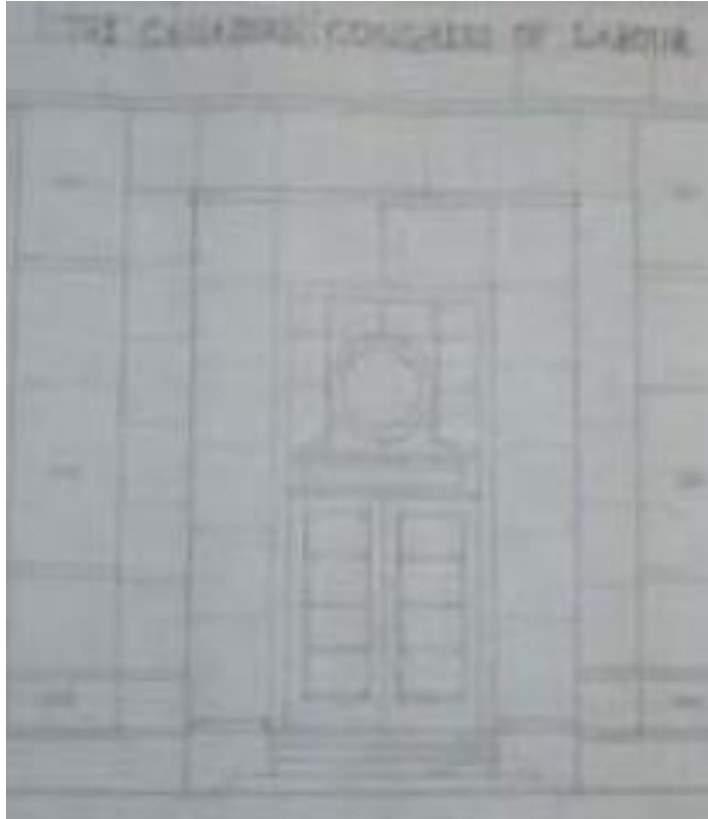
Figure 16: Close-up of the front elevation illustrating the original double doors with the elaborate transom. Source Archives and Library Canada.

The entrance to the reconstructed front podium will be set at a lower grade than currently exists. The front entrance portico will be modified and the existing stairs, which are not original will be removed with access from the street provided at grade. This will require setting the grade of the ground floor lower. The modification of the main entrance level to the building is an acceptable conservation approach within the context of a building 'rehabilitation' in order to meet accessibility objectives. 'Rehabilitation' involves the sensitive adaptation of a historic place or individual component for a continuing or compatible contemporary use, while protecting the property's heritage attributes. In order to provide universal accessibility. Archival drawings provide an indication of the appearance of the 1954 doors that have been replaced. This appear on the elevation attributed to James Strutt
