Introduction

Project name: Hintonburg Pumphouse Heritage Conservation Approach

Project #: 2143-01

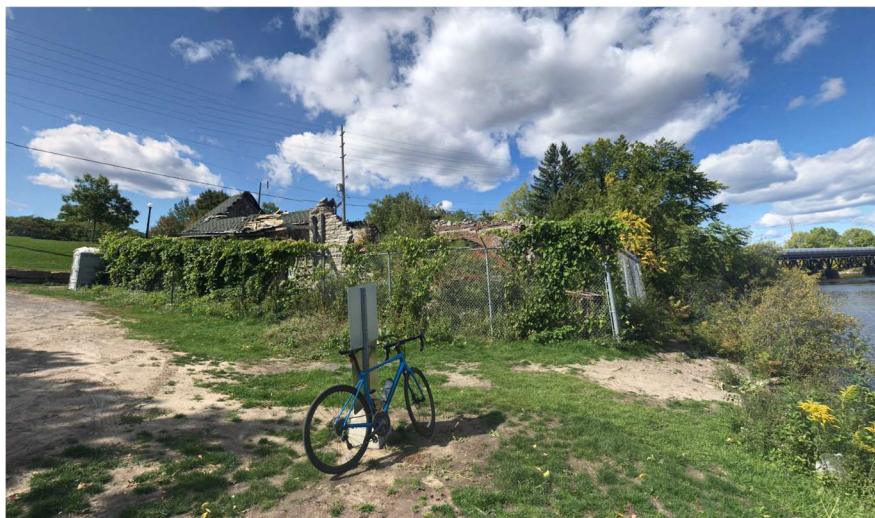
iii Current Condition of the Ruin - Source: Google Maps

After the 1989 fire, the roof, turret and the floor of the verandah were all destroyed. In the subsequent years, the unprotected masonry has deteriorated such that little of the half round window on the south façade remains, and the north window aperture is unstable. The surrounding grounds are generally open, with some nearby forests, which have suffered from colonization from invasive species, unstable ground and flooding.

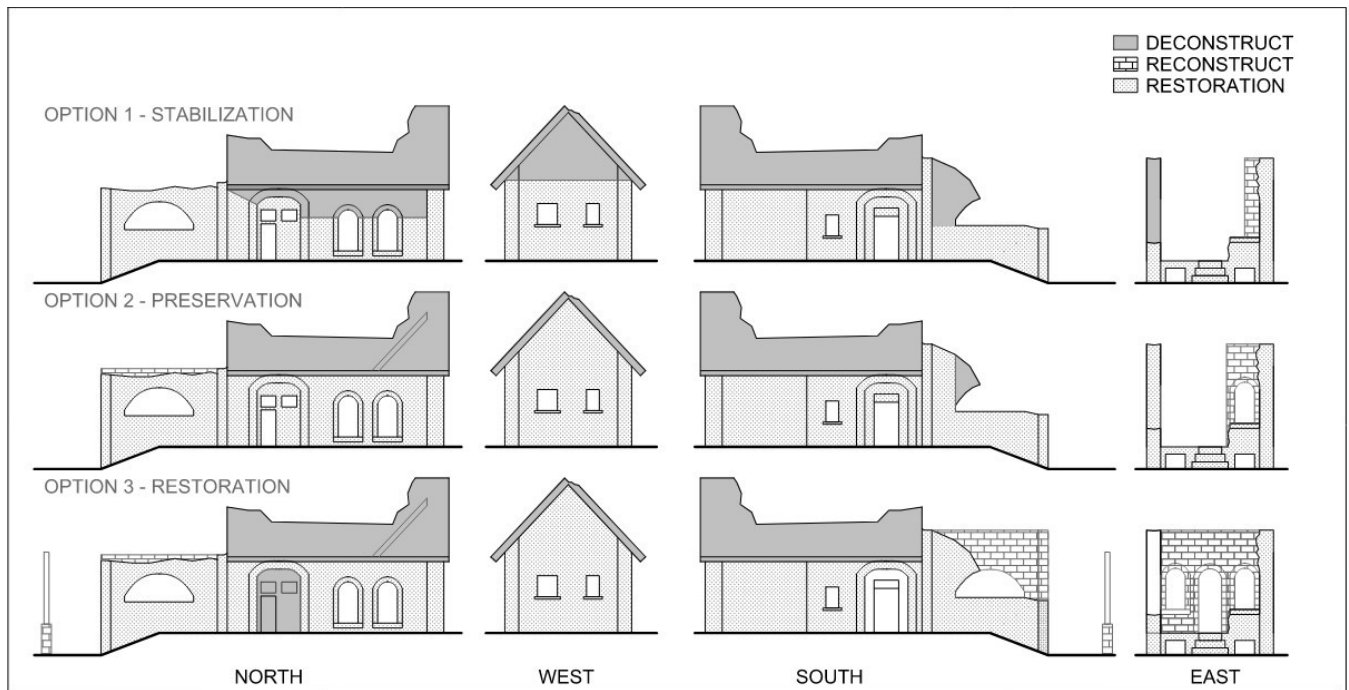
iv Illustrations of Stabilization Options - Source: J.G. Cooke

- *“Option 1 – Stabilization: Remove any masonry in poor condition, restore the remaining masonry walls and protect by capping skyward facing joints to prevent water infiltration.*
- *Option 2 – Preservation & Protection: Restore all remaining masonry elements by deep repointing, local dismantling and rebuilding, and core consolidation. Protect the masonry walls by capping skyward facing joints to prevent water infiltration, or by a partial self-supported roof structure.*
- *Option 3 – Restoration & Reconstruction: Restore all remaining masonry elements by deep repointing, local dismantling and rebuilding, and core consolidation. Reconstruct collapsed masonry elements based on existing physical evidence and historic photos or documentation. Protect the masonry walls by a self-supported roof structure, supported by the verandah posts.”*

Option 1, the most basic treatment, is the minimum of what is required to prevent further deterioration of the structure, and includes the demolition of existing elements of the ruin that would otherwise require dismantling and rebuilding. Option 2 proposes to retain all aspects of the ruin that are currently standing, with different degrees of intervention proposed to stabilize the most deteriorated elements. Option 3 proposes to retain what remains and reconstruct elements of the building that are currently non-existent.

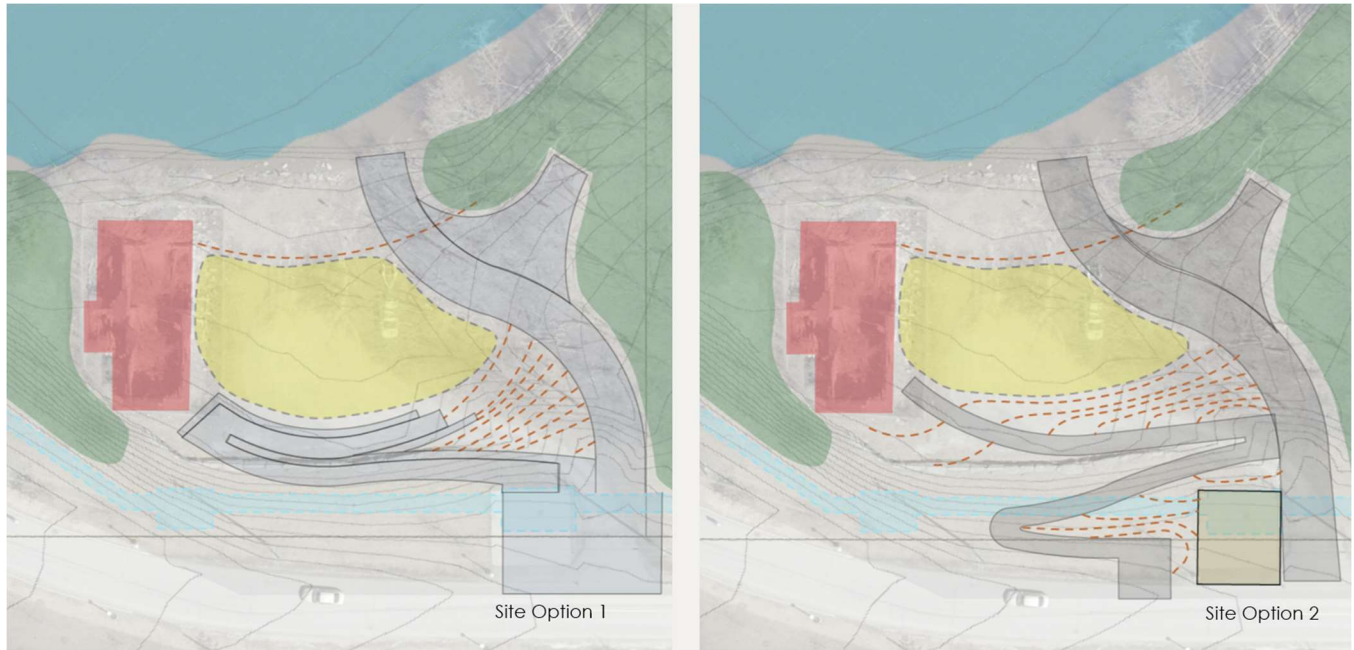
v Open Space and Accessibility Option Diagrams - Source: CSW

- While the grounds of the building were included in the designation, no specific character-defining elements were identified. The proposal to alter the grounds to support new community use is not considered to be a misuse of the space. Two alternatives to provide universally accessible pathways into the site and up to the ruin were illustrated.

is supported but the new design should be as 'green' as possible. The accessible route shown in Site Option 2 below, was preferred by the engagement groups.
