Hintonburg Pumphouse

Conservation and
Redevelopment Project

Final Technical Report

Revision 3
October 5, 2023

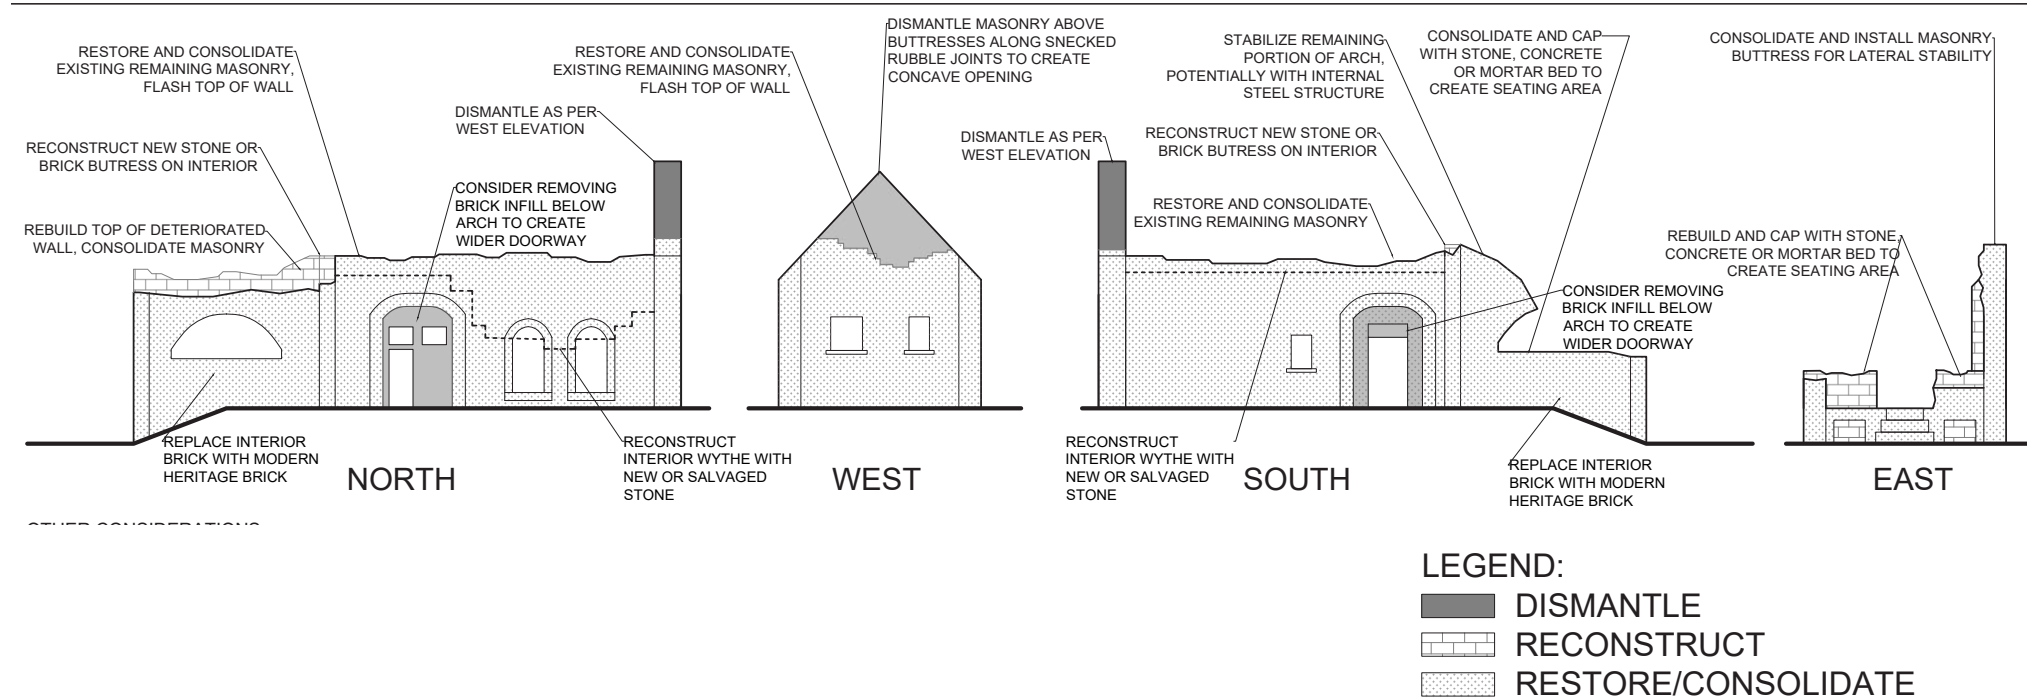
Image 1.12 Proposed conservation elevations prepared by Cooke & Associates, 2023

The preferred option was the modified "Stabilization/ Preservation" approach of the ruin which includes (Image 1.12):

- Removal of the severely deteriorated components such as the roof.
- The addition of discreet structural elements to stabilize the stone walls.
- Removing unstable high wall portions of the west gable and consolidating the masonry along the top of the north and south walls.

- Use of capping and flashing for the top of walls to prevent further deterioration. Walls below 1.2m in height will be capped with stone or a mortar bed to avoid creating a hazard for the public, as they would be accessible and may serve as seating.

- Demolition of a small cinder block structure added later in the building's history on the north façade, which is in poor condition and made with inferior materials.

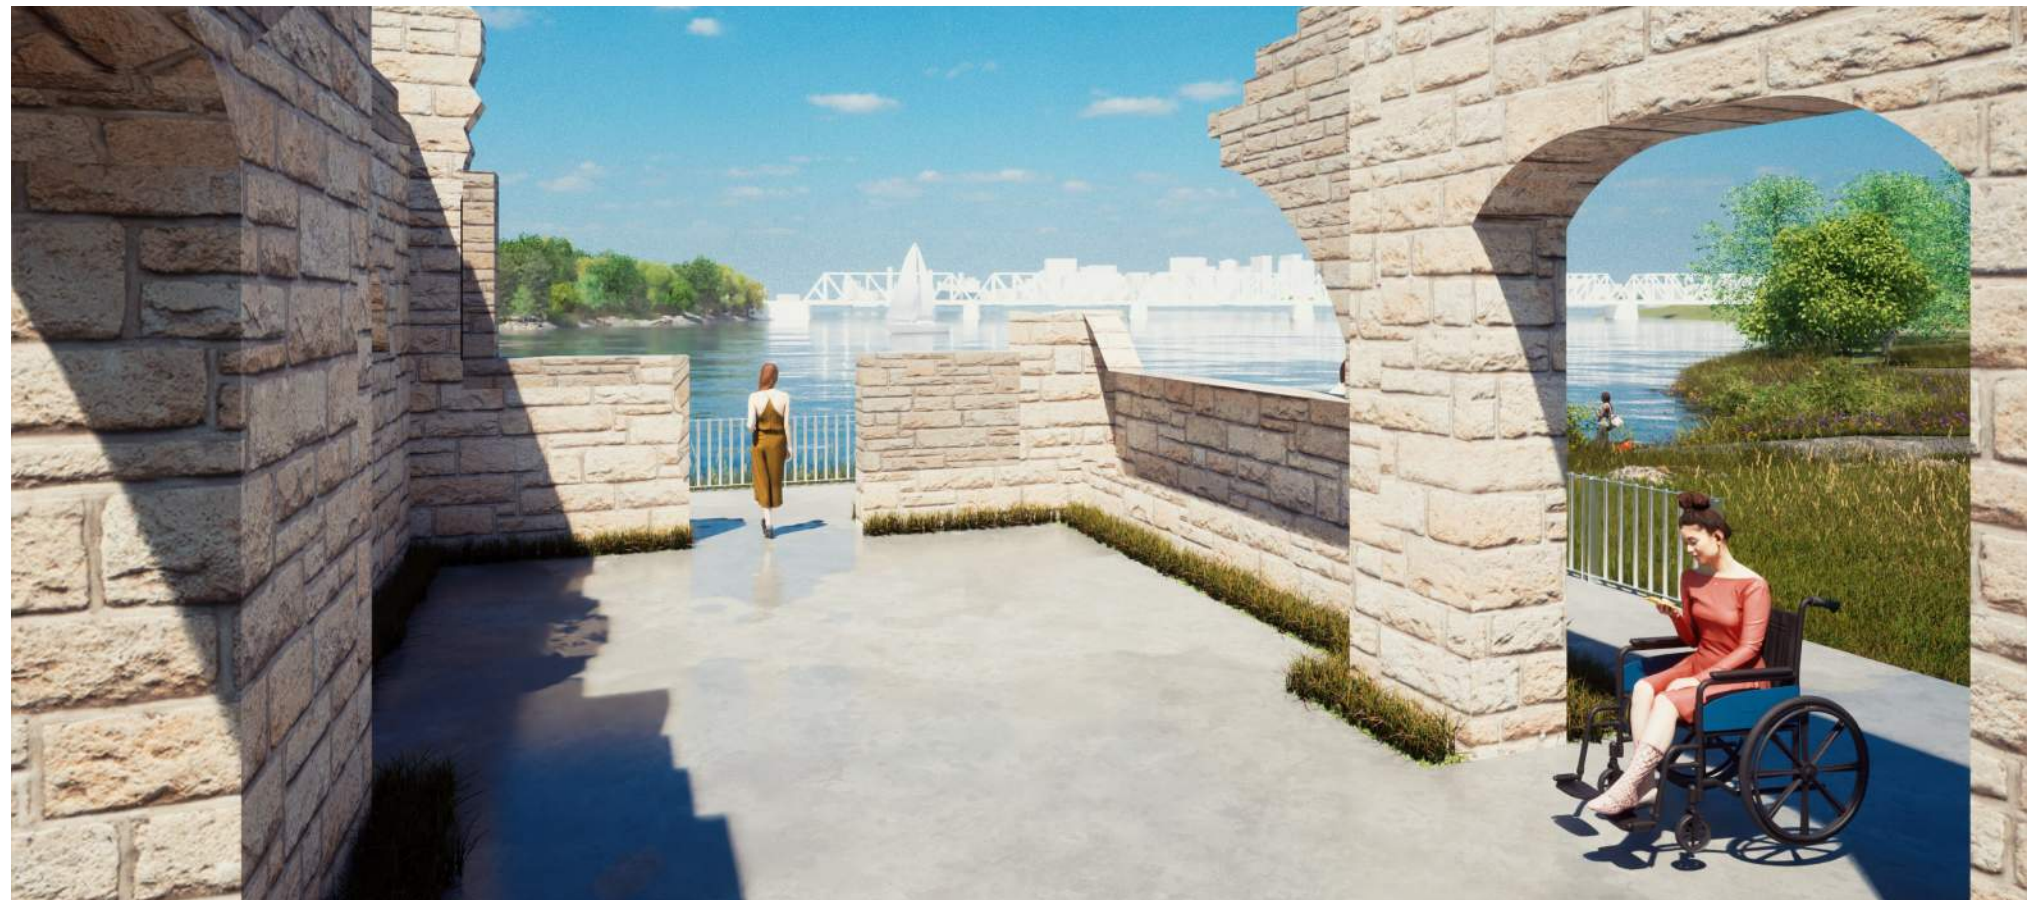
Image 1.13 Proposed interior treatment of the ruin

- Filling the existing sub-floor crawlspace with granular and topping with a smooth concrete floor (Image 1.13) to improve accessibility, reduce ongoing maintenance challenges, and address inundation from flooding due to recent high-water levels in the Ottawa River.

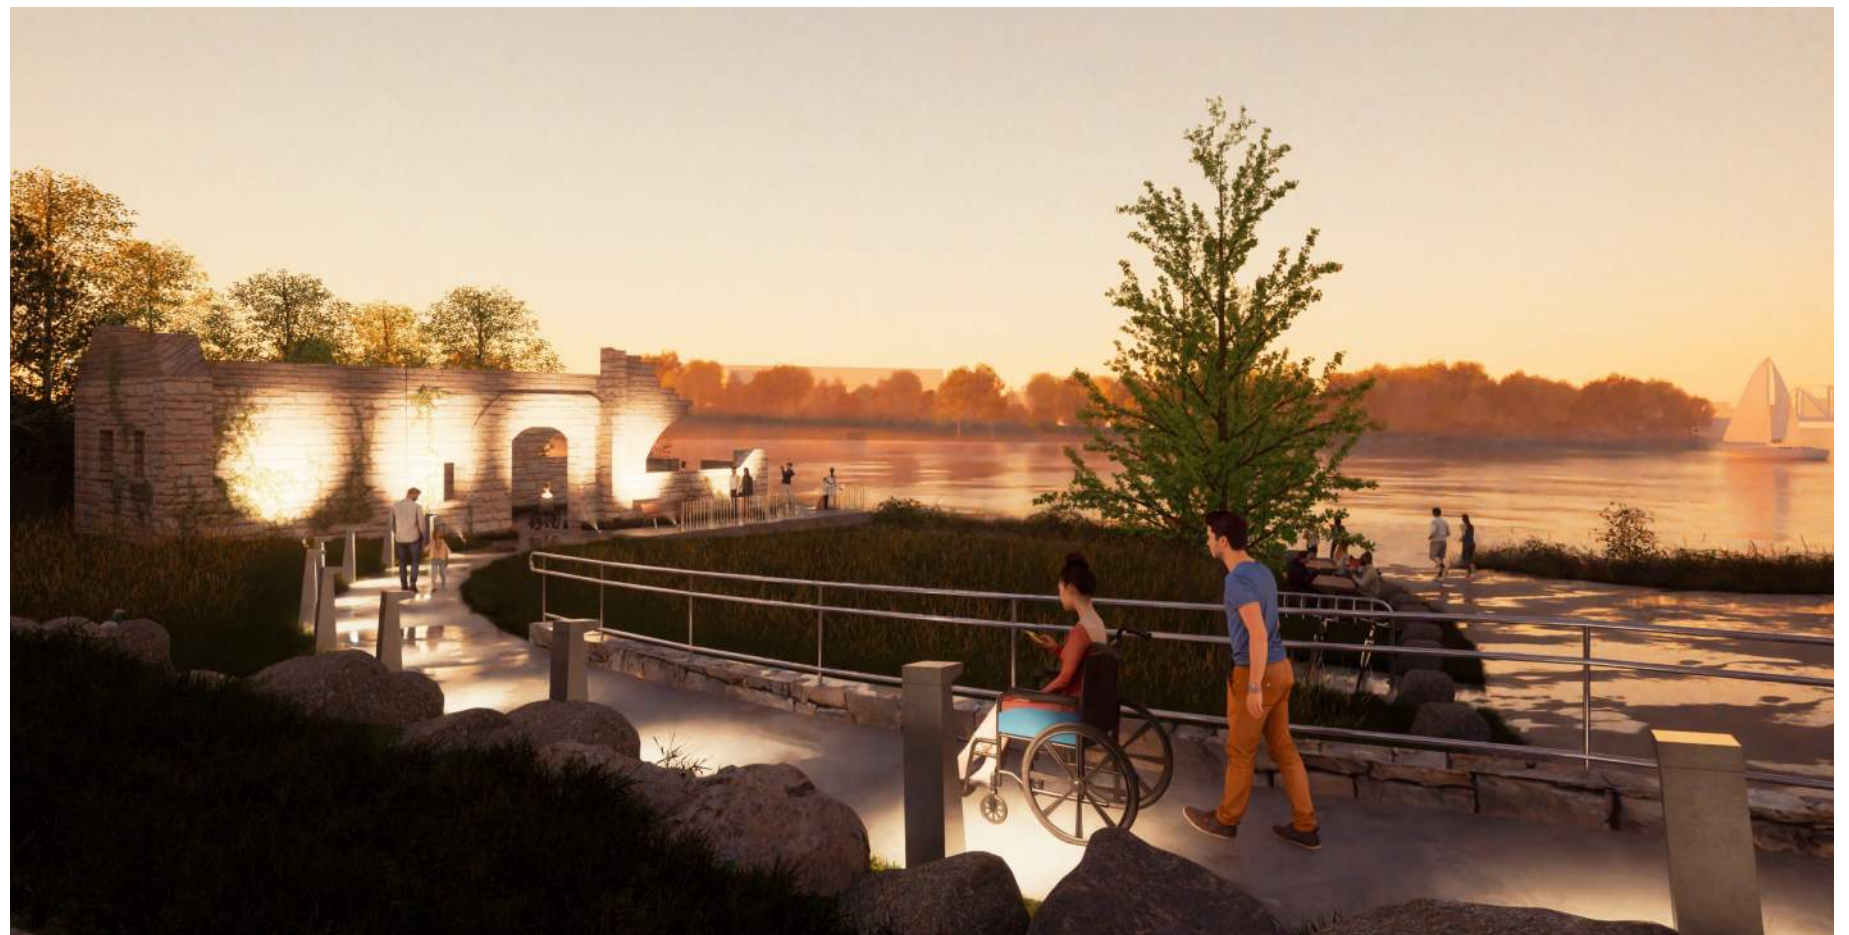
Image 1.20 Proposed lighting of the ruin

Lighting of the site is recommended as it is desirable for accessibility and can enhance the aesthetic experience of the ruin if implemented properly. Some possibilities are uplighting the ruin walls and implementing small low lighting such as pedestrian bollards along the pathway, with consideration given to avoiding negatively affecting wildlife or detracting from the peaceful, quiet character of the ruin (Image 1.20).

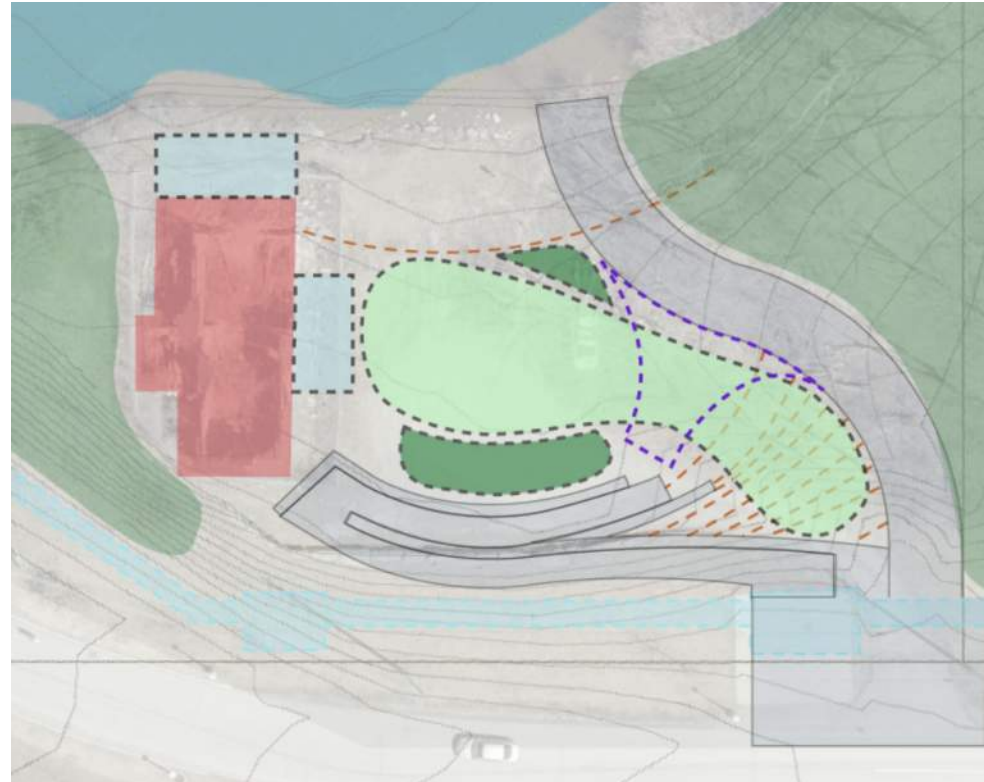
Image 1.21 Site treatment option 1

The first option (Image 1.21) proposed a larger plaza space at existing unit paver pad and vehicular entrance that would serve as a combined entrance for vehicles and pedestrians. An accessible pathway would be provided to mitigate the steep grades. It would switch back and end on the south side of the site near the road, requiring pedestrians to cross the open space to visit the pumphouse. This would require extensive retaining walls to support the pathway and would have a longer travel distance from the entrance to the pumphouse. A simple vehicular roadway to the boat launch was proposed and included a small hammerhead turn around that would reduce the vehicular use of the open space next to the pumphouse. This option could incorporate the hammerhead within the open space to reduce the amount of vegetation removal required. However, it was agreed that a clearly defined vehicular space separate from the pedestrian space would be safer and limit conflicts.

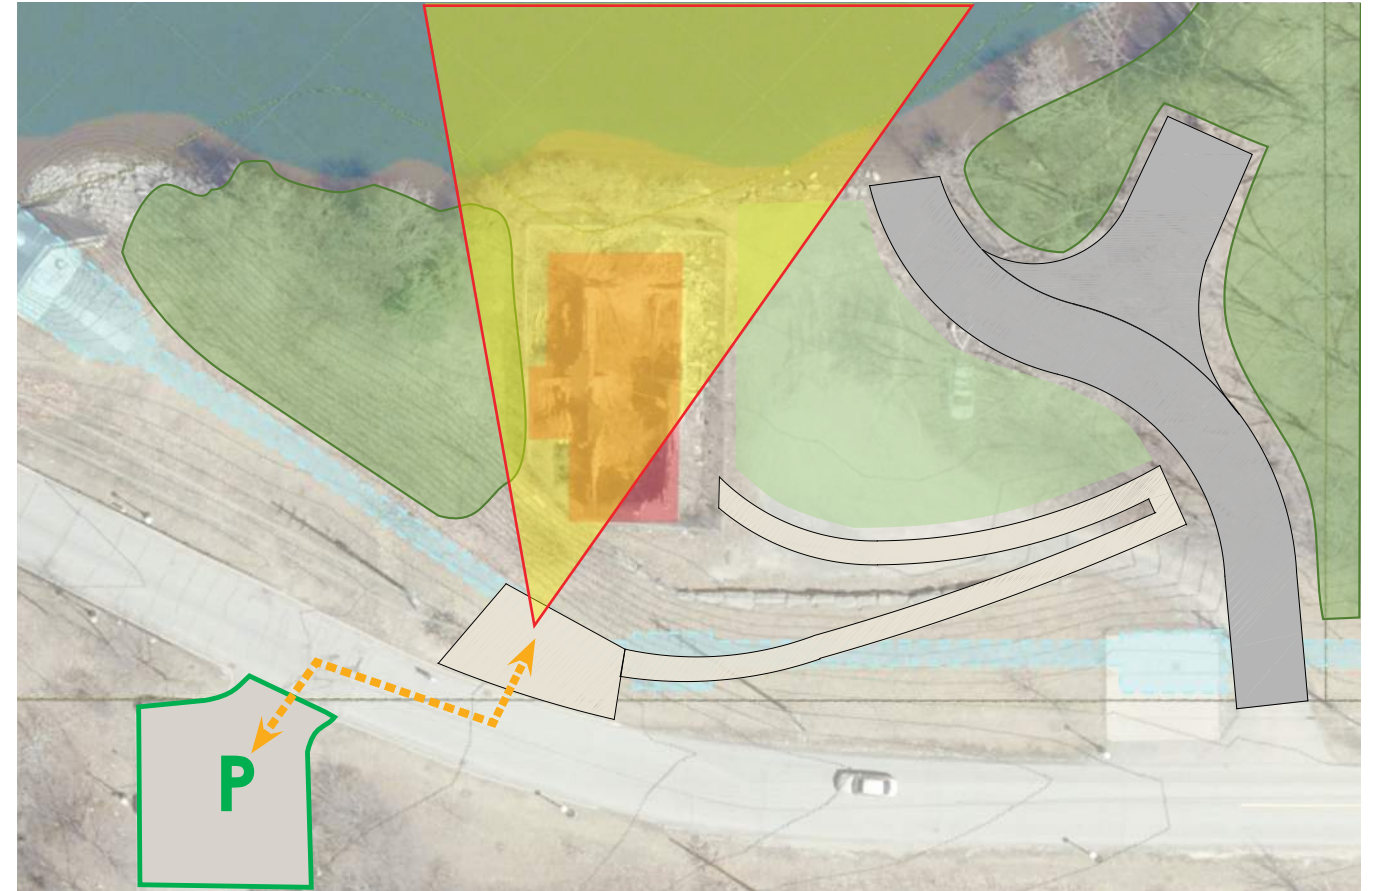
Image 1.24 Preferred site treatment

The preferred concept was developed based on the feedback from the engagement sessions and more in-depth design considerations. In the preferred site treatment plan, the pedestrian pathway is simplified to reduce the number of switchbacks and the entrance was moved to the north so that it has a direct connection to the parking lot (Image 1.24). The pathway entrance from the parking lot also provides a different perspective of the ruin when entering the site (Image 1.25). The pathway then leads the users directly to the pumphouse. The vehicular road and hammerhead are clearly separated from the open space. This will require the removal of some of the vegetated area, which is dominated by non-native invasive plant species and those in decline, while protecting more valuable trees and re-vegetating the area. The open space created is proposed to be treated as picturesque, relaxing, and serve as a contemplative space that enhances the ruin's presence to create a degree of mystery.

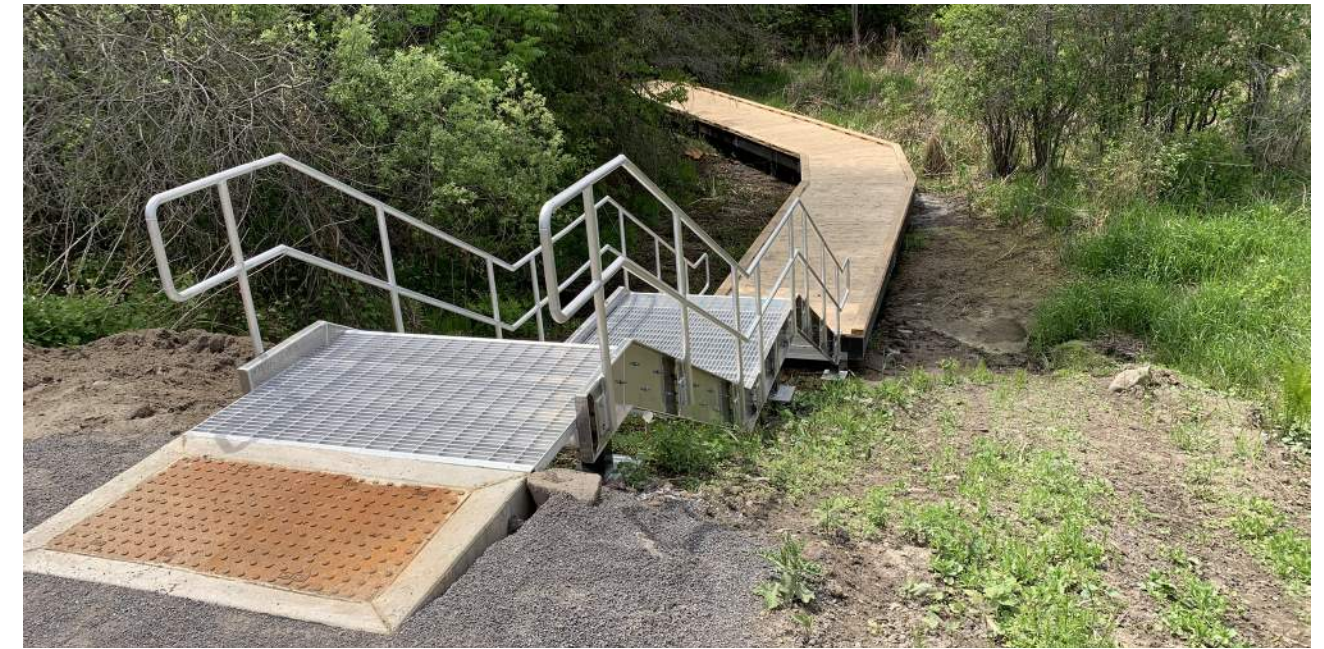
Image 1.29 Kizell Trail Expansion stair - Source: CSW

Stairs have been included from the bus drop-off to the pathway of the ruin to provide direct access to the open space and boat launch. The stairs could be simple metal stairs using helical piles to reduce the construction cost and excavation of the site. An example of this type of stair was designed by CSW and constructed as a part of the Kizell Trail Expansion along Goulbourn Forced Road in Kanata (Image 1.29)

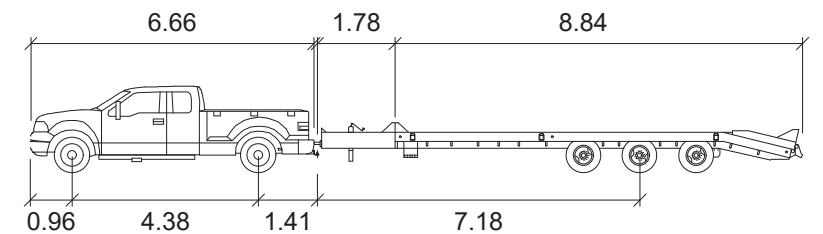
Big Tex 5XPH-24+5 Heavy Hitch

meters
Car Width	: 2.03
Trailer Width	: 2.59
Car Track	: 2.41
Trailer Track	: 2.59
Lock to Lock Time	: 6.0
Steering Angle	: 34.2
Articulating Angle	: 70.0

Image 1.32 Vehicle with trailer used for AutoTURN analysis

The boat launch and access road have been modified since the community consultation after reviewing multiple possible travel route options. The Ottawa River Rafter's use a large van and 28' trailer to launch their boats (Image 1.31). Using the AutoTURN software, we tested a large truck with a trailer with a similar axel length as the van and boat trailer (Image 1.32). It became apparent that the vehicle would need much more room than the small hammerhead illustrated in the preferred site treatment option, and it would still be quite difficult (Figure 1.33). We assessed their current process, however it uses a good portion of the open space adjacent to the pumphouse and would reduce the open space for leisure and public use (Figure 1.34). Therefore, we explored an alternative that proposed the vehicle would continue from the entrance straight down to the river, through the vegetated area, and around some trees that are slated to be preserved (Figure 1.35). This allows for the vehicles to turn around the preserved trees and naturalized space and back into the boat launch (Figure 1.36). Parking for extra vehicles is provided to ensure safe coordination of the boat launch when there are multiple users (Figure 1.37). This parking could also serve as potential parking for the school bus if necessary. The access road was designed to accommodate the turning radius of the large vehicle and trailer, but modifications to slim down the extents of paved area can be reviewed during detail design. Potential locations for temporary bathroom/change facilities for the Ottawa River Rafter's could be accommodated within the central naturalized area, or by the parking (Figure 1.37).

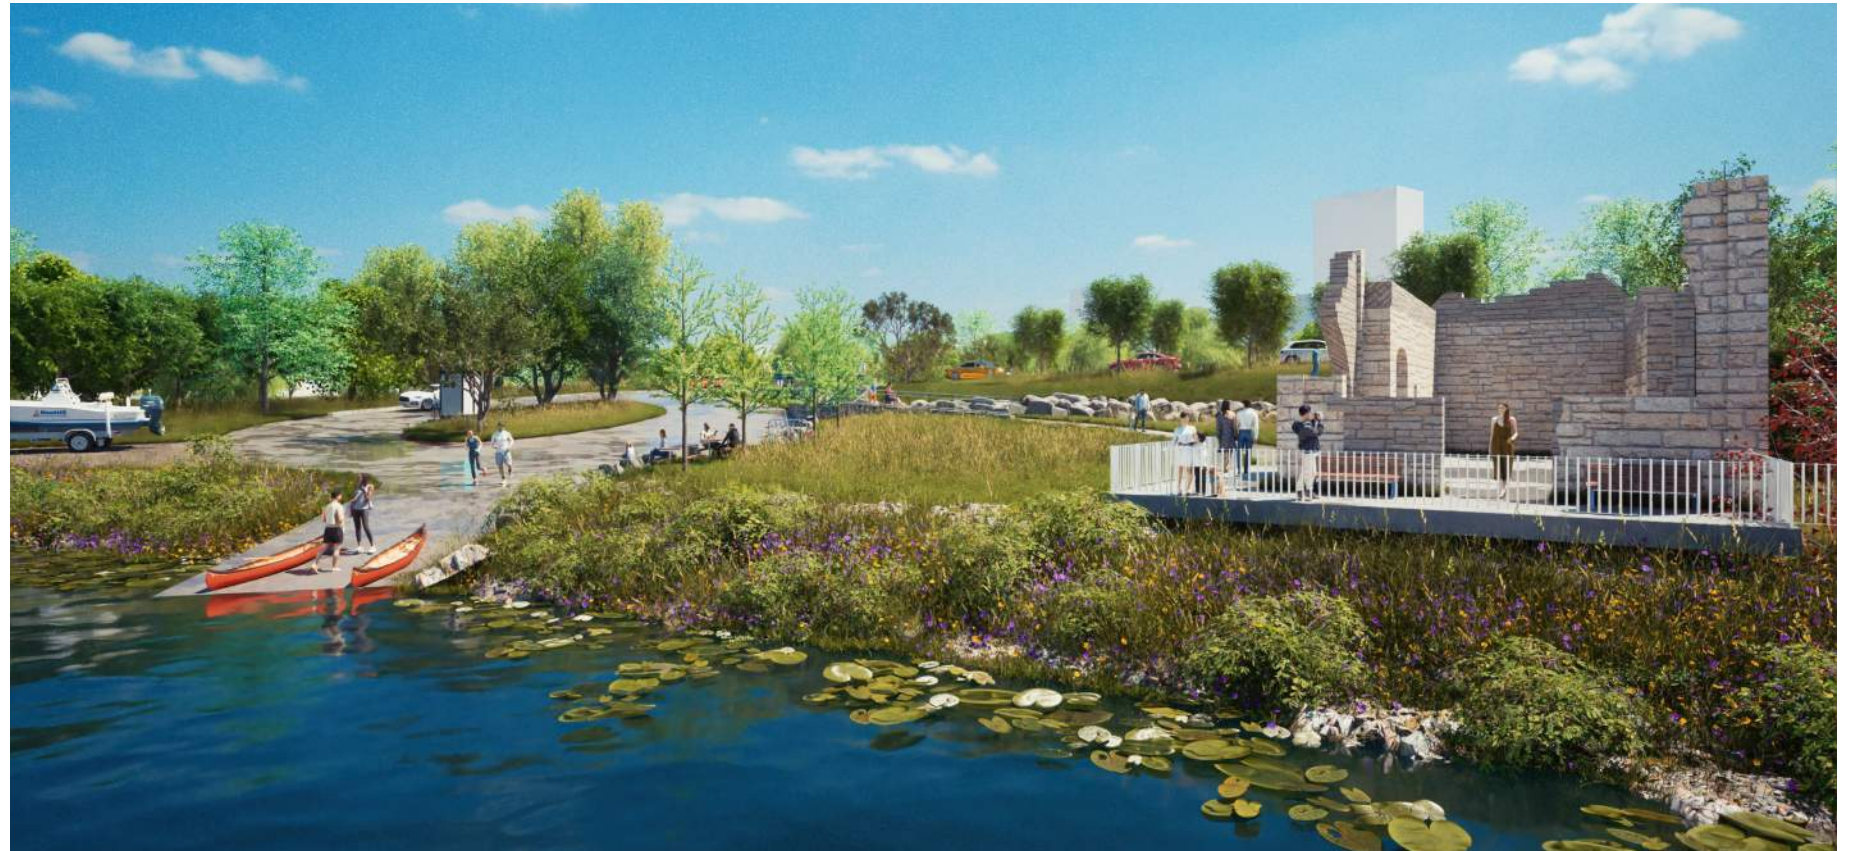
Figure 1.39 Proposed vegetation along the Ottawa River

The new design of the access road and boat launch has a significant impact on the vegetated area on the east side. However, the vegetated area is not densely treed, but mostly small shrubby species, and it suffers from significant degradation and invasive species such as buckthorn. Additional trees could be planted along the new access road and along Onigam Street as compensation for the removal of this vegetated area. Native tree and shrub species could be planted along the edge of the new access road to replenish the vegetated area and reintroduce a healthier ecosystem. Larger hardwoods such as maples and oak should be planted upland, closer to Onigam Street, with fast-growing and water-loving poplars and aspens closer to the Ottawa river. Coniferous trees should also be added to provide habitat in the winter. Understory woody shrubs such as sumac, hazels, and elderberries should be planted upland closer to Onigam Street, with shoreline flood fringe shrubs species such as dogwoods, winterberries, nannyberries, and alders planted in the riparian zone. The naturalization of the shoreline on either side of the boat launch should be planted extensively with willows, sedges, and rushes to help stabilize the soil and prevent erosion during large flooding events. Rip rap in this area could also be considered to provide areas for fishing or dog play and provide another layer of shoreline protection (Image 1.38 and 1.39).

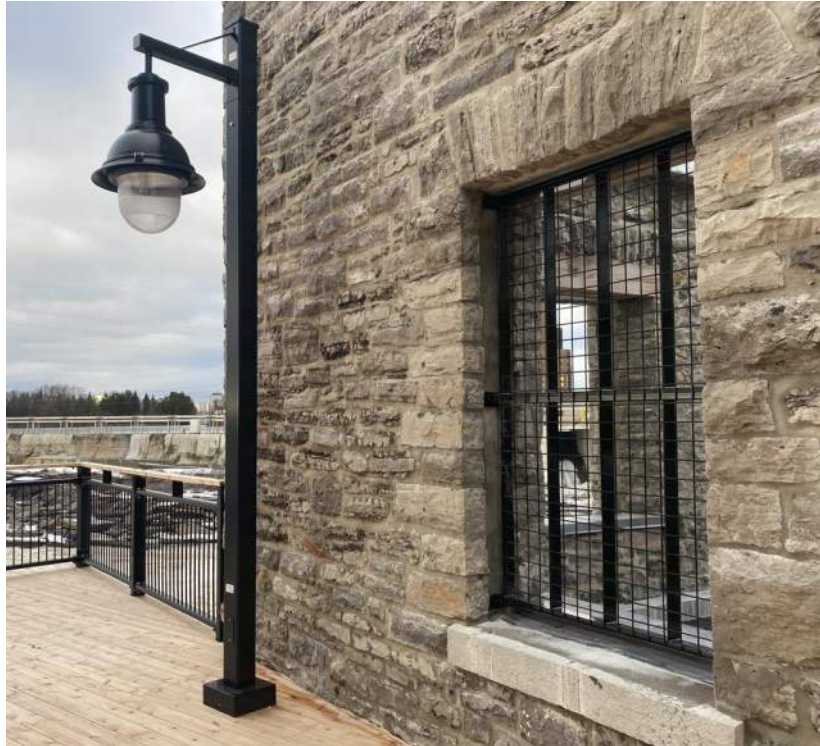
Photo 1: Black metal grilles installed at Chaudiere Falls Lookout, in Ottawa. Grilles were designed as guardrails to protect the public from a fall hazard. Spacing of metal bars mimic original window detailing.

In keeping with the landscaping plan laid out by CSW, the ruin will not be roofed and would not require locking during off-hours. A concrete pad may be installed inside the ruin, leaving a reveal along the walls to allow drainage and to keep the existing and new elements distinct. A porch may be added on the east façade to increase public access to the building and strengthen the building's relationship to the Ottawa river. Metal grilles imitating the form of the original window panes may be installed in openings if desired from an esthetic or security standpoint. In some cases, these grilles could be used to partially support overlying masonry. It is not anticipated that grilles must be used to support the masonry; instead they could be optionally used to support unstable masonry where constructing masonry supports is undesirable. For instance, at the partially collapsed arch window on the south elevation, a grille could be used to support the overhanging masonry and maintain the *ruin* appearance of the opening.

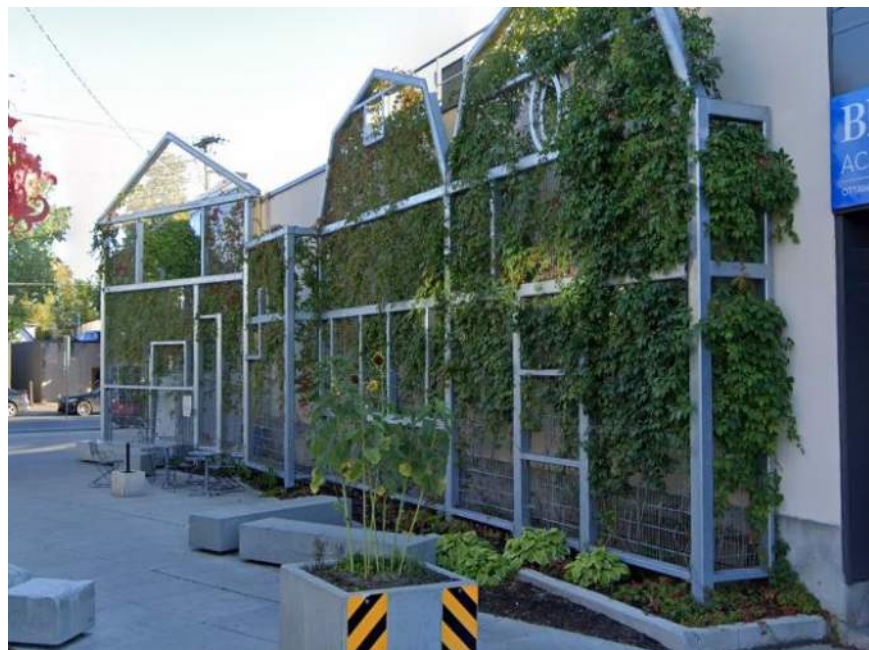
Photo 2: A second example of metal grilles located in Westboro (at Richmond and Winston Ave) shadowing the architecture of homes in the area.

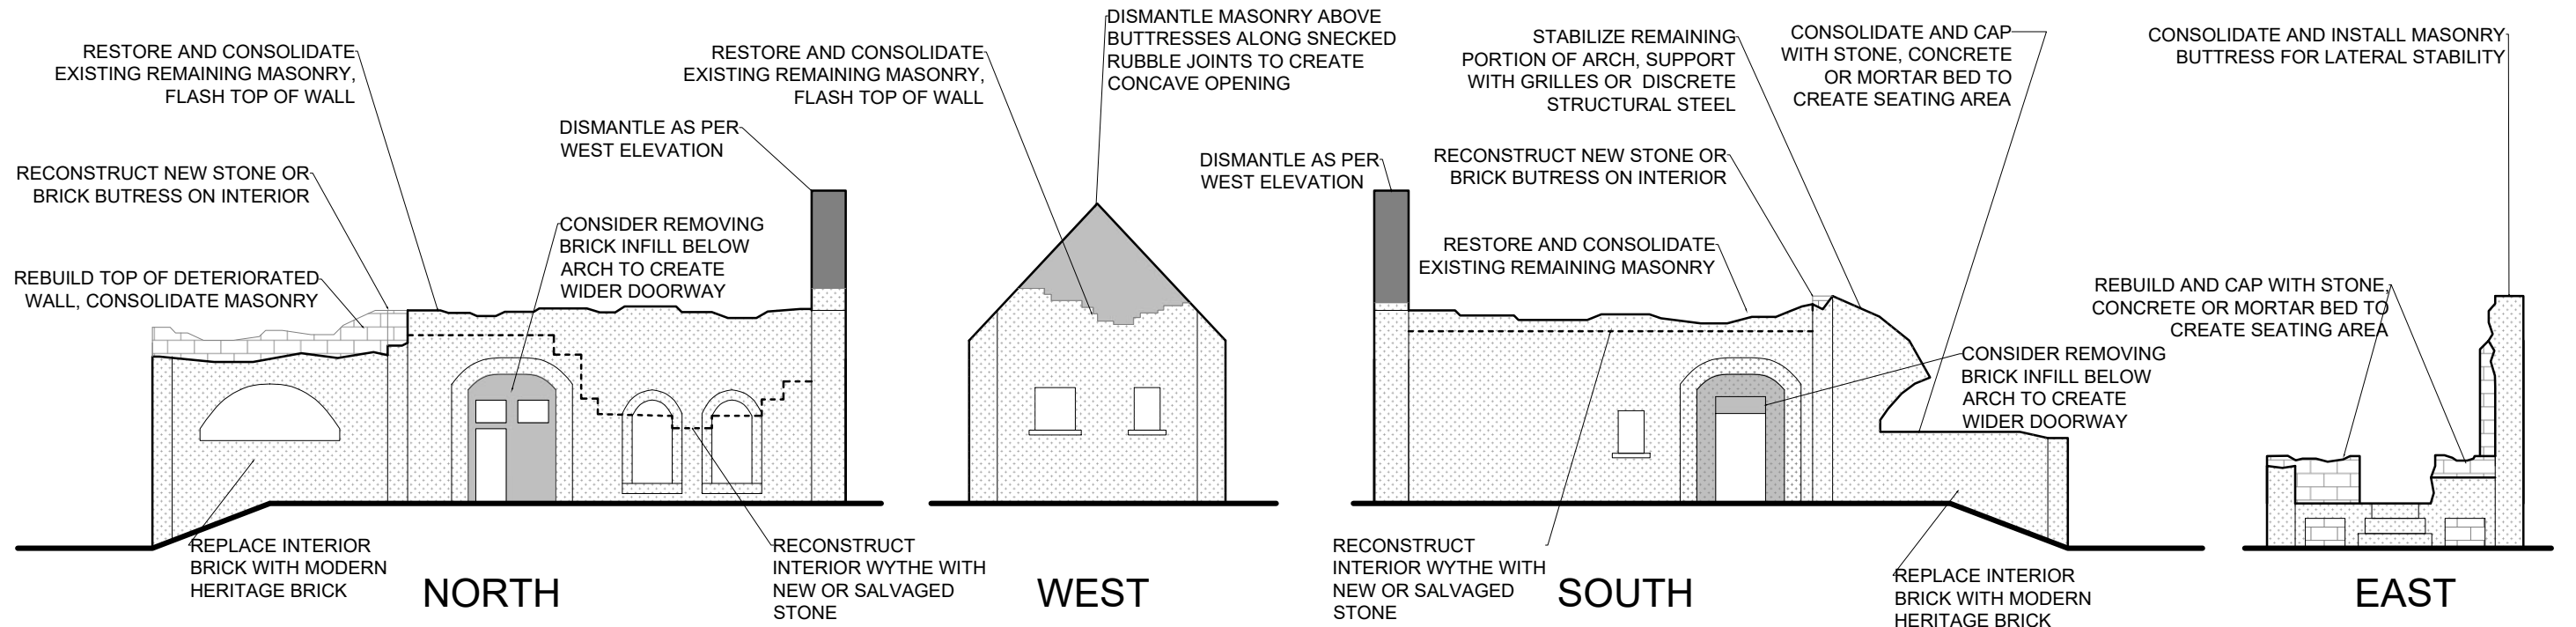
1. REMOVE GREENERY AND LOOSE MATERIAL, (I.E. ROOFING, WOOD DEBRIS) FROM SITE PRIOR TO START OF WORK. SALVAGE LOOSE STONE FOR REUSE IN MASONRY RESTORATION OR ELSEWHERE ON SITE. STORE IN PROTECTED AREA.

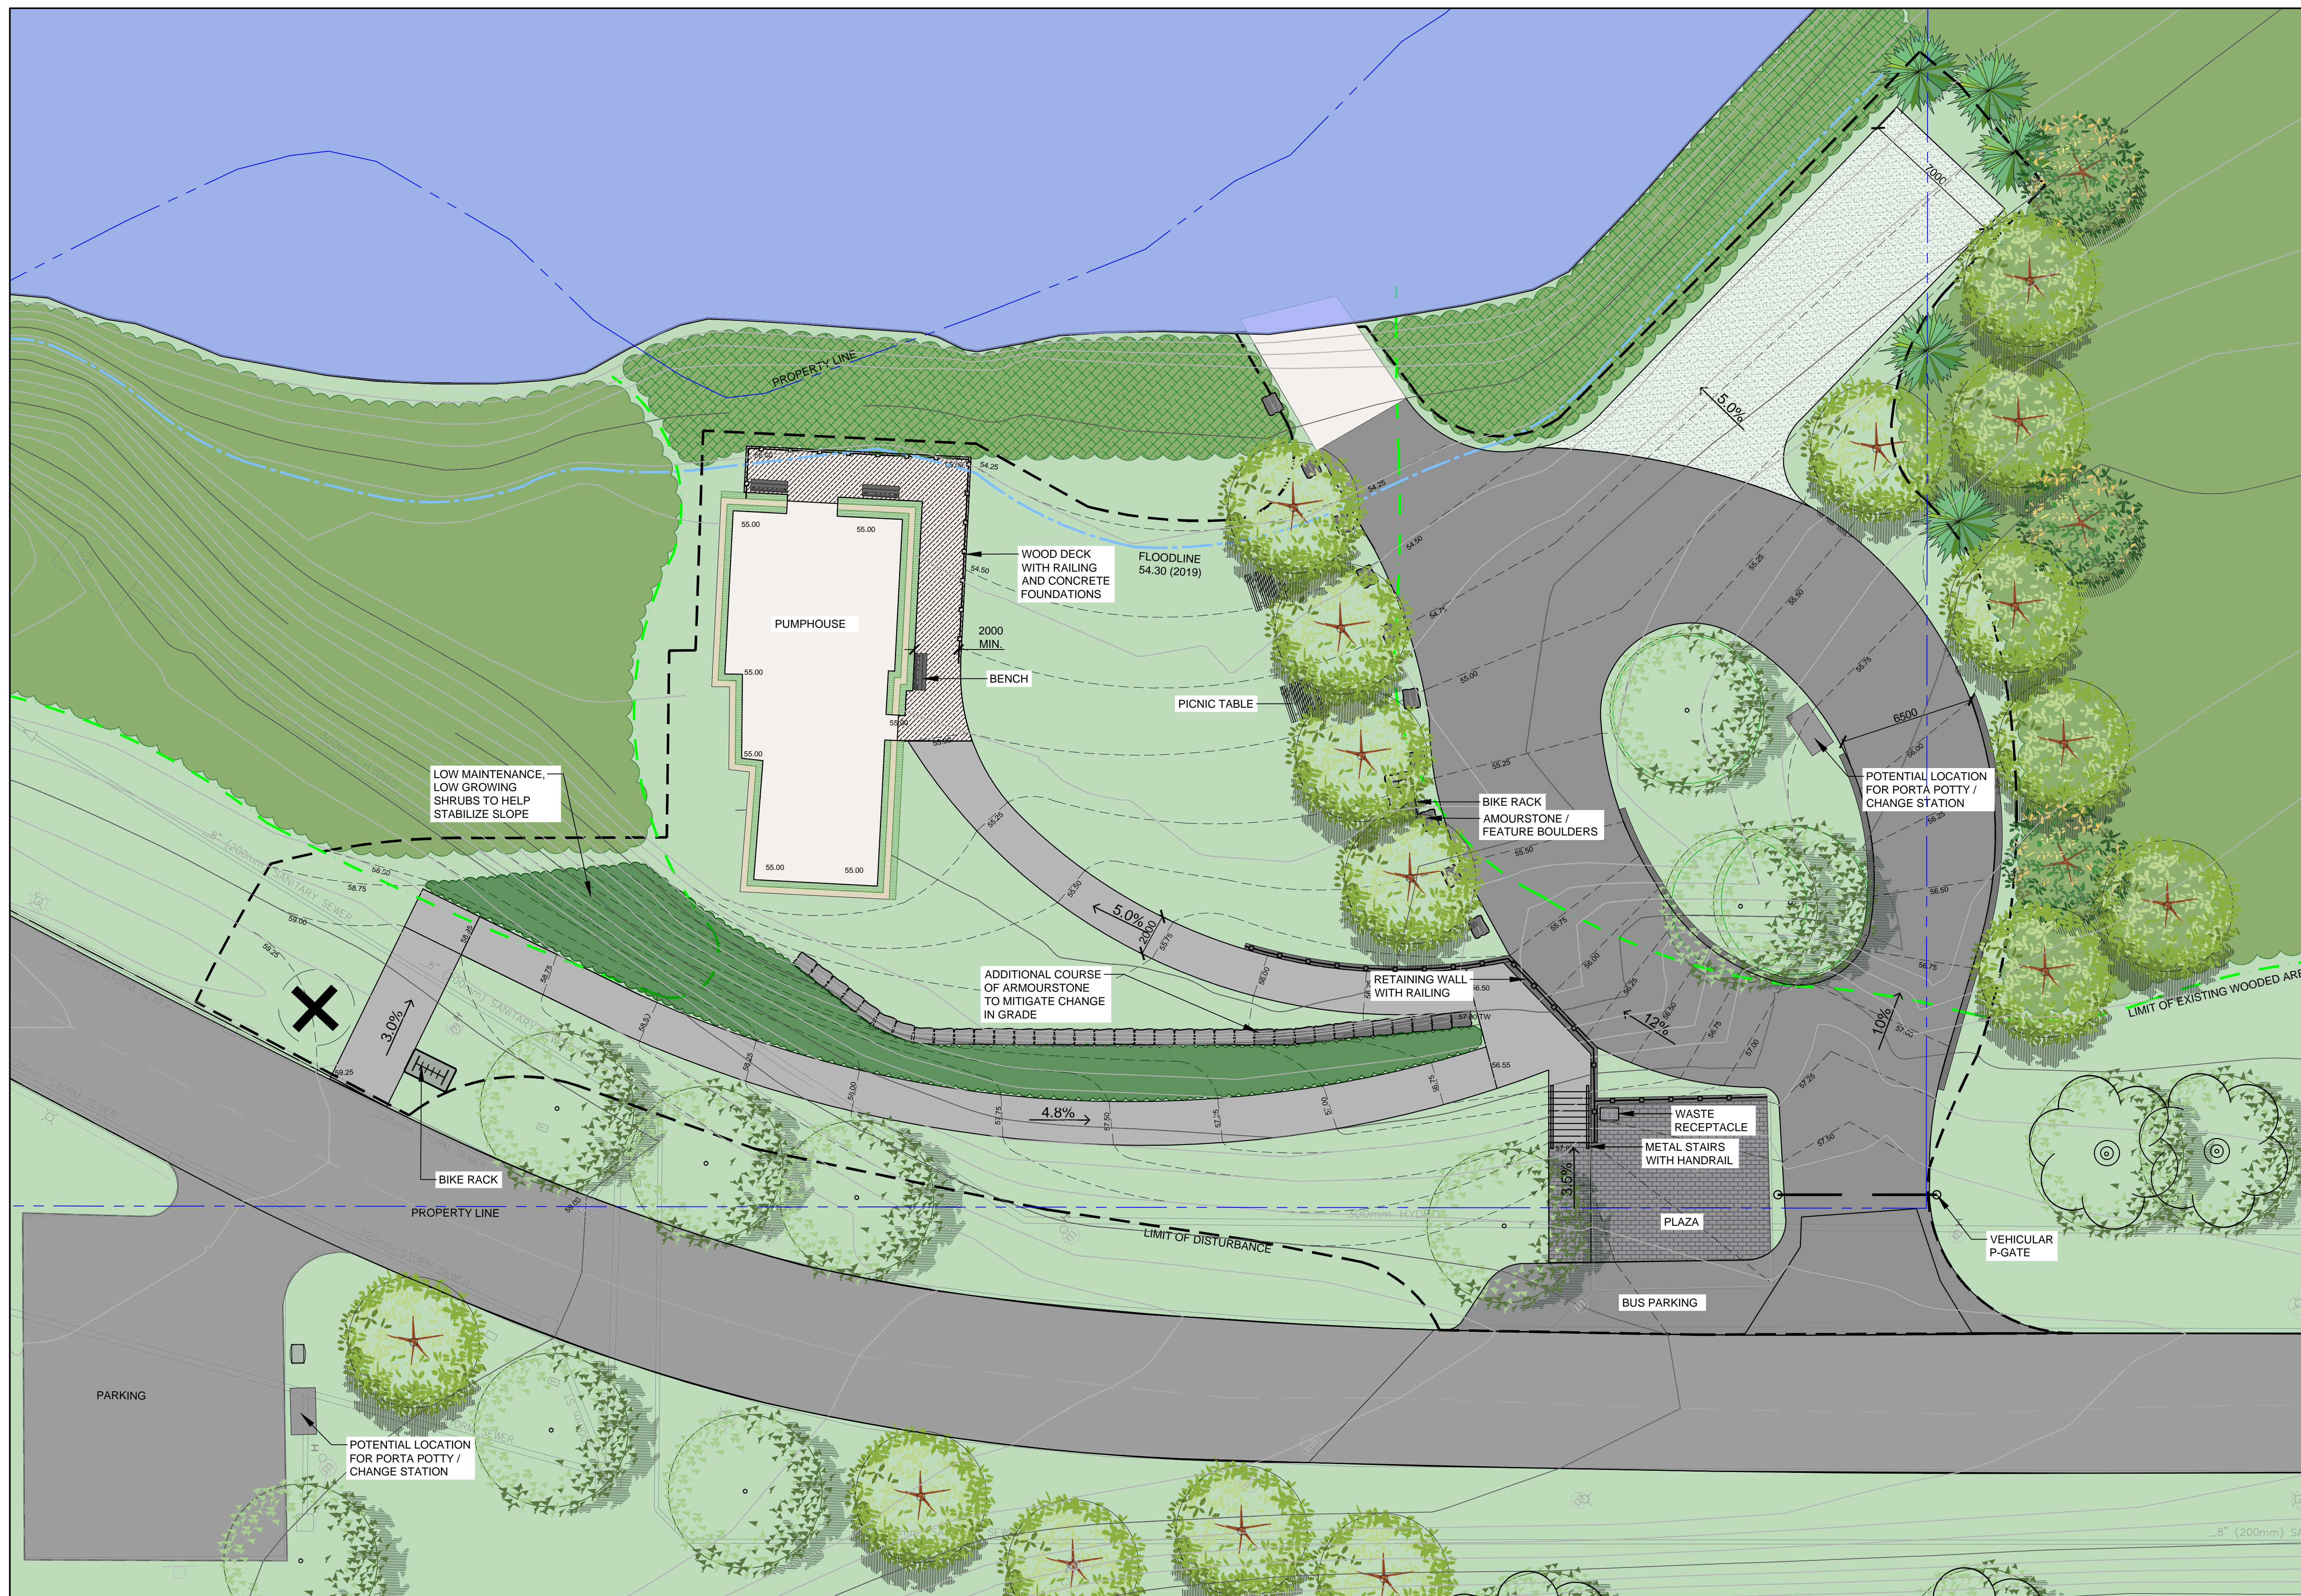
HINTONBURG PUMPHOUSE - PREFERRED CONCEPT PLAN CONSERVATION AND REDEVELOPMENT PROJECT

SCALE 1:150
