Introduction

Project name: Hintonburg Pumphouse Heritage Conservation Approach

Project #: 2143-01

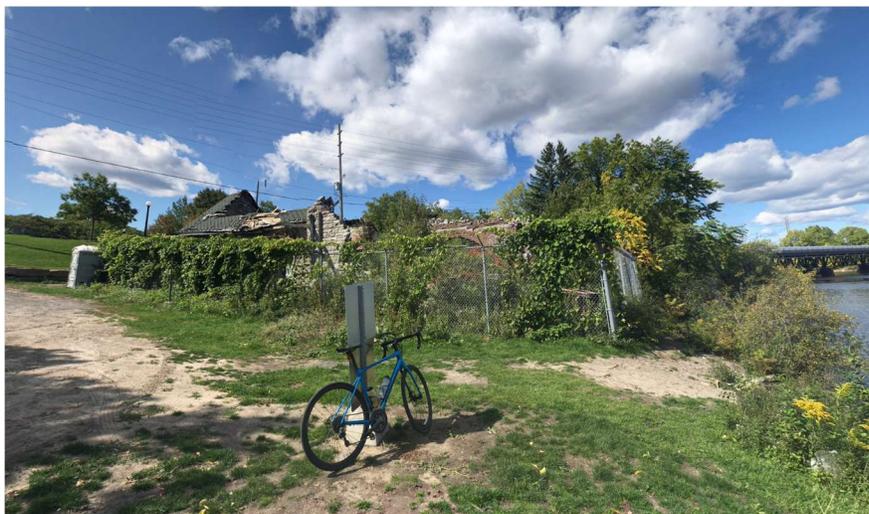
After the 1989 fire, the roof, turret and the floor of the verandah were all destroyed. In the subsequent years, the unprotected masonry has deteriorated such that little of the half round window on the south façade remains, and the north window aperture is unstable. The surrounding grounds are generally open, with some nearby forests, which have suffered from colonization from invasive species, unstable ground and flooding.

iii Current Condition of the Ruin - Source: Google Maps

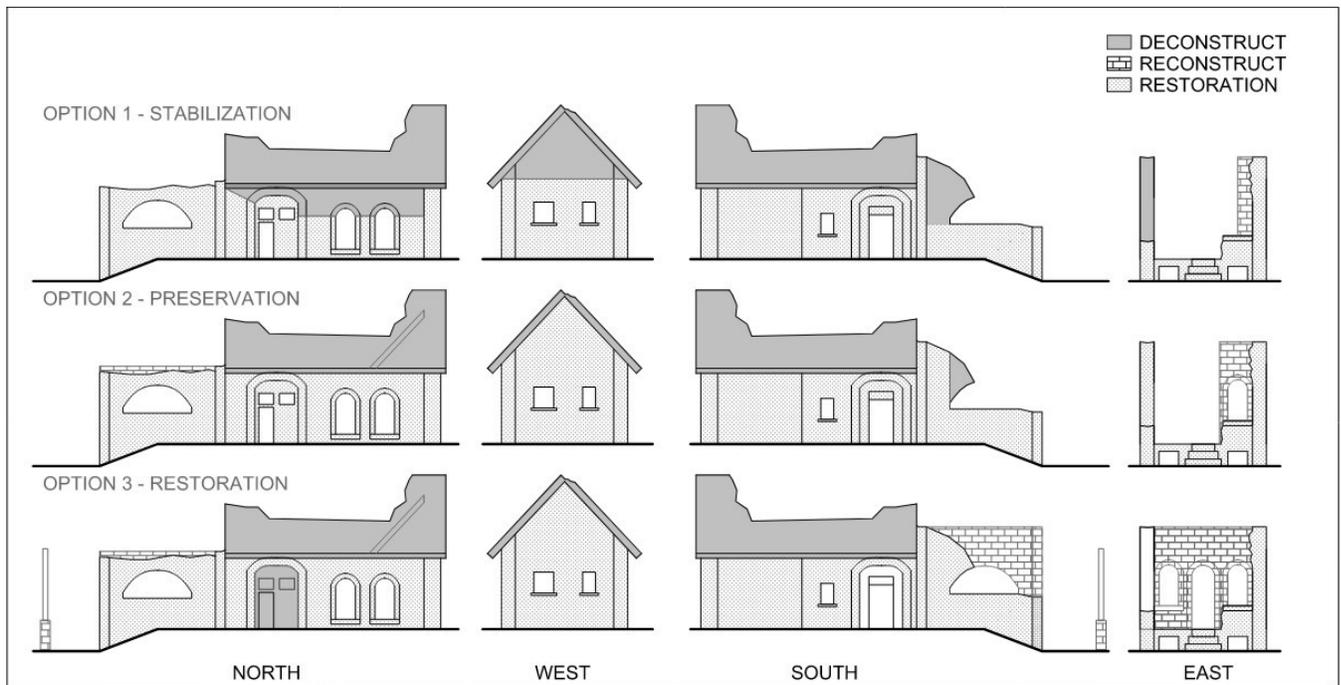
- *“Option 1 – Stabilization: Remove any masonry in poor condition, restore the remaining masonry walls and protect by capping skyward facing joints to prevent water infiltration.*
- *Option 2 – Preservation & Protection: Restore all remaining masonry elements by deep repointing, local dismantling and rebuilding, and core consolidation. Protect the masonry walls by capping skyward facing joints to prevent water infiltration, or by a partial self-supported roof structure.*
- *Option 3 – Restoration & Reconstruction: Restore all remaining masonry elements by deep repointing, local dismantling and rebuilding, and core consolidation. Reconstruct collapsed masonry elements based on existing physical evidence and historic photos or documentation. Protect the masonry walls by a self-supported roof structure, supported by the verandah posts.”*

iv Illustrations of Stabilization Options - Source: J.G. Cooke

Option 1, the most basic treatment, is the minimum of what is required to prevent further deterioration of the structure, and includes the demolition of existing elements of the ruin that would otherwise require dismantling and rebuilding. Option 2 proposes to retain all aspects of the ruin that are currently standing, with different degrees of intervention proposed to stabilize the most deteriorated elements. Option 3 proposes to retain what remains and reconstruct elements of the building that are currently non-existent.

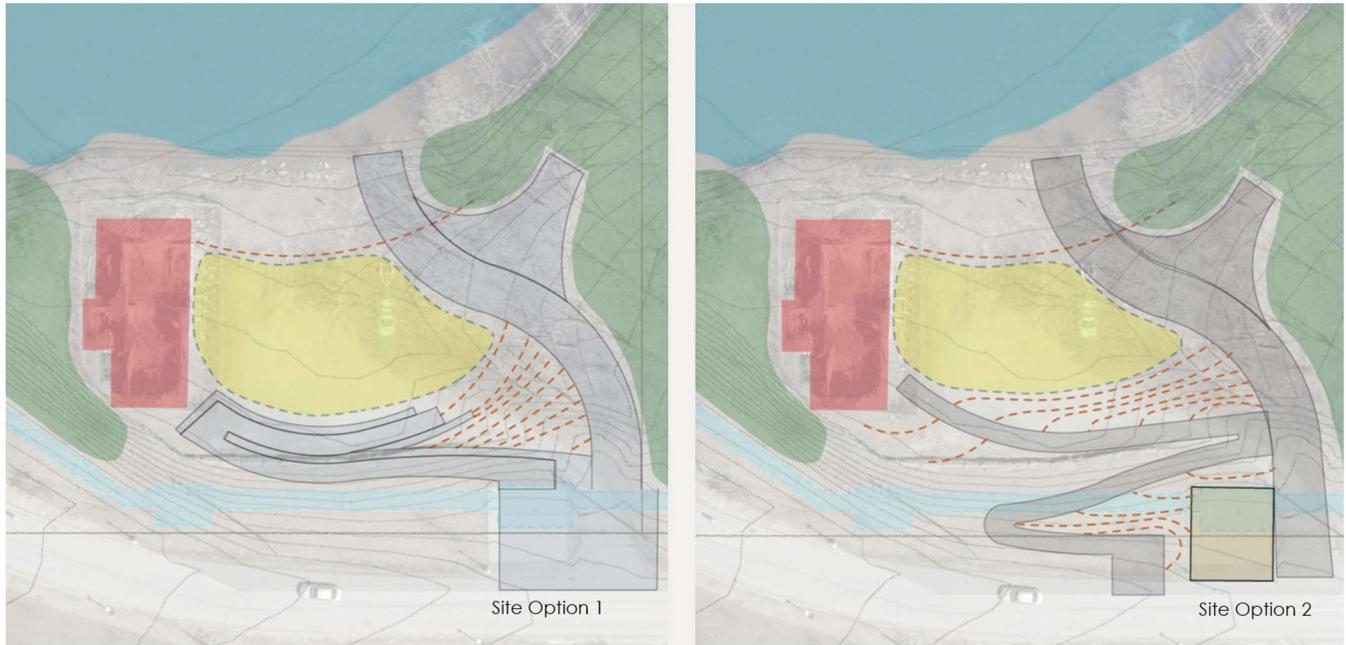
is supported but the new design should be as 'green' as possible. The accessible route shown in Site Option 2 below, was preferred by the engagement groups.

v Open Space and Accessibility Option Diagrams - Source: CSW

- While the grounds of the building were included in the designation, no specific character-defining elements were identified. The proposal to alter the grounds to support new community use is not considered to be a misuse of the space. Two alternatives to provide universally accessible pathways into the site and up to the ruin were illustrated.
