Document 1 - Large-Diameter Watermain Condition Assessment Program

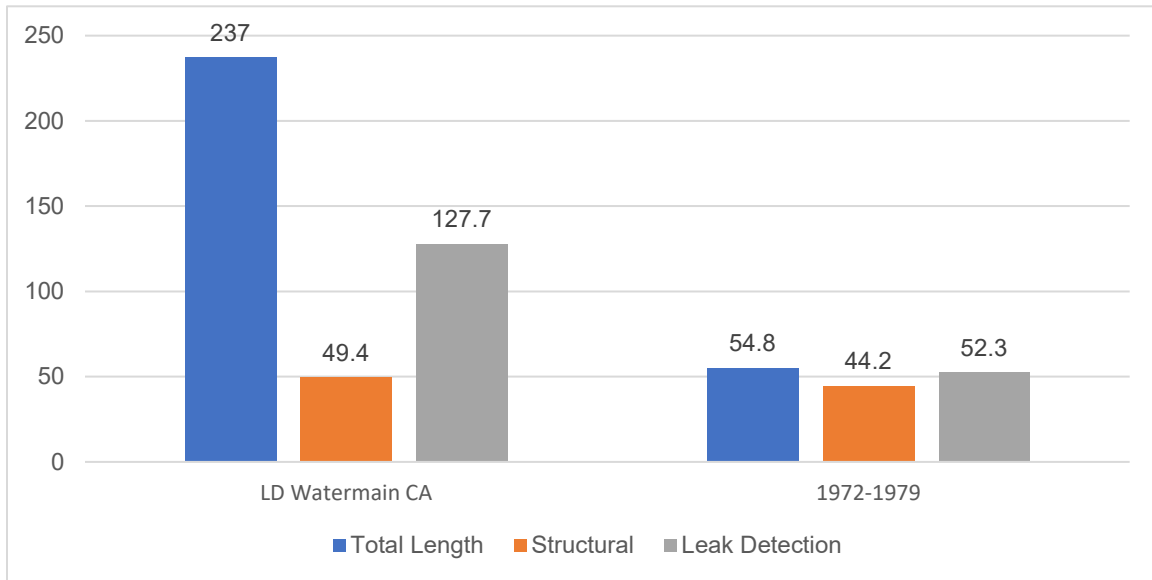
Figure 1 - Large Diameter (≥ 610 millimetres) Condition Assessment Progress Unique Inspections to Date (kilometres)

In 2023, 3.3 kilometres of watermain were newly considered fully completed. Figure 1 illustrates the progress to date for the Large Watermain Condition Assessment Program - the left-side shows the total large diameter watermains (including the cohort of pipes installed from ~1972 to 1979) and the right side shows the cohort of the pipes installed from ~1972 to 1979.
