Large-Diameter Watermain Condition Assessment Program

The City has continued to move forward with the large-diameter watermain condition assessment program. The main benefit of this program is the ability to proactively assess and identify deficiencies that can be addressed in a planned and controlled fashion without negatively impacting customers. There are currently 238 kilometres of large-diameter watermain (≥610 millimetres) in the City. The expected service life is between 80 and 110 years and the average age is approximately 39 years.

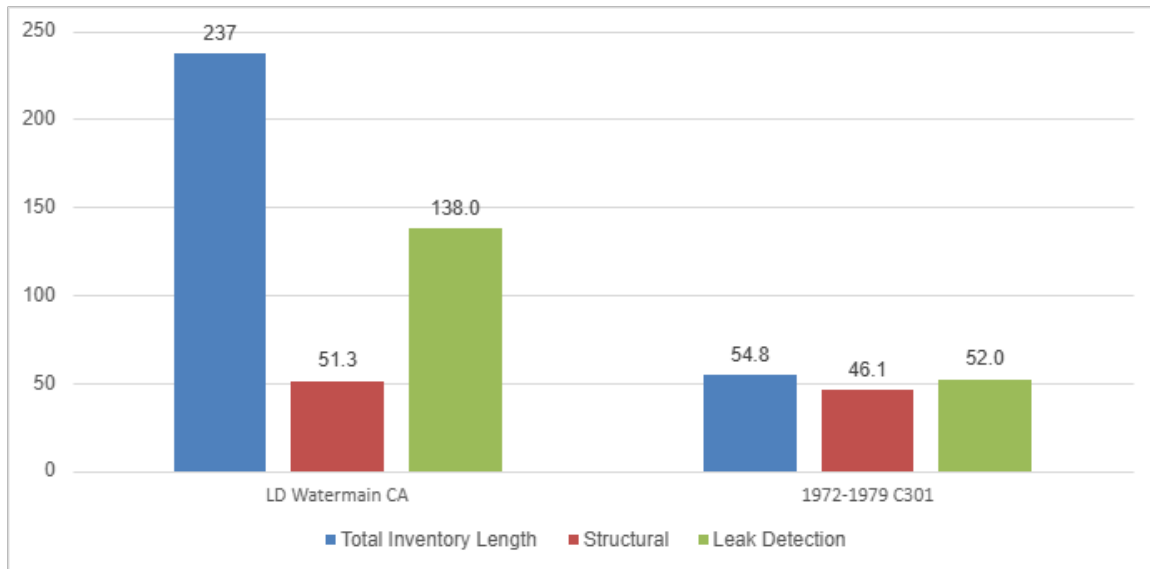
Through this program, 16.7 kilometres of large-diameter watermain was inspected for leaks and 12.3 kilometres for structural deficiencies in 2024. Each type of inspection provides unique condition information upon which rehabilitation and replacement decisions are made. Completion of both types of condition assessment often takes multiple years. A watermain segment is considered to be completely inspected when both leak detection and structural condition have been assessed, as appropriate based on engineering analysis, pipe material and current technology available on the market. The figure below illustrates the progress to date for the Large Watermain Condition Assessment Program - the left-side shows the total large diameter watermain

(including the cohort of pipes installed from ~1972 to 1979) and the right side shows the cohort of the pipes installed from ~1972 to 1979.

Figure 1 - Large Diameter (≥ 610 millimetres) Condition Assessment Progress Unique Inspections to Date (kilometres)
