# 3.9 Streamflow Monitoring

Kanata North Urban Expansion Area – Water Budget Analysis (Novatech, February 2016)

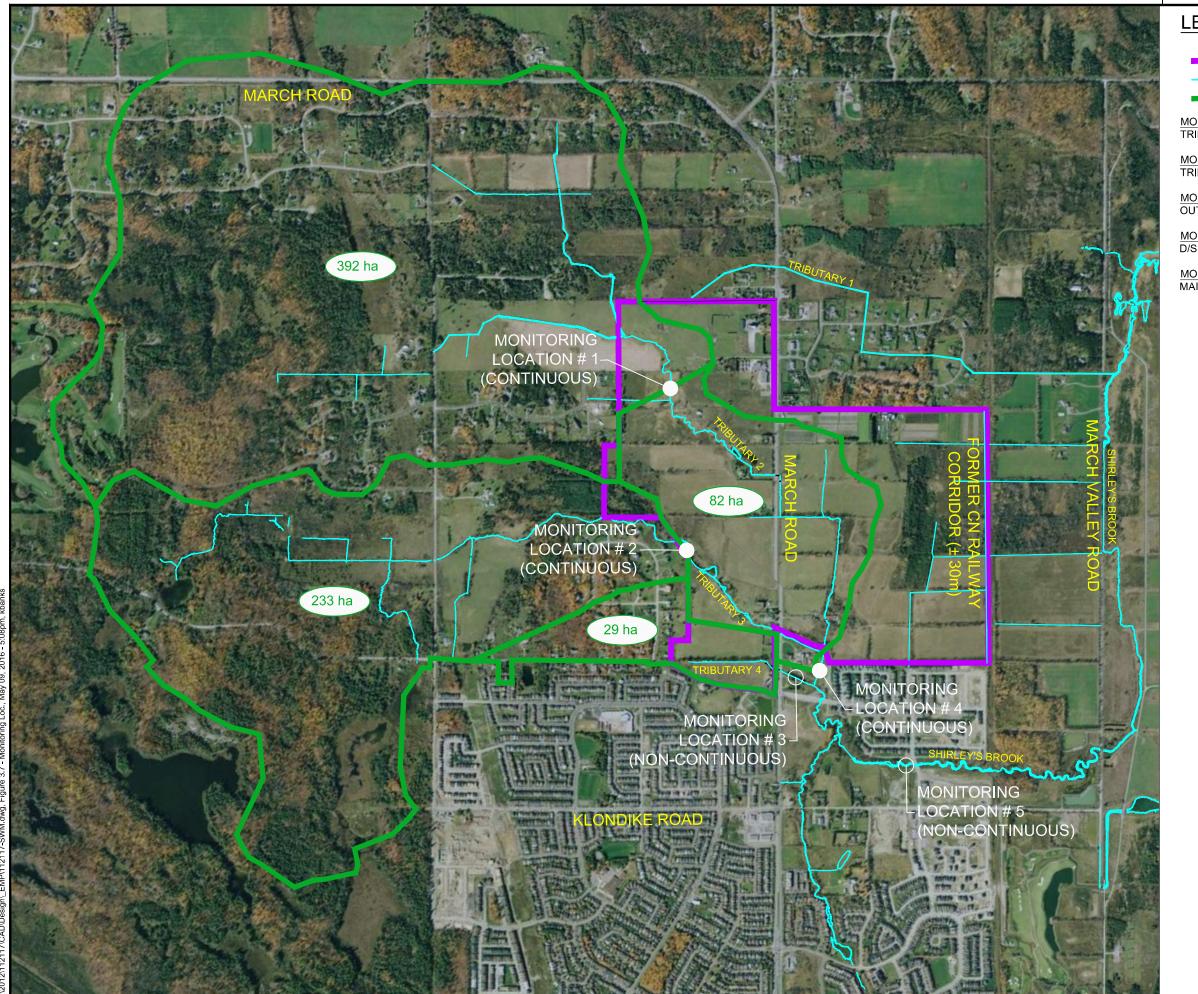
Stream level loggers were installed in three locations on the Northwest Branch of Shirley's Brook, as shown on **Figure 3.7**.

- Monitoring Station 1: Tributary 2
- Monitoring Station 2: Tributary 3
- Monitoring Station 3: Downstream of the confluence of the Tributaries 2 and 3.

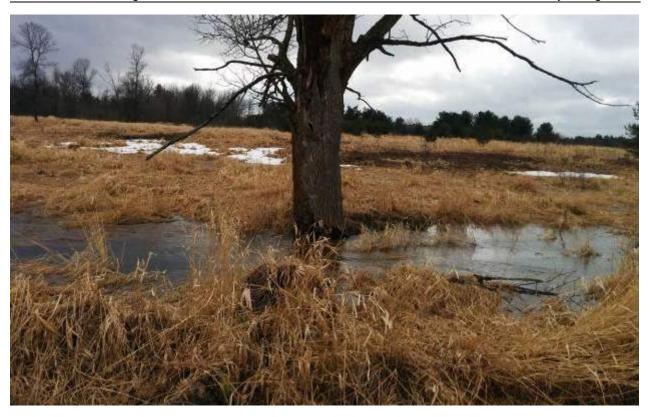
Figure 3.8: Tributary 2 (April 10, 2015)

• April 10, 2015: High flows were observed in Northwest Branch tributaries during the spring freshet.

Baseflows in the tributaries comprising the Northwest Branch of Shirley's Brook were observed to vary significantly over the course of the year. Flows during the spring months are relatively high, sustained by the snow and water retained in the wetland areas in the upper portion of the watershed. Over the course of the summer, baseflows decrease as soil moisture is depleted by evapotranspiration until the channels are dry, only flowing for short durations following storm events. In the fall, the wetland areas gradually replenish their storage as evapotranspiration rates decrease and the tributaries begin to flow for longer durations following storm events.

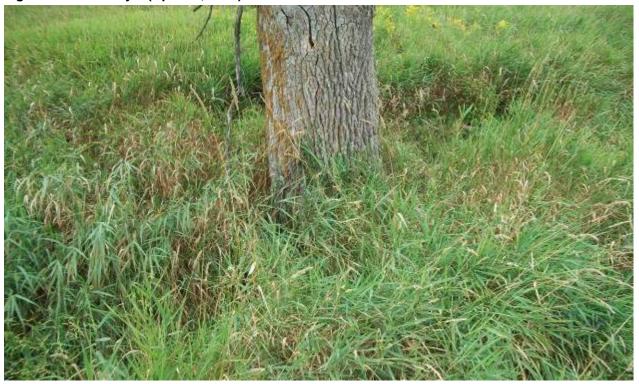
**Figure 3.9: Tributary 2 (August 24, 2015)**

August 24, 2015: The Northwest Branch tributaries were observed to be dry following 22mm of rain between August 20-24.
