FORMER CFB ROCKCLIFFE
MASTER SERVICING STUDY

Hydrogeological Report
Stormwater Management Support Studies
Former CFB Rockcliffe, Ottawa, Ontario
DST Reference No.: OE-OT-017184

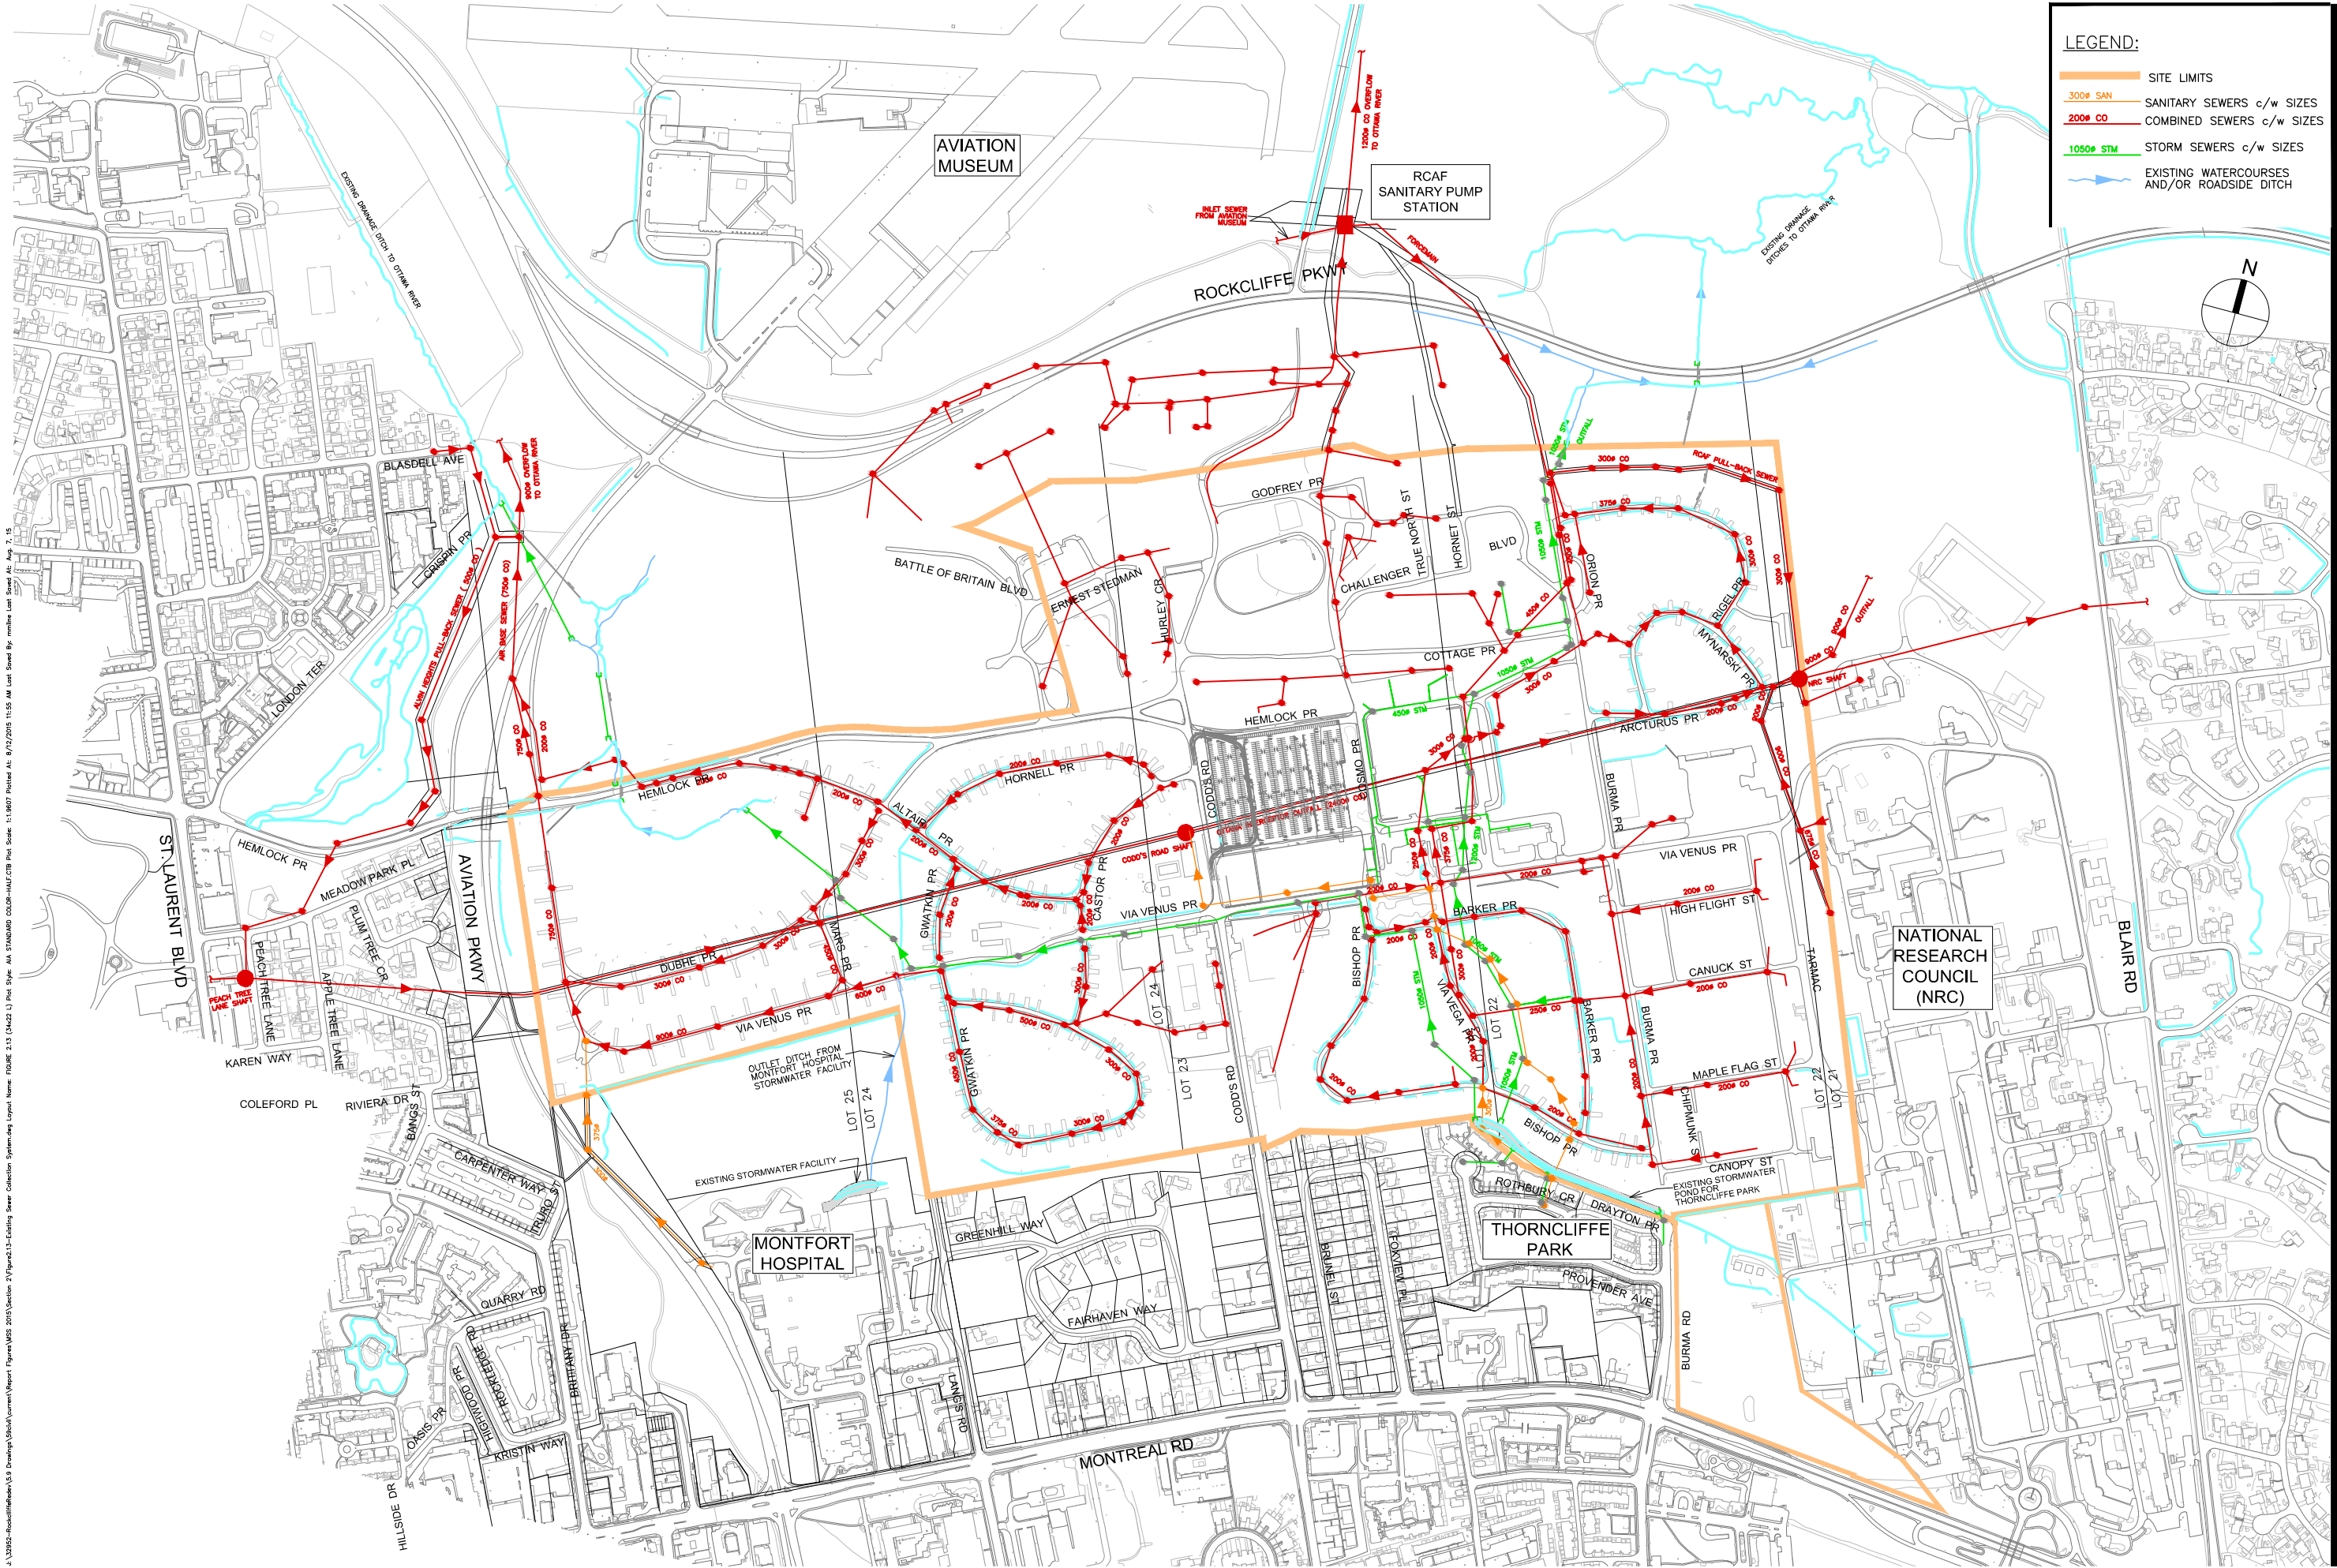
A:\20952-Rockcliffe\Info\A6 Drawing\A6\Current\Report Figures\MS 2010 Section 2\Figure 2.13-Existing Sewer Collection System.dwg Layout Name: FIGURE 2.13 (CM22 L) Plot Style: AIA STANDARD COLOR-HALFTONE Plot Scale: 1:18007 Plotted At: 8/22/2015 11:55 AM Last Saved By: mmlme Last Saved At: Aug 7, 15

All collected wastewater flow in the City of Ottawa is routed to a central treatment plant, known as the R.O. Pickard Environmental Centre, which is located several kilometers to the east of the Rockcliffe site. Wastewater flows are delivered to the treatment plant by several large trunk sewers including the Ottawa Interceptor Outfall Sewer (IOS) which flows through the middle of the Rockcliffe site in a west to east direction. This major collector sewer is 2.4 m in diameter and was constructed approximately 45 m below the existing ground surface. **Figure 2.13** shows the location of the IOS trunk sewer as well as the location and sizes of the sanitary sewer system in and around the Rockcliffe site.

The existing sewers within the site consist of mostly combined sewers carrying both wastewater and storm runoff. There are only two dedicated storm sewer systems within the site and two short sections of dedicated sanitary sewers which carry sanitary flows from two external areas to the site. These dedicated sewers are also illustrated on **Figure 2.13**.
