Appendix F: Cultural Heritage Impact Statement ***Demolition of the Chapel Wing*** ***of the Deschâtelets Building***

Greystone Village
375 Deschâtelets Avenue, Ottawa, Ontario.

Prepared by: COMMONWEALTH HISTORIC RESOURCE MANAGEMENT

Revised August, 2020

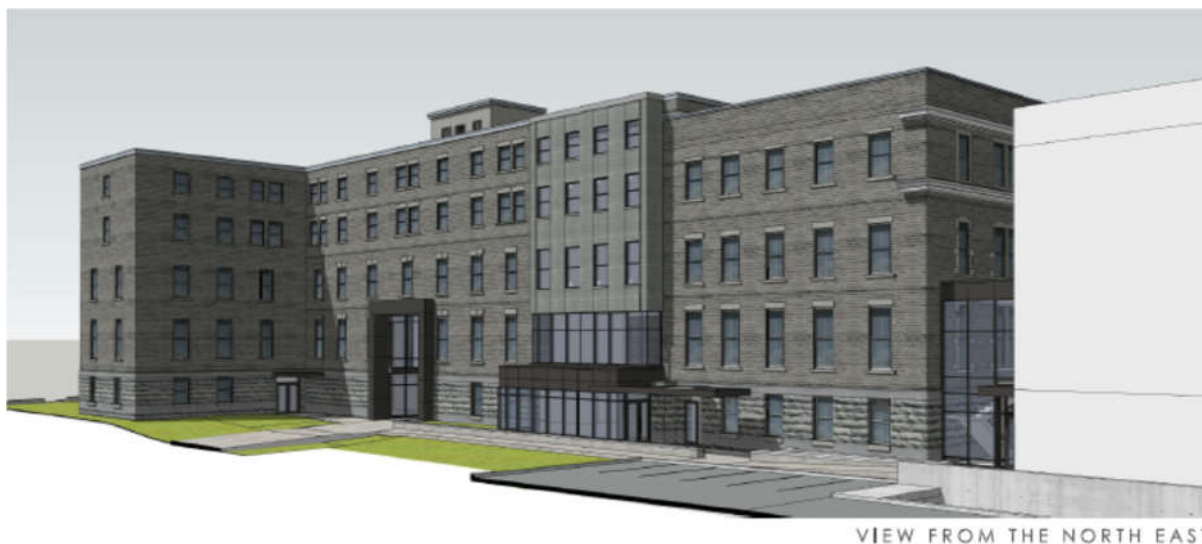
Cover: Artist's rendering of the east elevation showing the demolition of the Chapel wing and the veranda. It is proposed to construct a shallow five-storey bay envisioned as contemporary in design. The cladding, securing the exposed facade will be a combination of accent masonry curtain wall and prefinished metal shingle scaled to harmonize with the existing stone coursing. The two-storey aperture shown on the left is conceptual and not part of this construction phase. Hobin Architecture, 2020.

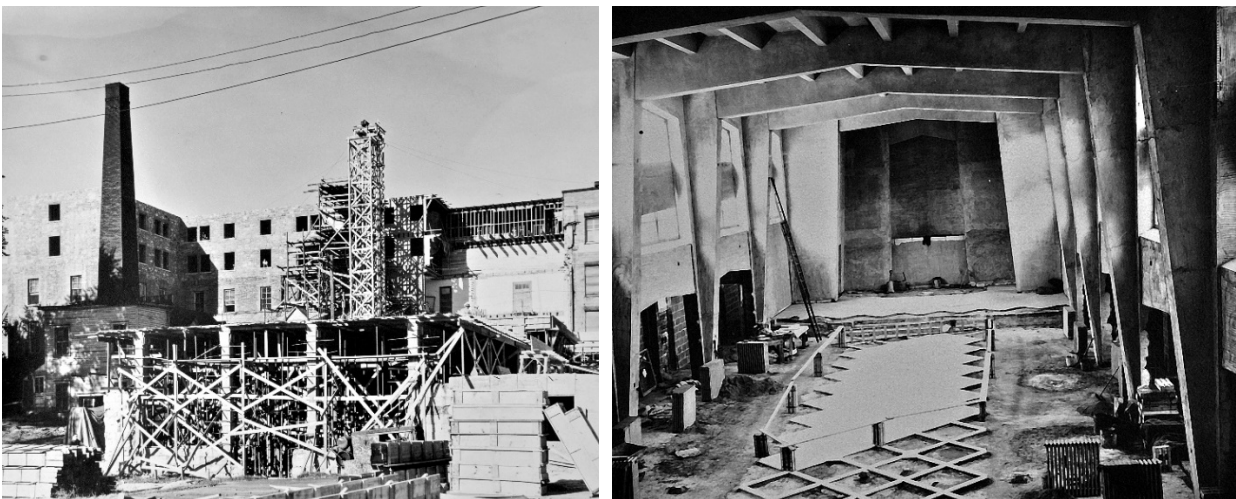
Views of the chapel under construction. Supposedly, the construction crew included priests using the novitiates and lay members of the order as the labour force.

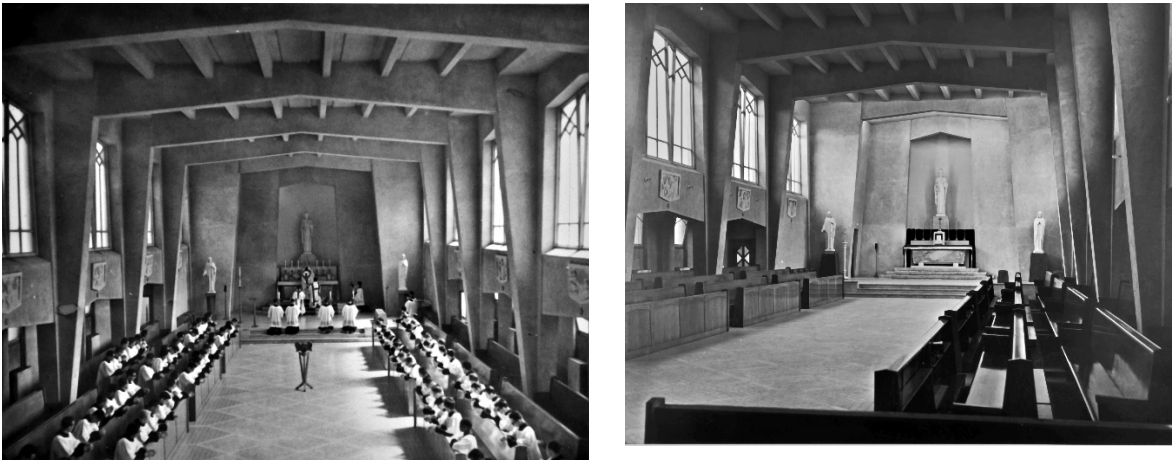
Two views of the designated interior. The modernist statuary, the stripped-down linear altar and the 'stations of the cross' below each window and the windows all contribute to the Chapel's character.

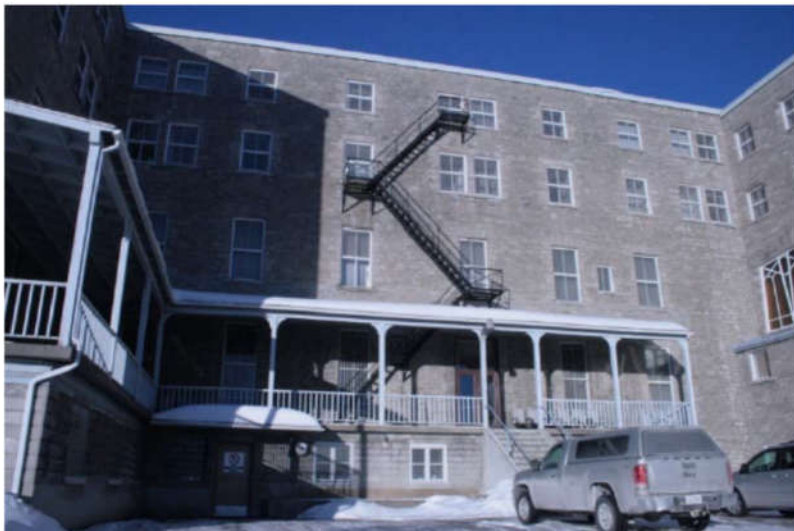
View of veranda along the east elevation with the raised foundation.

The wrap around shed roofed veranda on the east façade appears on Fire Insurance plans including the 1956 map. An aerial view from the late 1960s suggests that it was removed and then rebuilt sometime later. The photo is clear, but the south wing is in shadow and may be obscuring the roof. The present veranda is a simple structure, a masonry base with windows, and decorative columns supporting a shed or lean-to roof and a flight of stairs to the parking area.

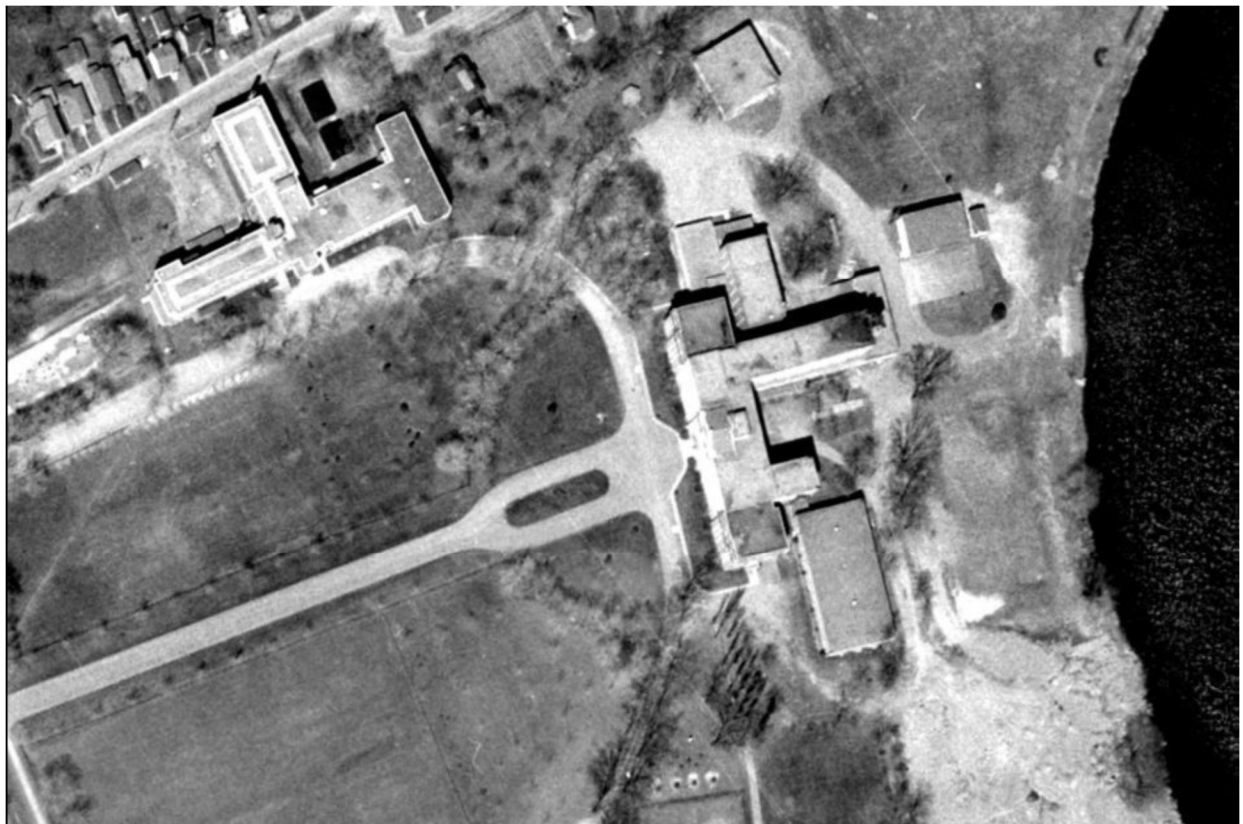
The aerial view of a portion of the Oblate Lands in the late 1960s suggests that the covered veranda has been removed, and the existing verandah is a later addition. The photo is clear, but the south wing is in shadow that may simply be obscuring the roof.
