**LANSDOWNE PARK
OTTAWA CIVIC CENTRE & NORTH STANDS**

**FEASIBILITY STUDY
OF
POSSIBLE REDEVELOPMENT**

**STRUCTURAL DESIGN ANALYSIS
MAIN BOX GIRDER FRAMES**

**LANSDOWNE PARK
OTTAWA CIVIC CENTRE & NORTH SIDE STANDS**

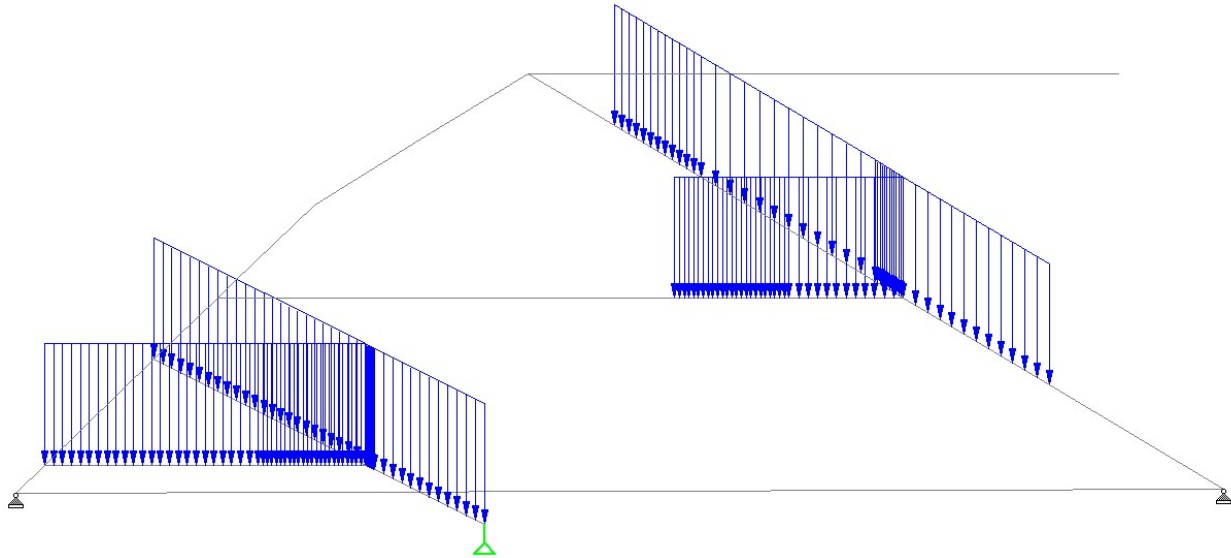
Live Loads:

L 4 : LIVE
UNI GY -6067 lb/ft
