A HERITAGE IMPACT ASSESSMENT

514 MANOR AVENUE, ROCKCLIFFE PARK
OTTAWA

Prepared For: Dwell Capital Group
By: John Stewart Commonwealth Historic Resource Management

Final Report V6 May 2023

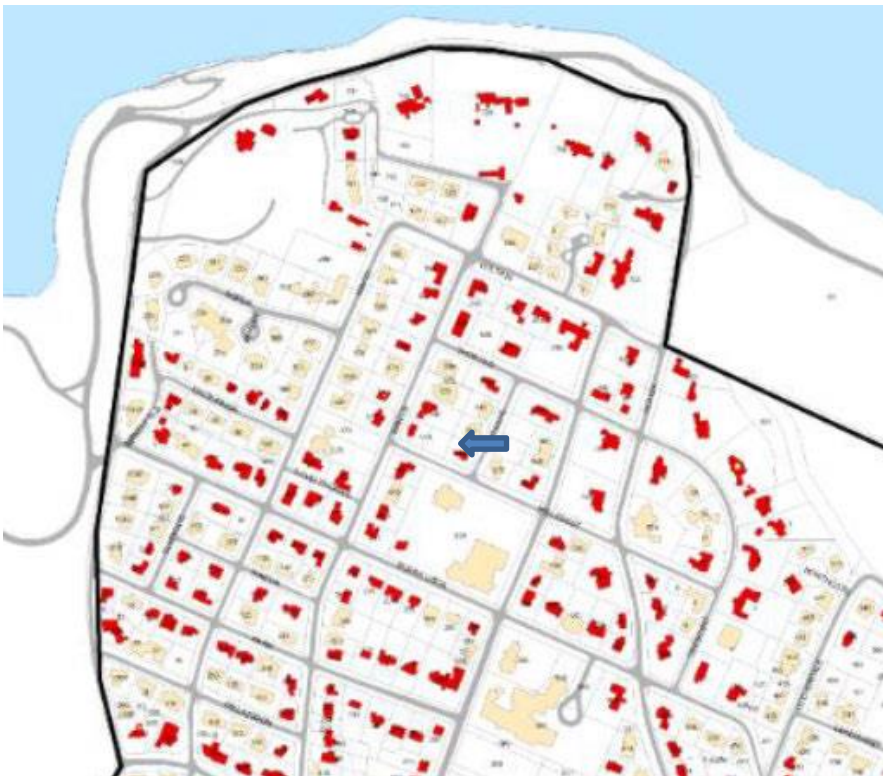
Figure 17: Partial plan of the Rockcliffe HCD, development site arrowed. The site at 514 Manor Avenue and adjacent properties at 540, 541, 519, and 480 Manor Avenue are all Grade 1 heritage properties within the context of the HCD Plan. Site arrowed. Source: City of Ottawa 2010.

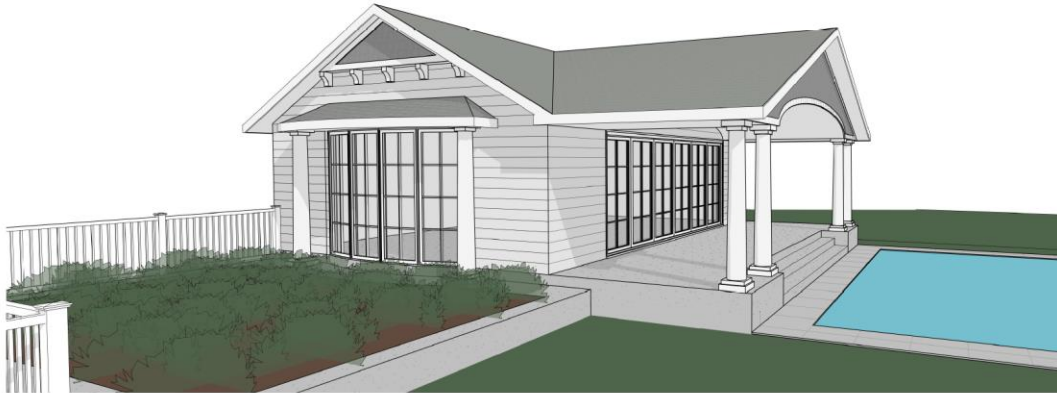
Figure 25: Pool house and garage addition revised design Development Package November 29, 2021

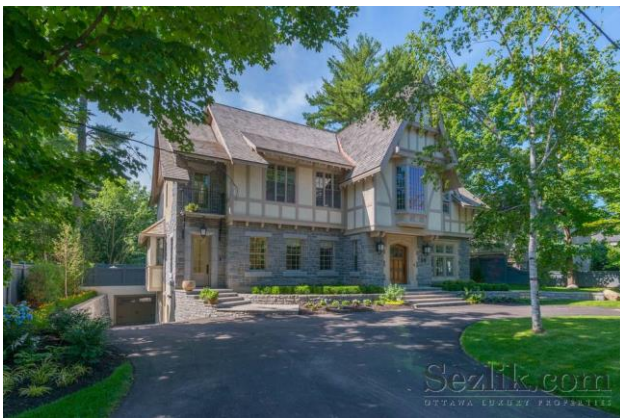
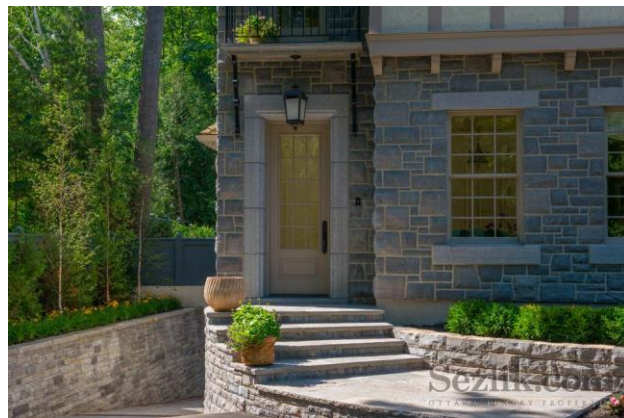
Figure 30 and 31: Two views of house on Park St. in Rockcliffe 2022 illustrating the treatment proposed for the reverse grade driveway at 415 Manor with a coursed limestone facing on the retaining walls. Source Greg Statler.

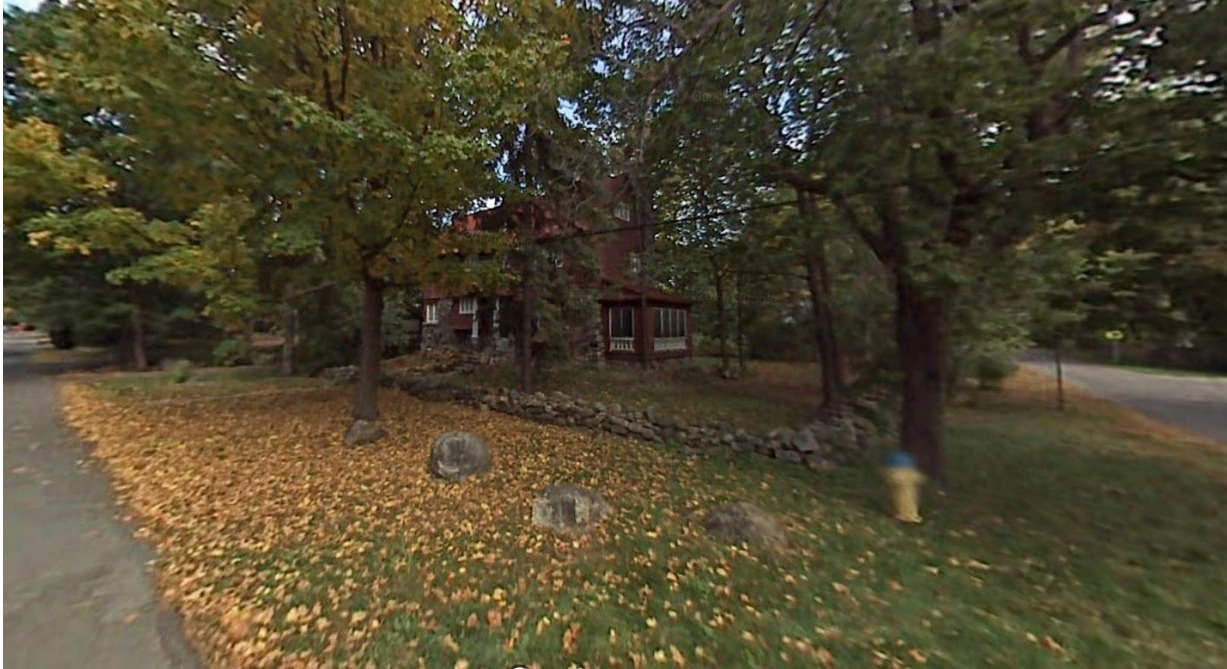
Figure 32: The 2009 Google view of the property illustrates the relationship of the house to its environment. The loose stone wall interspersed with trees along Manor Avenue has been replaced with a stone retaining wall and the grade leading up to the front entrance formalized with a stone stairway at the retaining wall.

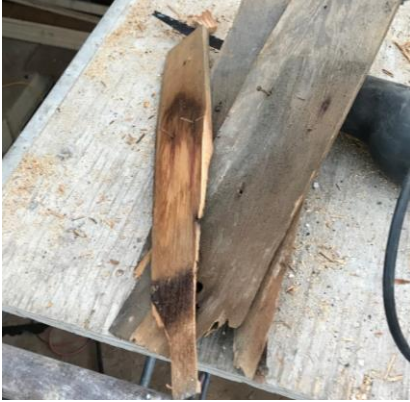
Figure 1-A: Record of roofing material. Source: Greg Statler documentation during construction.

According to the 1949 Insurance Plan the roof was clad in a red asphalt shingle. As-found evidence indicates that the asphalt was installed over a shingled roof. The applicant re-introduced cedar shakes to reroof the existing building. The wood shingle roofing was based on the as-found evidence (Figure 1-A). Wood shingle is a compatible choice used throughout Rockcliffe. The same shingle treatment is planned for the proposed addition.
