Report / Agenda: ACS2023-PRE-RHU-0016 / Built Heritage Committee Agenda 5

Item / Article: 5.1 Application to alter 514 Manor Avenue, a property designated under Part V of the Ontario Heritage Act, located in the Rockcliffe Park Heritage Conservation District

A HERITAGE IMPACT  
ASSESSMENT  
514 MANOR AVENUE, ROCKCLIFFE PARK  
OTTAWA

**Final Report V6 May 2023**

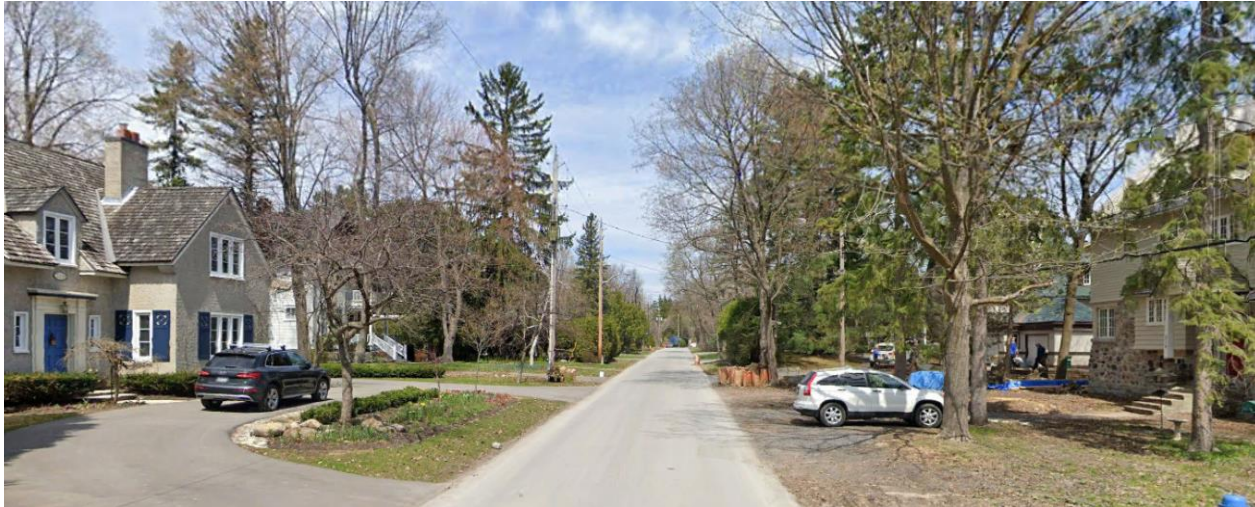
*Figure 3: Street view looking north on Manor Avenue from Hillcrest Avenue. The development site is to the right. Note the informal street edge and the semi-circular driveway on the facing property (left). Source: Google Earth May 2019.*

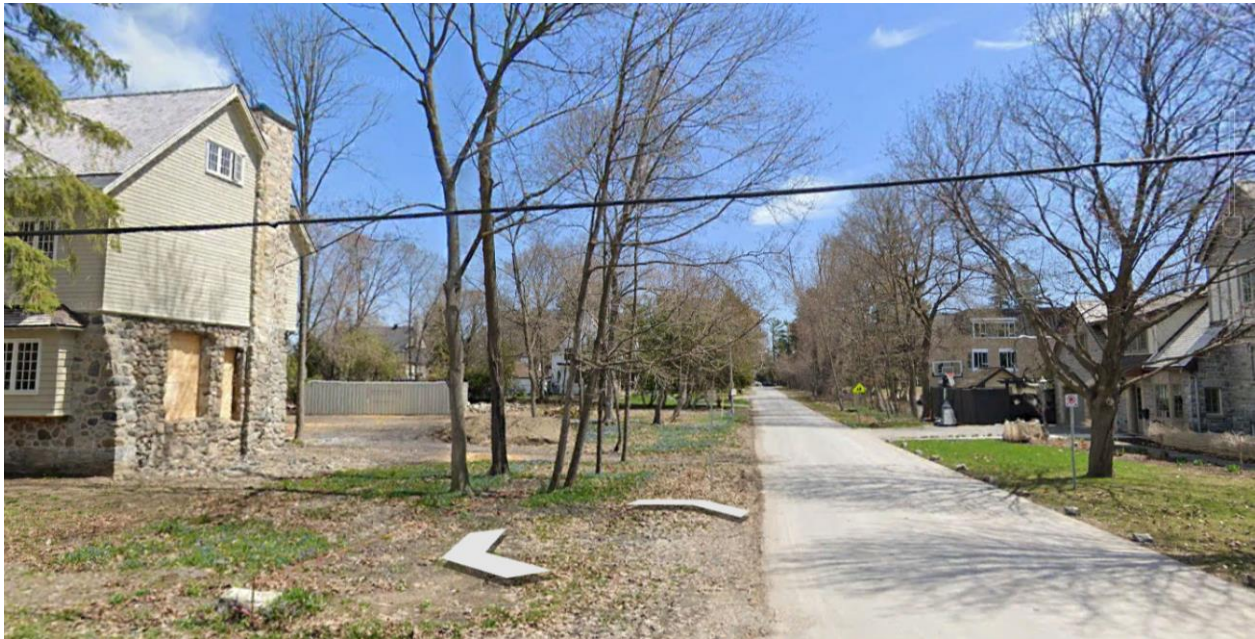
*Figure 4: Street view looking east on Hillcrest Avenue with 514 Manor Avenue to the left. The image was taken in May 2019 when the existing residence was being rehabilitated. Note the informal grassed verge and informal planting of street trees. Note the masonry veneer chimney that was rebuilt in 2017. Source: Google Earth May 2019*

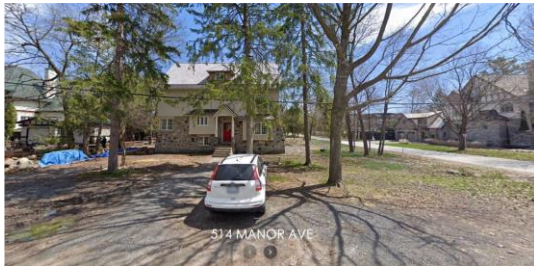
Figure 7 & 8: Street view of 514 Manor Avenue. A low stone retaining wall extended along the property line prior to the installation of new services in 2018. Remnants of the stone wall are piled along the interior side yard (left Google Earth May 2019)

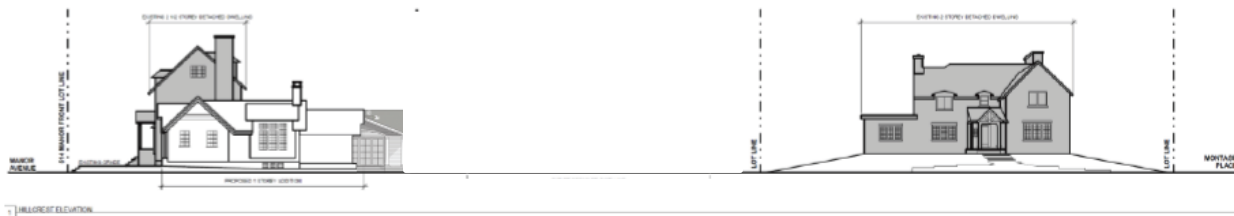
Figure 15: Along Hillcrest Road there are two residences on the north side of the road 514 Manor Avenue and 241 Hillcrest Road on the Montagu Place corner. Across the street the side yard and garage at 480 Manor Avenue faces the subject property. Elmwood School takes up the rest of the frontage along Hillcrest.

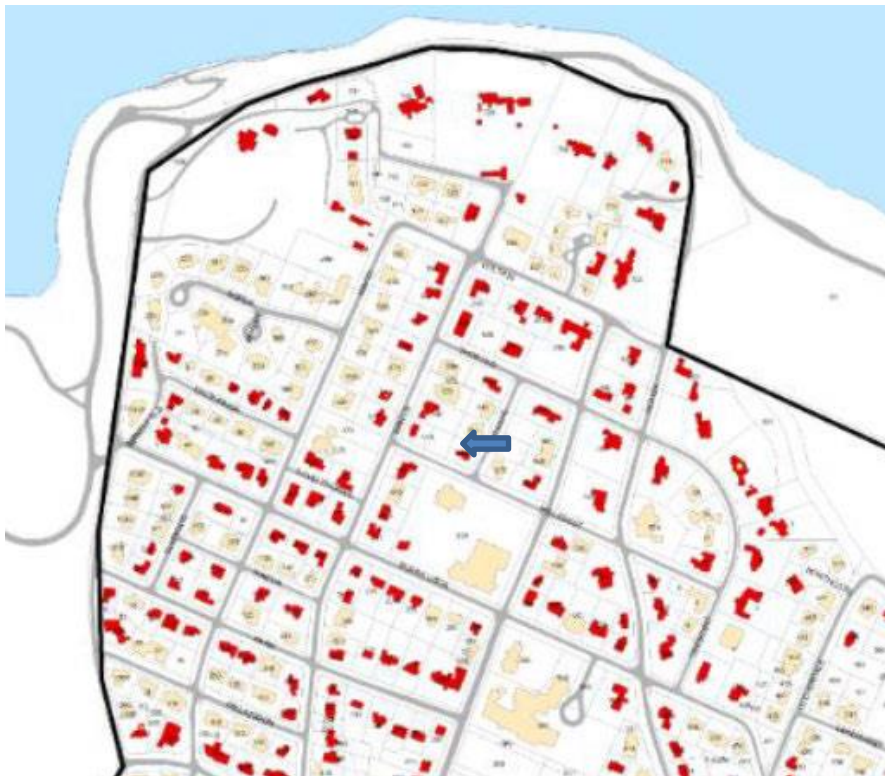
*Figure 17: Partial plan of the Rockcliffe HCD, development site arrowed. The site at 514 Manor Avenue and adjacent properties at 540, 541, 519, and 480 Manor Avenue are all Grade 1 heritage properties within the context of the HCD Plan. Site arrowed. Source: City of Ottawa 2010.*

The installation of services by the City of Ottawa along Manor Avenue resulted in the dismantling and stockpiling of the large boulder wall that delineated the Manor and Hillcrest streets boundaries. A drystone retaining wall has replaced the boulder wall along Manor Avenue.

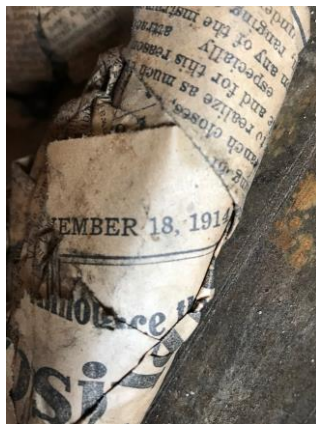
*Note: There is evidence that the date of construction is around 1912-14 and supports the specific Arts and Crafts character of this building. The newspaper dated November 18, 1914 was found in the wall cavity. Source Greg Statler construction Record. An early 1928 aerial view of Rockcliffe Park also supports the earlier date of the building.*

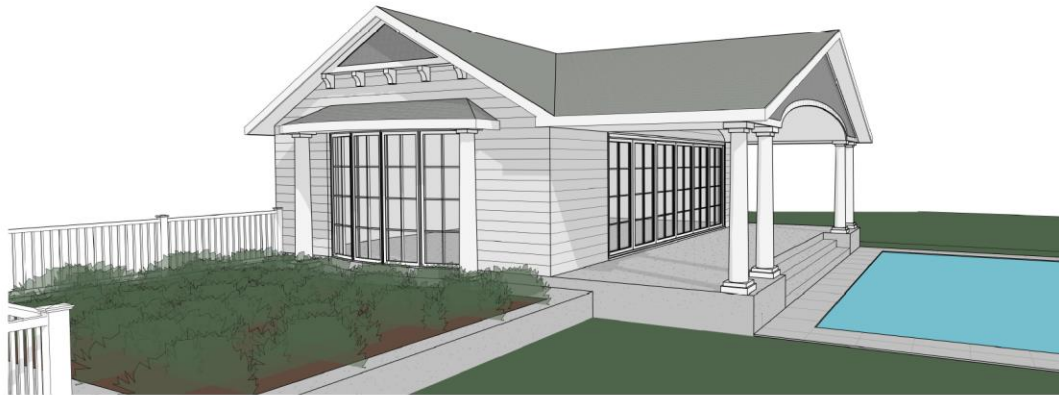
Figure 26: Site plan with zoning specifications illustrating the new addition, below grade garage, pool, and pool house within the unsevered lot. Source: revised site plan Design Valley 2022

The revised plan (Figure 26) respects the retention of the driveway off of Manor Avenue with a new reverse-slope driveway along the property line, leading towards the rear of the property to access the new two-car below-grade garage. The grade on the property drops as it moves towards the rear of the house, lending itself to a natural progression for a reverse-slope driveway. A green roof of the underground garage will support the effort to provide soft landscape.

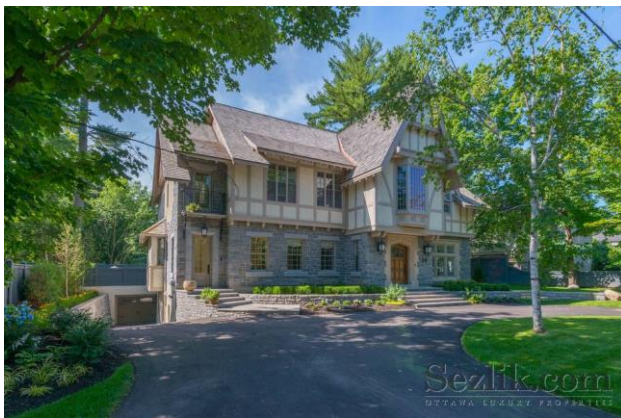
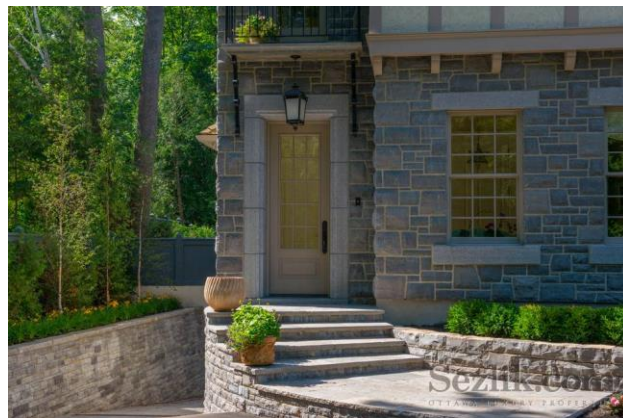
Figure 30 and 31: Two views of house on Park St. in Rockcliffe 2022 illustrating the treatment proposed for the reverse grade driveway at 415 Manor with a coursed limestone facing on the retaining walls. Source Greg Statler.

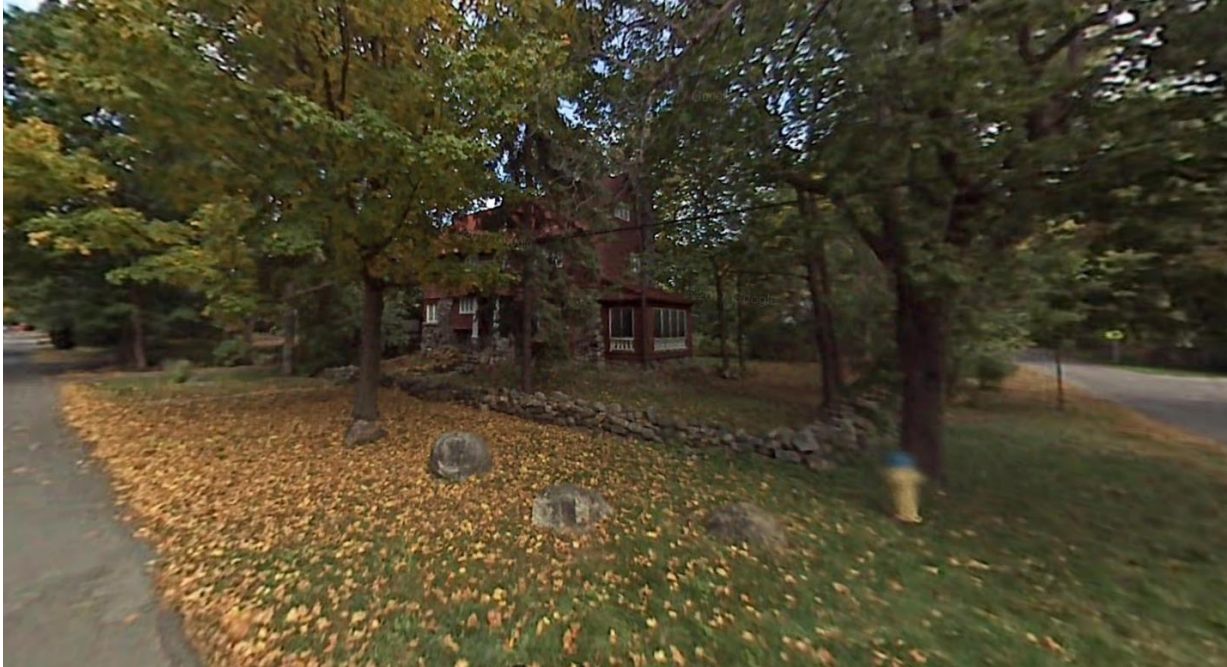
*Figure 32: The 2009 Google view of the property illustrates the relationship of the house to its environment. The loose stone wall interspersed with trees along Manor Avenue has been replaced with a stone retaining wall and the grade leading up to the front entrance formalized with a stone stairway at the retaining wall.*

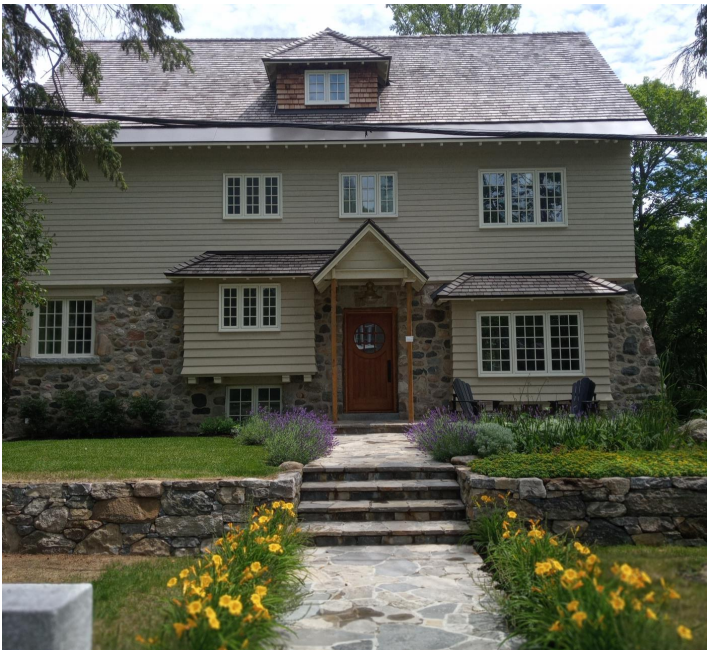
*Figure 33: View of the front entrance walk with the new dry stone retaining wall and raised terrace. The wall is a beautifully executed example of masonry work. Source: Commonwealth 2021.*

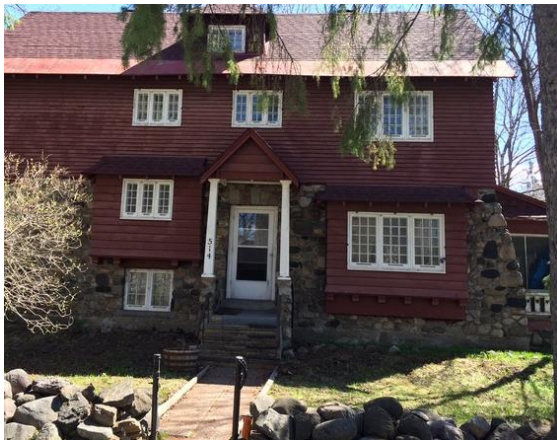
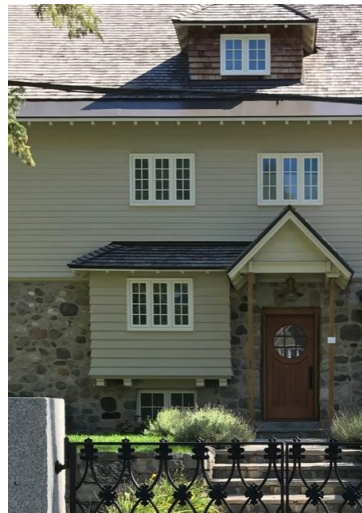
Figure 1-A: Comparison of the building before and after. Source G. Statler construction photos

Windows on the house had deteriorated, lacked basic thermal efficiency, and required replacement. These were replaced with metal-clad wood windows units of the same size, shape, and divisions. The windows on the new addition will follow the same pattern. They will have the same division as on the existing house.

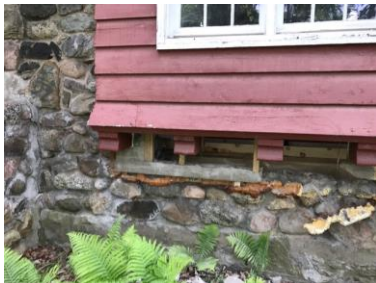
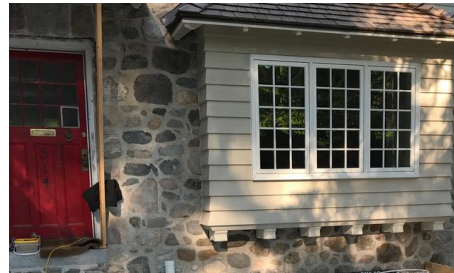
Figure 2-A: Before and After Details of the deterioration of the siding and trim around windows  
Source: G. Statler

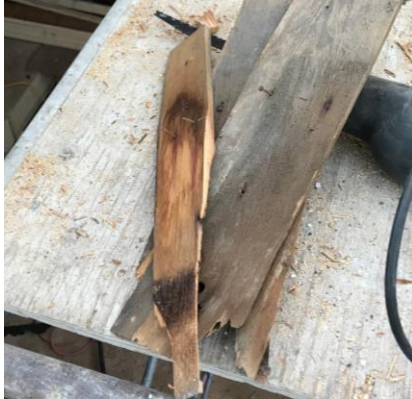
*Figure 1-A: Record of roofing material. Source: Greg Statler documentation during construction.*

According to the 1949 Insurance Plan the roof was clad in a red asphalt shingle. As-found evidence indicates that the asphalt was installed over a shingled roof. The applicant re-introduced cedar shakes to reroof the existing building. The wood shingle roofing was based on the as-found evidence (Figure 1-A). Wood shingle is a compatible choice used throughout Rockcliffe. The same shingle treatment is planned for the proposed addition.

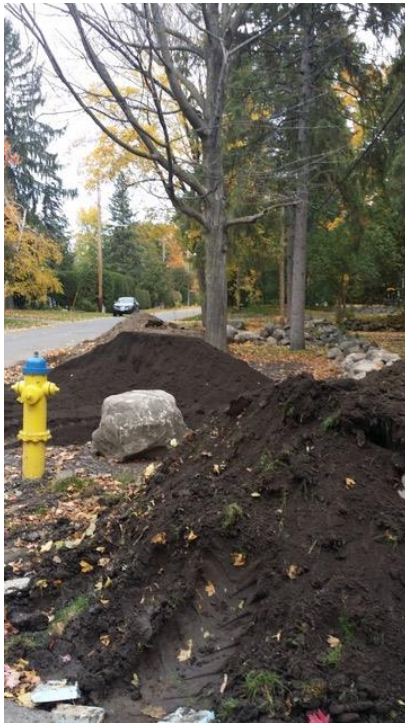
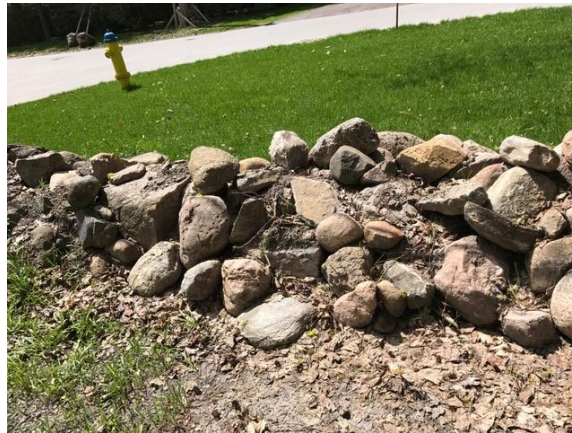
*Figure 3-A: City of Ottawa while using the front yard to store landscaping materials during sewer constructions removed sections of the loose stone wall. Note buried wall and soil piled up on tree roots.*

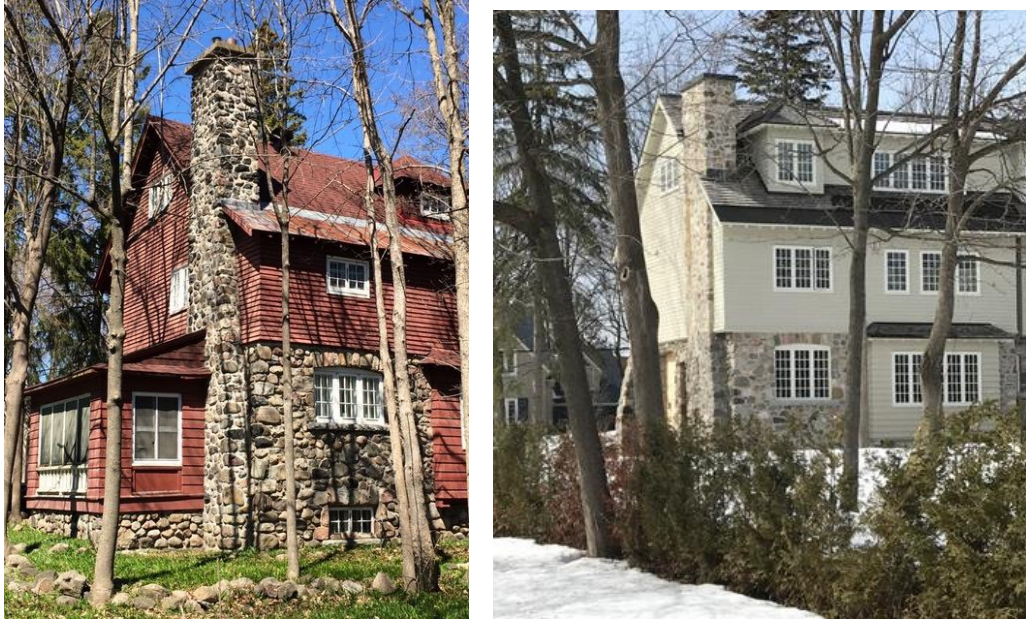
*Figure 4-A: Comparison of the building before and after. G. Statler Construction Record.*

As part of the overall first phase rehabilitation of the building, the applicant replaced the concrete slab walkway leading up to the Manor Avenue front door with flagstone pavers. The large boulder loose stone wall was a feature of the house and has replaced with a drystone retaining wall. In consultation with the City of Ottawa's arborist a plan was developed for the removal of the existing diseased trees and their replacement.
