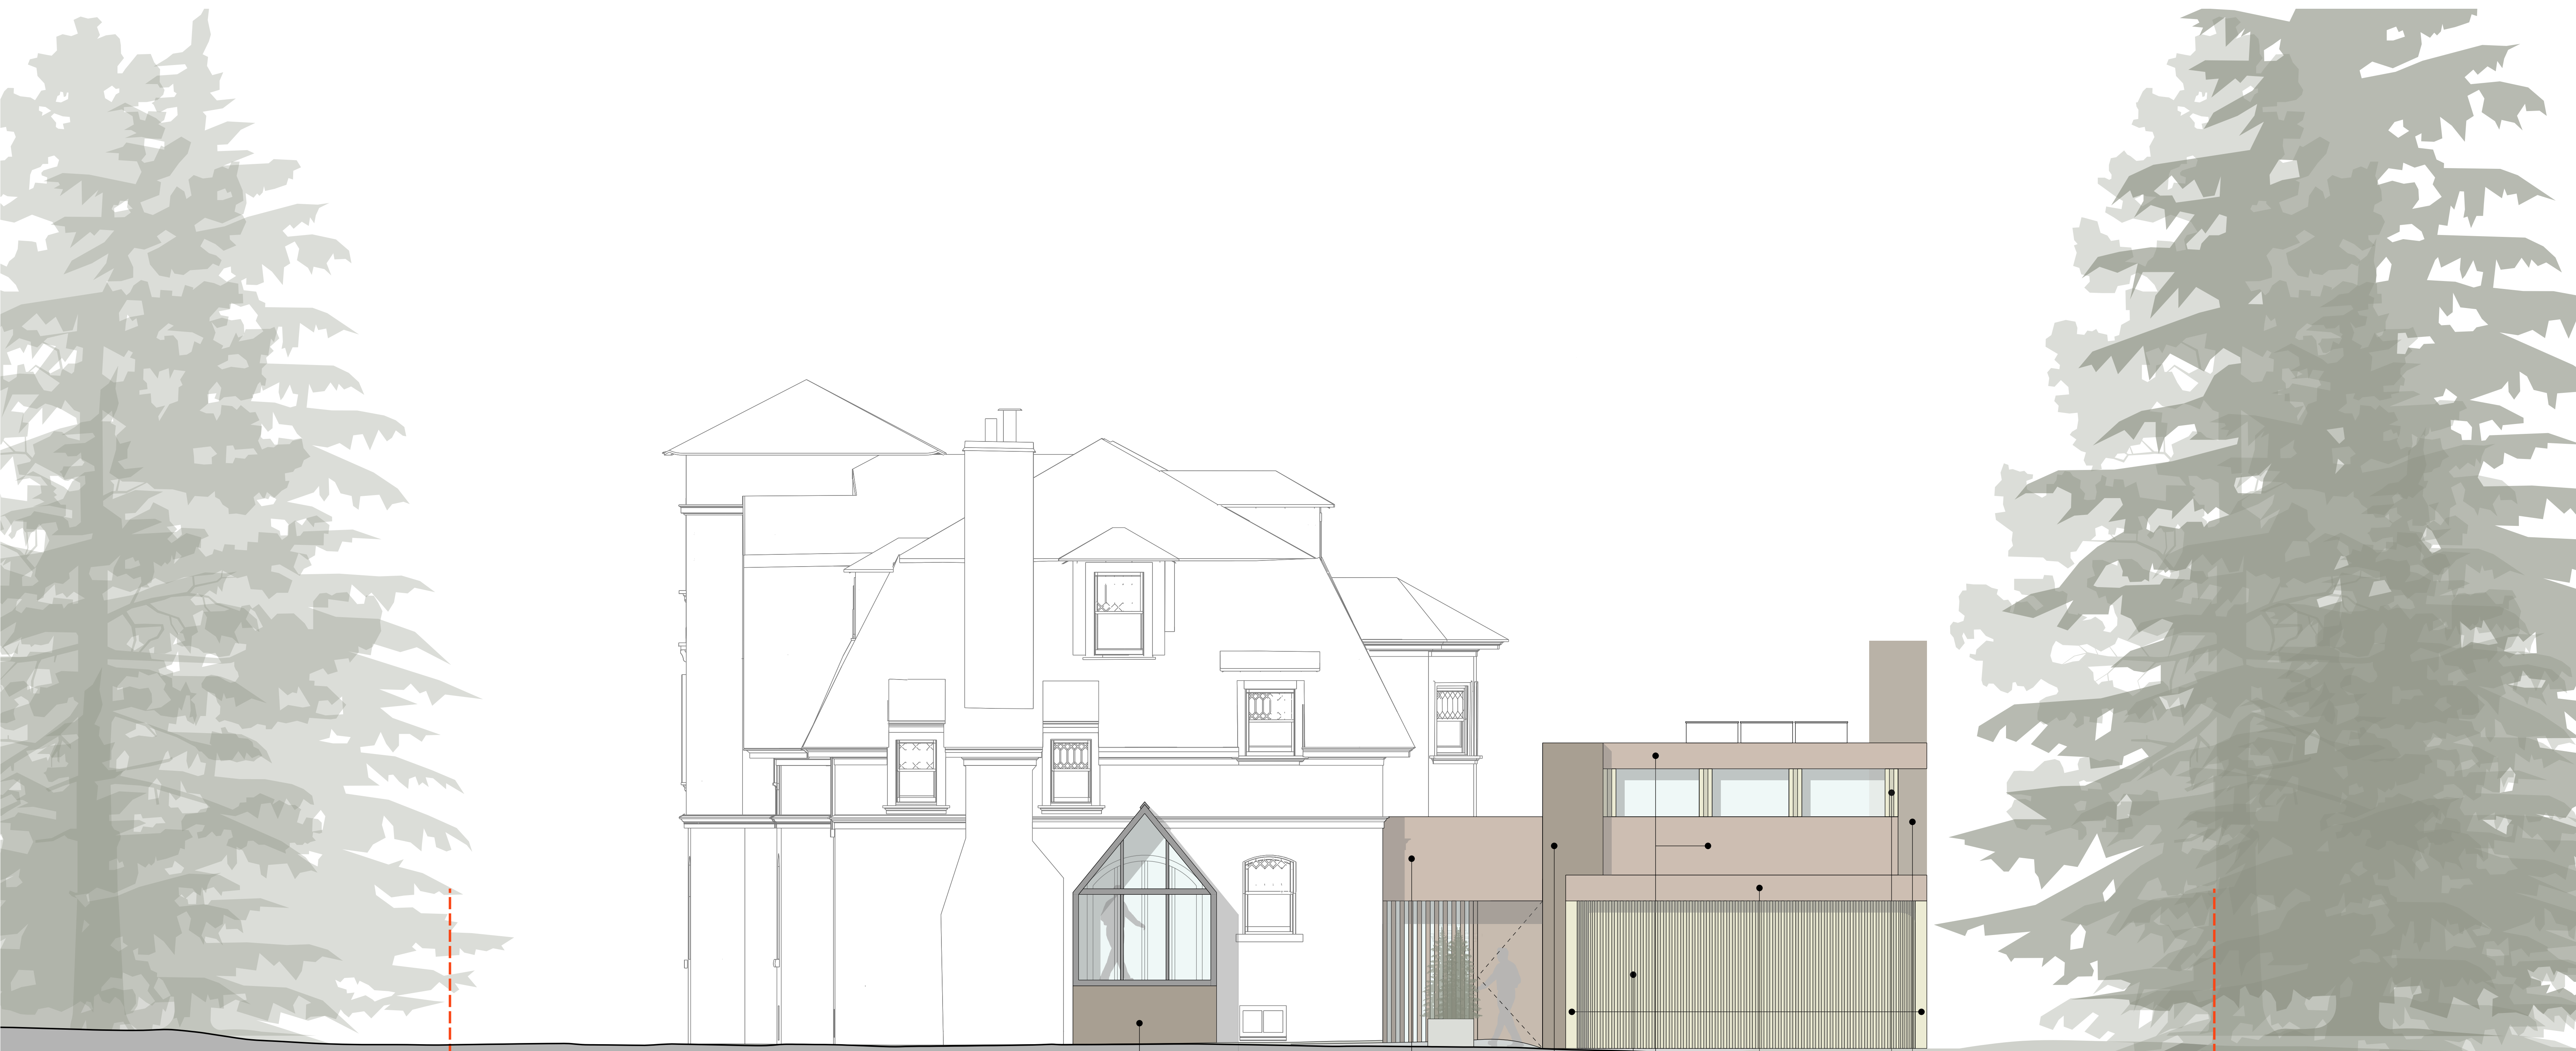
Natural Copper

Untreated Cedar Wood
Garage Door + Slats

Untreated Cedar Wood
Columns

Fieldstone Wall
(to match existing building)

Fieldstone Wall
Fireplace
(to match existing building)

- NOTE**
1. All timber trims to be repainted.
 2. All render walls to be repaired and repainted.
 3. All fieldstone walls to be repaired.
 4. All windows to be repaired and repainted as required.
 5. Roof structure to be repaired and asphalt shingles to be replaced with copper shingles.

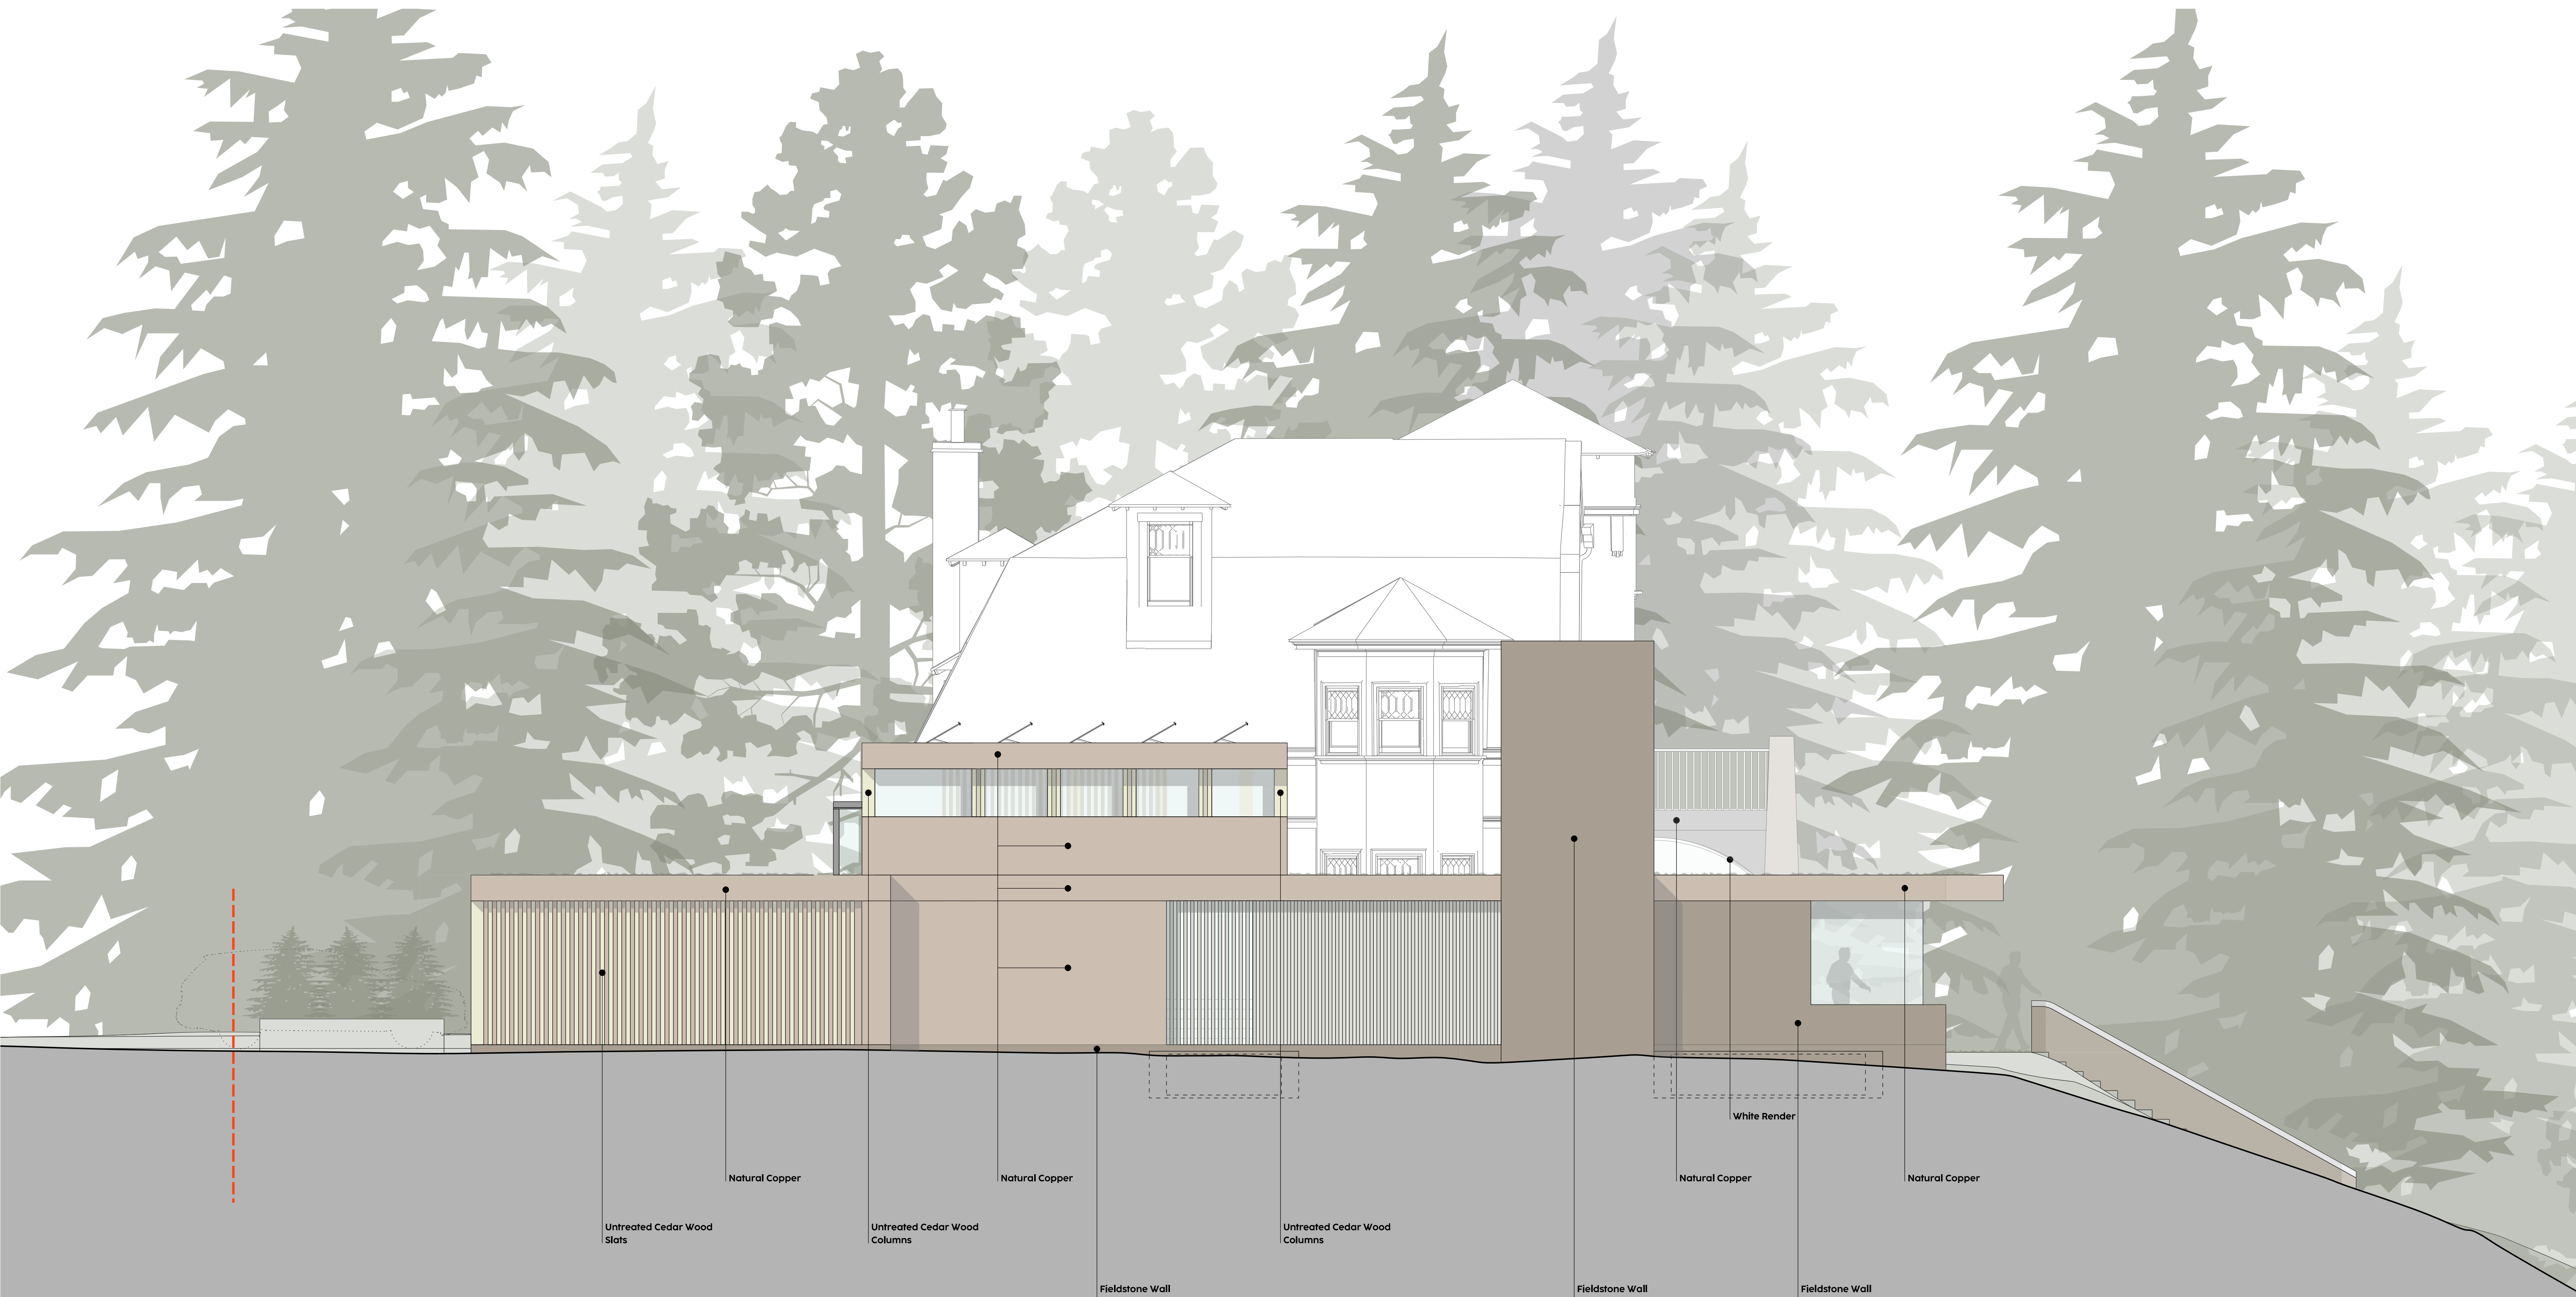
Natural Copper

Untreated Cedar Wood Slats

Untreated Cedar Wood Columns

Fieldstone Wall (to match existing building)

White Render

1. All timber trims to be repainted.
2. All render walls to be repaired and repainted.
3. All fieldstone walls to be repaired.
4. All windows to be repaired and repainted as required.
5. Roof structure to be repaired and asphalt shingles to be replaced with copper shingles.
6. North porch to be replaced with new porch based on original porch design with fieldstone columns and arched openings.

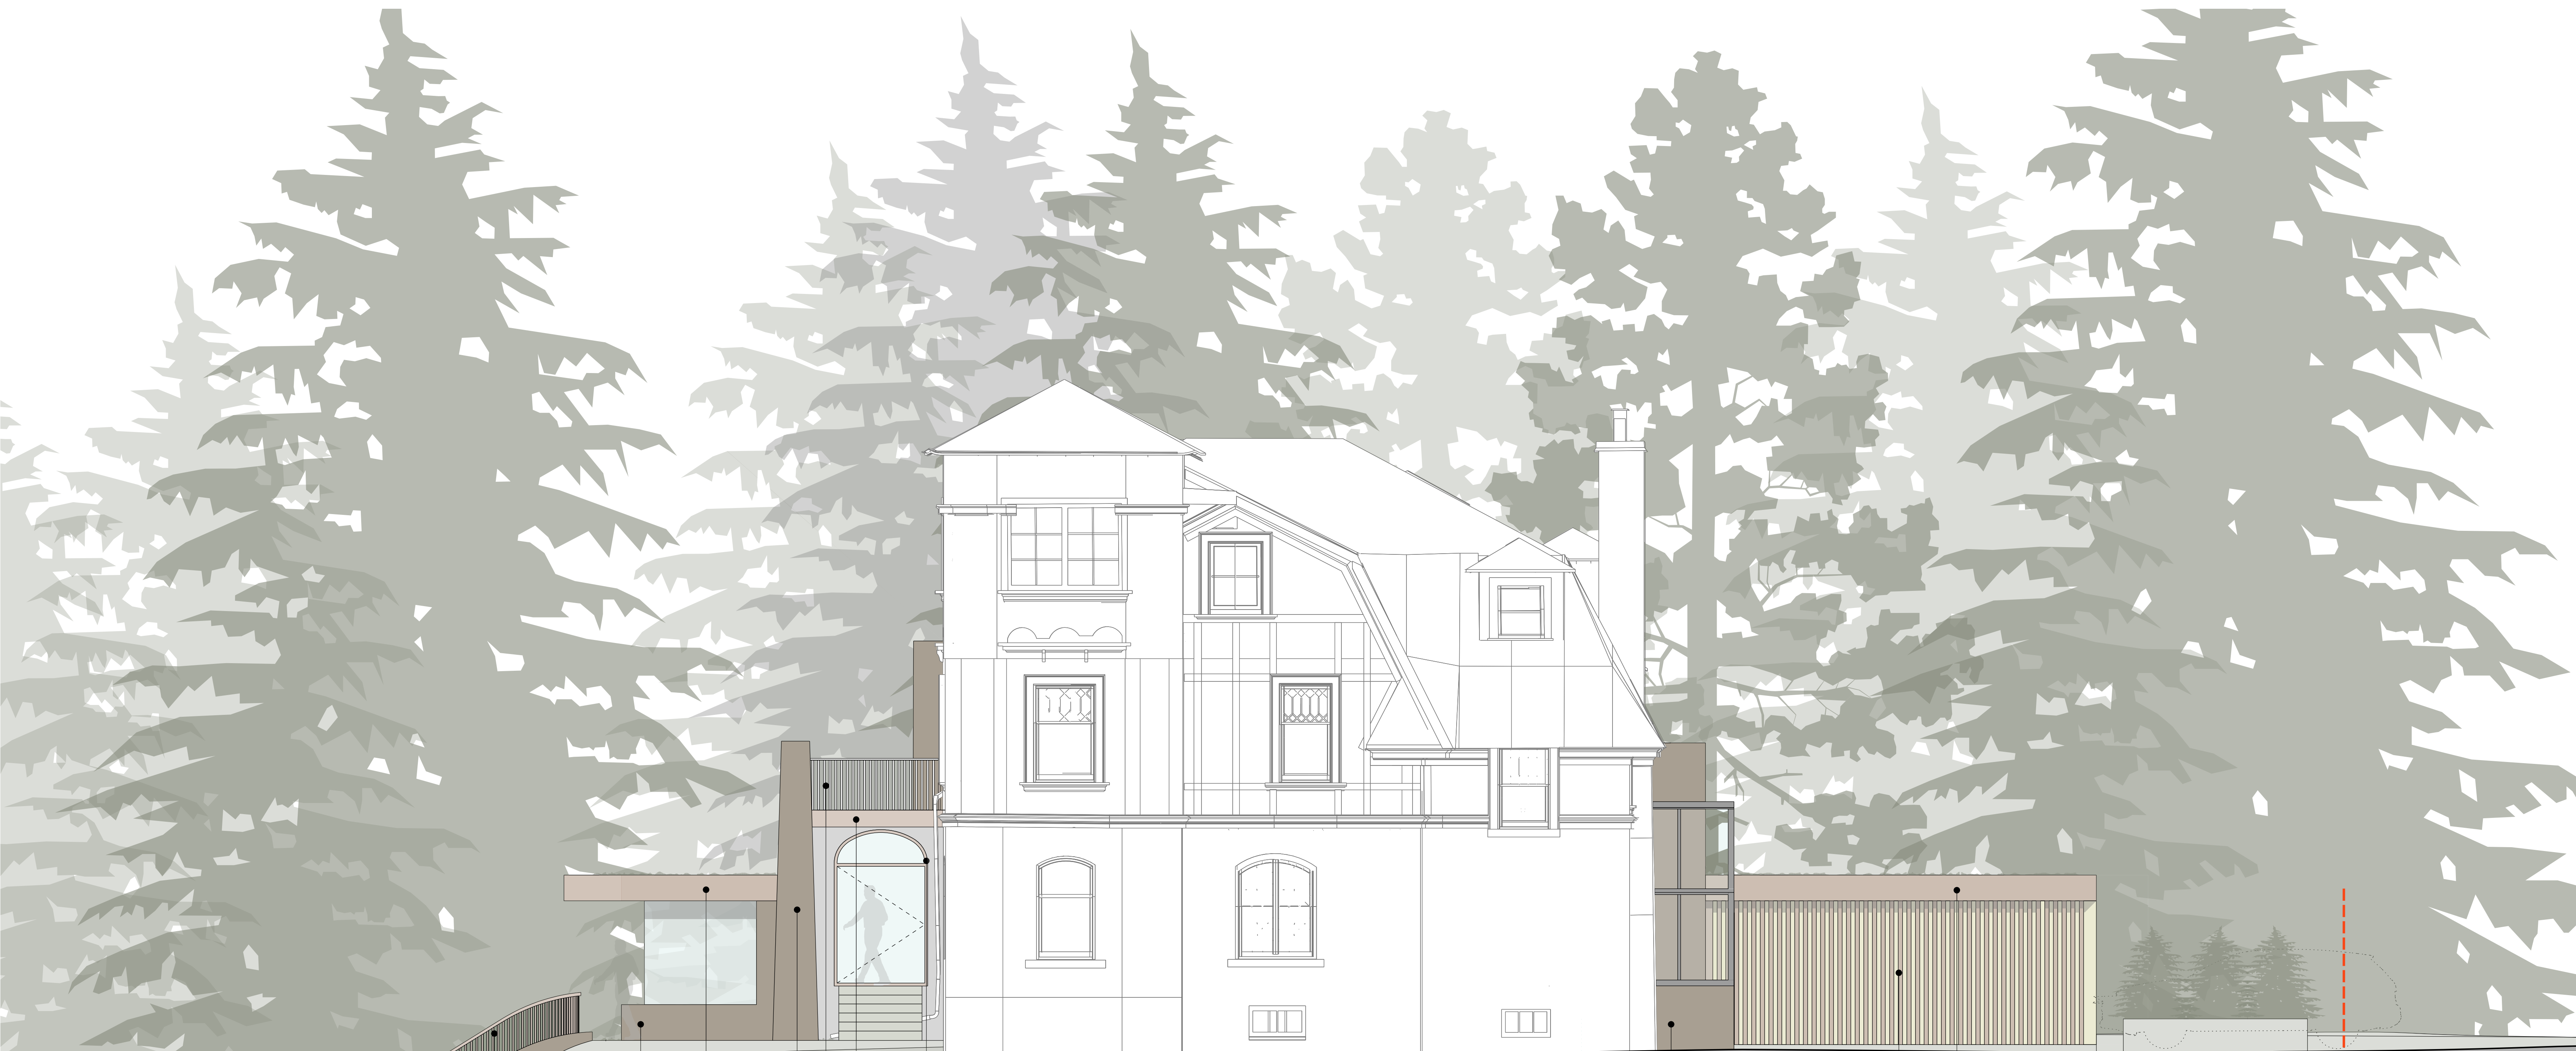
White Render

Natural Copper

Natural Copper Ballustrade

Fieldstone Wall (to match existing building)

Fieldstone Column (to match existing building)

Metallic Ballustrade

Untreated Cedar Wood Slats

1. All timber trims to be repainted.
2. All render walls to be repaired and repainted.
3. All fieldstone walls to be repaired.
4. All windows to be repaired and repainted as required.
5. Roof structure to be repaired and asphalt shingles to be replaced with copper shingles.
6. North porch to be replaced with new porch based on original porch design with fieldstone columns and arched openings.

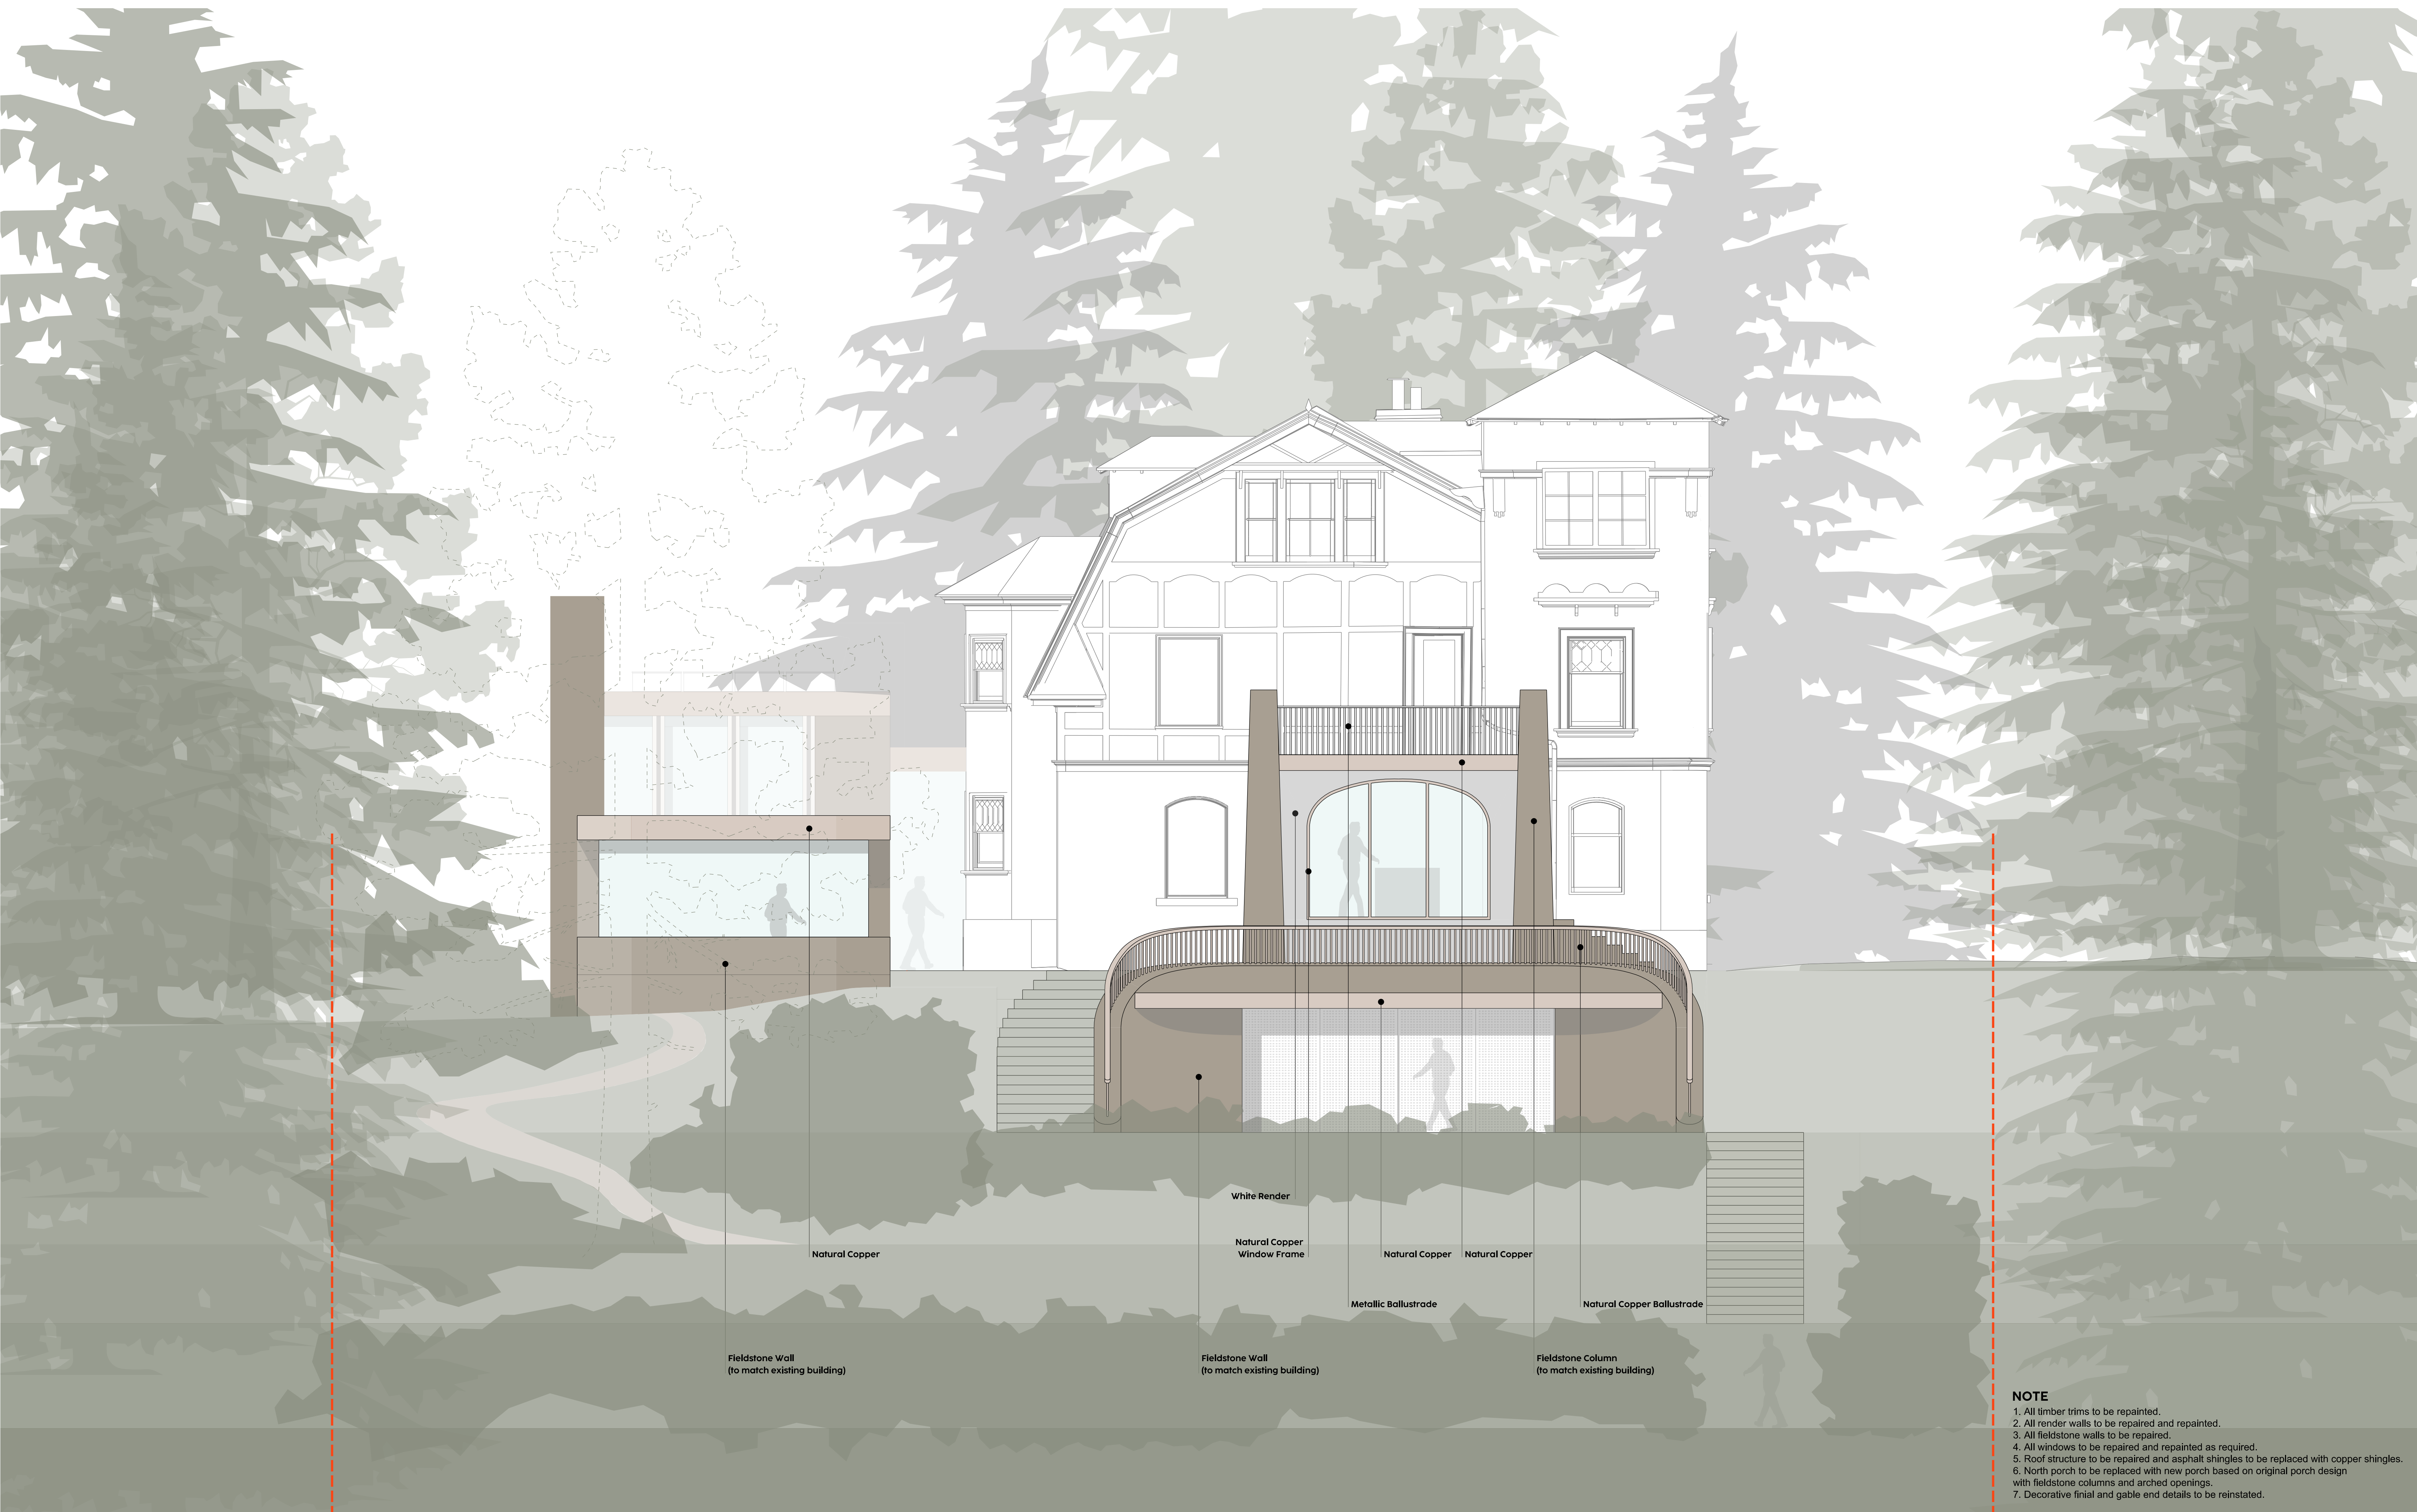
1. All timber trims to be repainted.
2. All render walls to be repaired and repainted.
3. All fieldstone walls to be repaired.
4. All windows to be repaired and repainted as required.
5. Roof structure to be repaired and asphalt shingles to be replaced with copper shingles.
6. North porch to be replaced with new porch based on original porch design with fieldstone columns and arched openings.
7. Decorative finial and gable end details to be reinstated.
