Tree Information Report

Submitted as part of Building Permit Application for the City of Ottawa

Address: 1680 Stittsville Main

Date: May 18, 2021

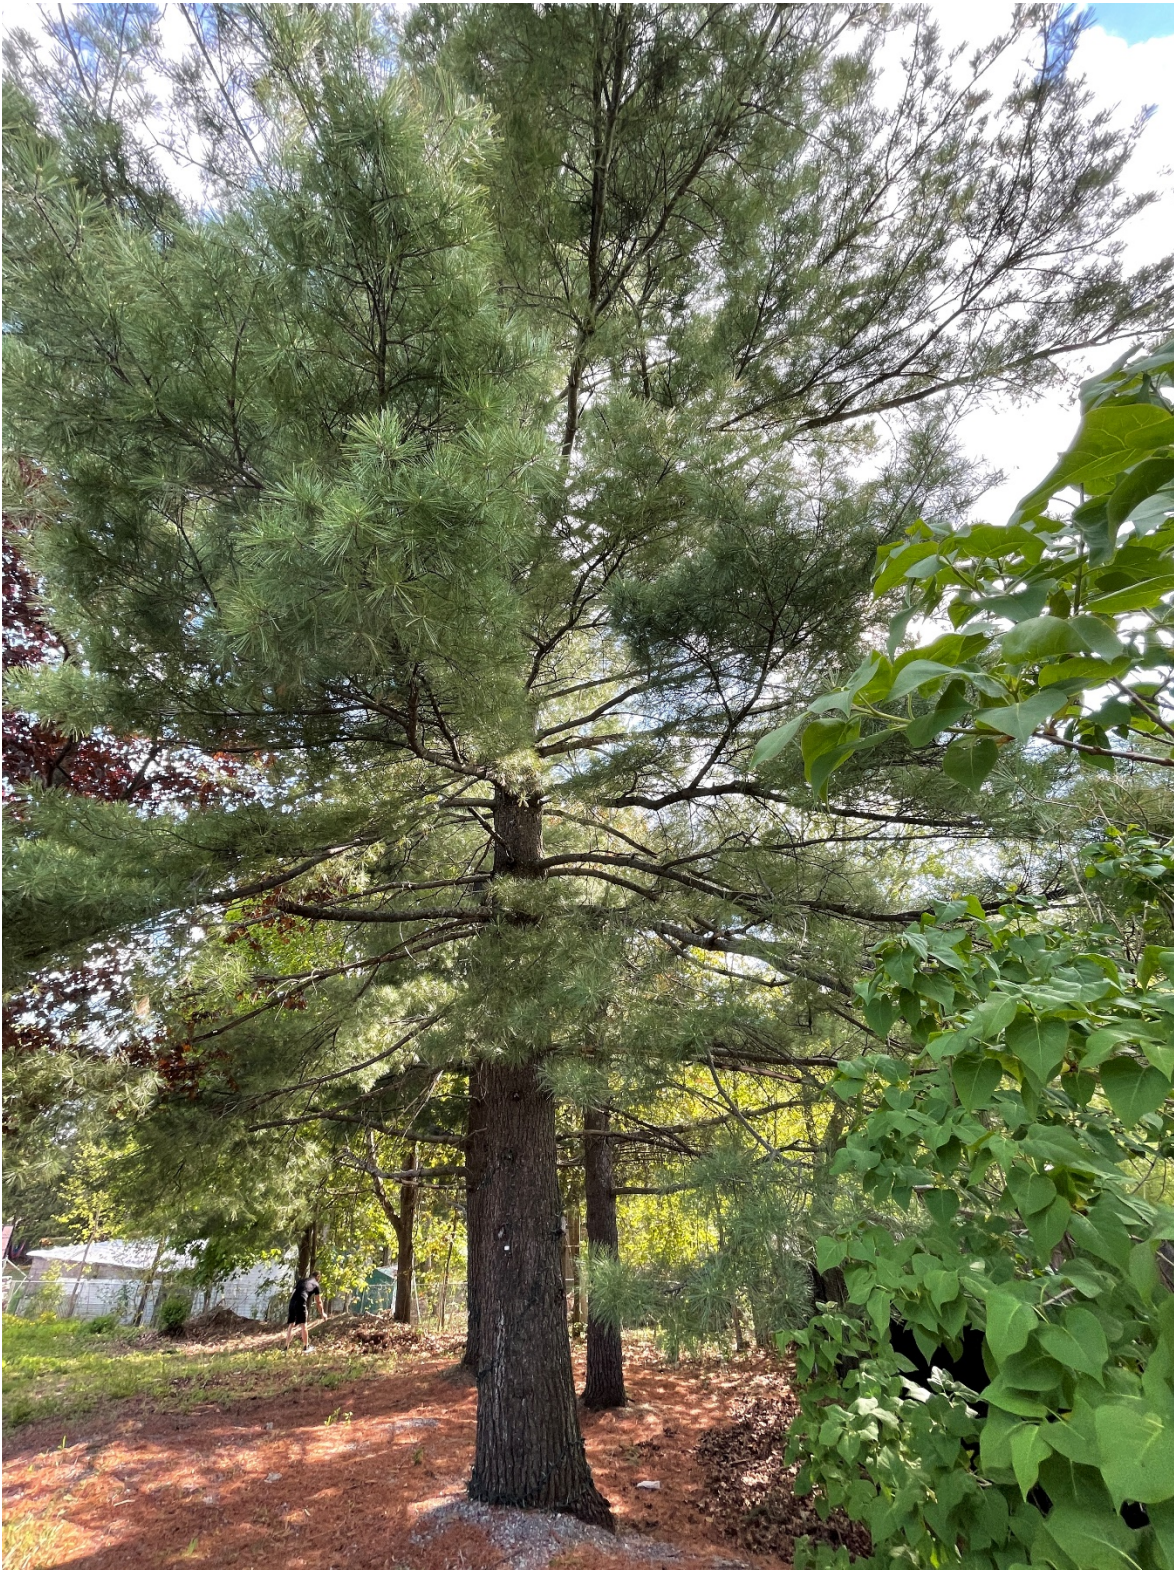
Figure 1: Tree 1, white pine to be retained

Tree ¹	Species	Diameter at breast height (cm)	Ownership ²	Condition	Action	Recommendations
1	White pine (<i>Pinus strobus</i>)	64 cm	Private	Good; 2 co-dominant stems split in canopy	Retain and protect	Protect with fencing as per specifications in report; arborist to pre-sever roots in advance; excavation approximately 3.8 m from tree
2	White pine (<i>Pinus strobus</i>)	60 cm	Private	Good	Retain and protect	Protect with fencing as per specifications in report

There are many trees on this property, but only the two large white pines are protected under the city tree by-law. The houses have been shifted forward to reduce the impact to these trees. The critical root zone of tree 1 will be impacted by the proposed construction, and the roots will be pre-severed by an arborist ahead of excavation to avoid tearing. The tree protection fencing is to be installed around the trees as per the Tree Information Map during all site works as per the specifications below.

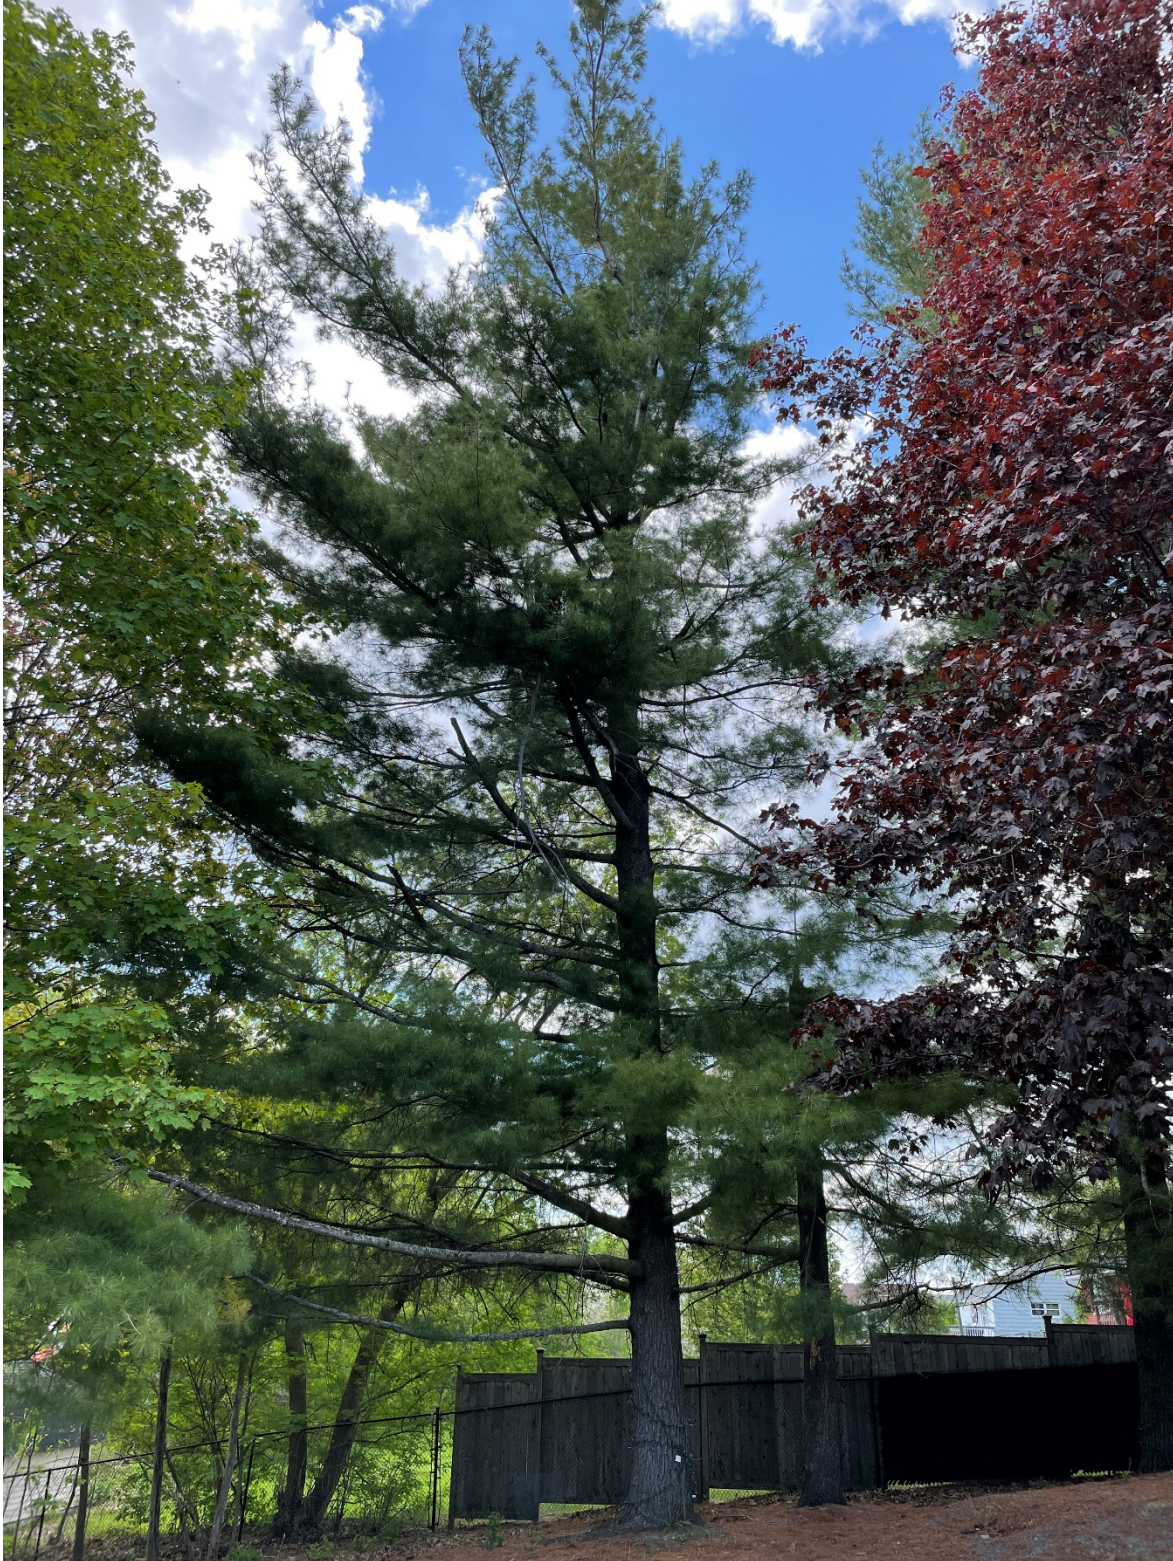
Figure 2: Tree 2, white pine to be retained
