Subject: Application for alteration and for new construction at 219-223 Bank Street, and 178 Nepean Street, properties designated under Part V of the Ontario Heritage Act as part of the Centretown Heritage Conservation District

File Number: ACS2024-PDB-RHU-0081

Report to Planning and Housing Committee on 4 December 2024

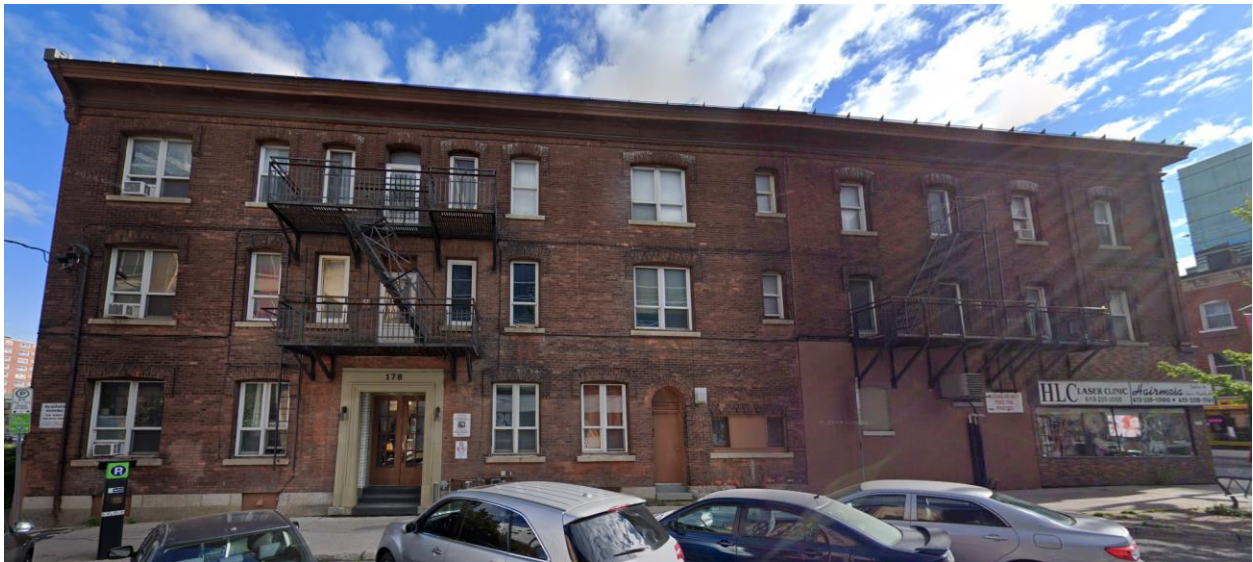
North façade of 178 Nepean Street

The northernmost block of buildings includes two distinct forms, one simple two storey flat roofed building, and the three-storey mixed use building at the corner. Both are clad in red brick, have large metal cornices, and have ground floors that have more recently been clad in a variegated brick. The corner property wraps around to Nepean Street and features a decorative stringcourse above the second floor, as well as brick hood moulding above the second and third floor windows, and fluted pilasters dividing certain bays. The conservation measures for these two buildings includes the removal of the unsympathetic brick along the ground floor, and the installation of salvaged brick or new appropriate brick to match the remainder of the buildings. Any cracking and damage to the bricks will be repaired. Appropriate storefronts will be reintroduced which maintain the existing recessed entrances, and introduces appropriate windows, knee walls and sign bands. Any metal fixtures will be removed, including balconies, and fire escapes. Masonry cleaning, using non-abrasive methods and repairs will be completed as required. New aluminum windows will be installed on the upper floors.

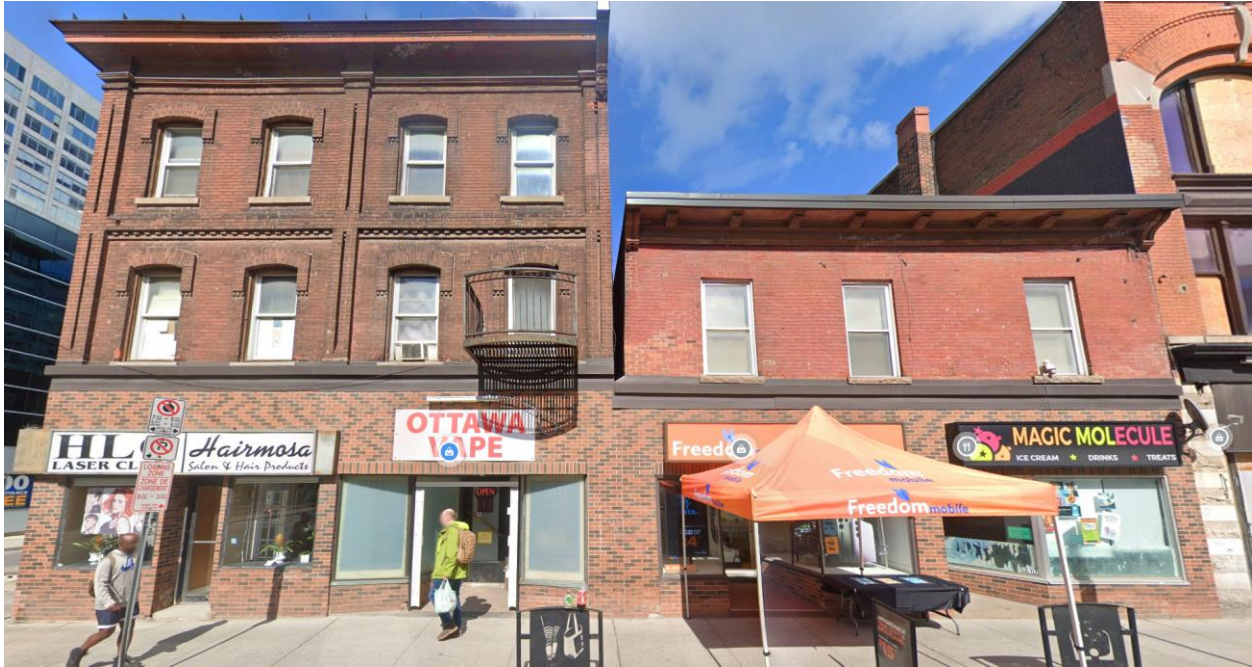
West façade (Bank Street) of 178 Nepean Street

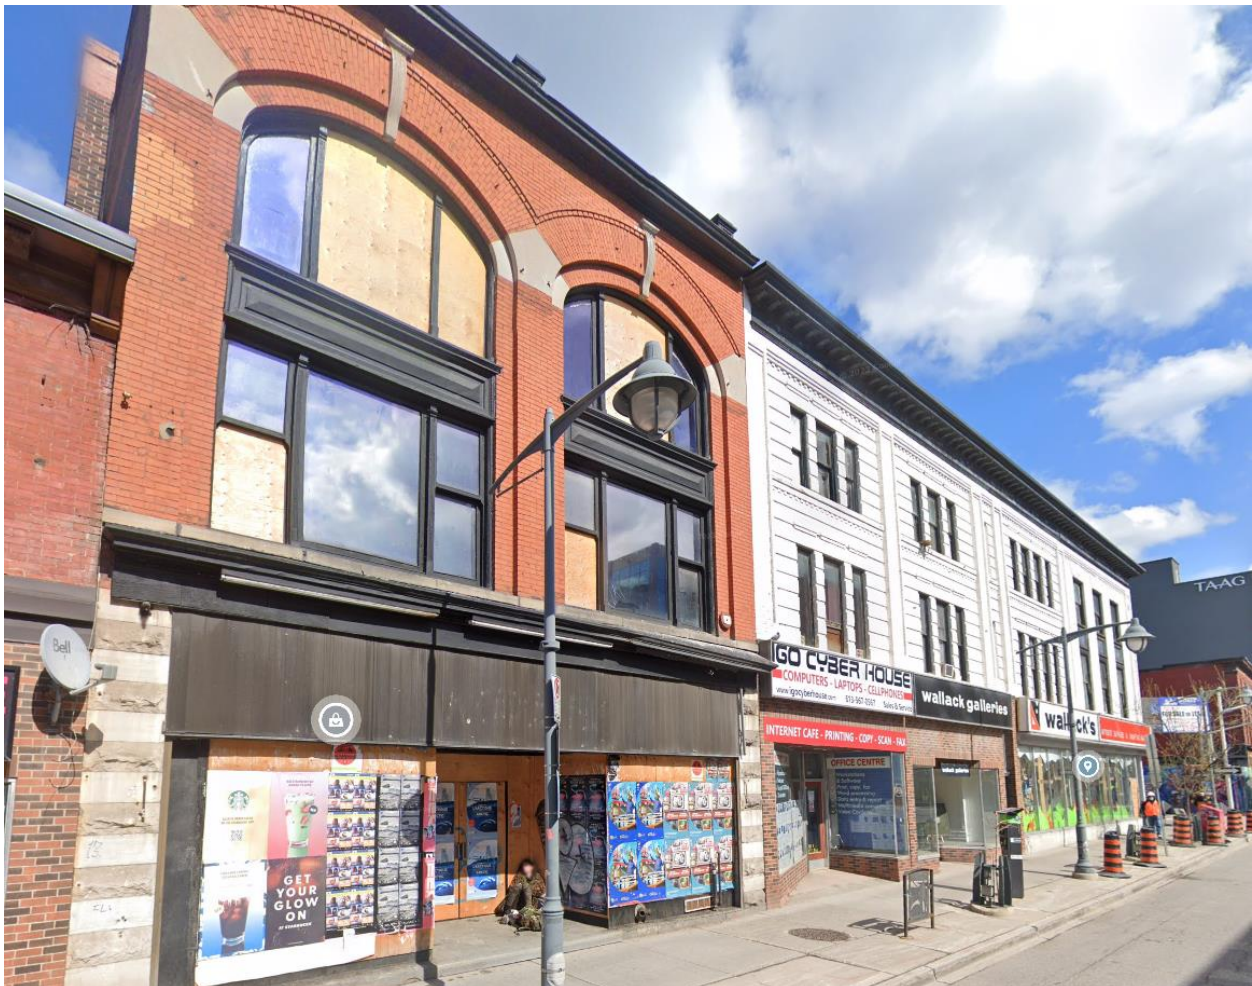
West façade (Bank Street) of 219-223 Bank Street

This building forms the centre part of the block and is the most elaborate in terms of its architectural expression. It is three storeys, with large two-storey round-arched windows, red brick, cornice and parapet baluster. The masonry on this building will be repaired as required, as well as the cornice. The baluster currently has missing sections, and this will be repaired and reinstated where needed. The large two-storey windows will be replaced with new windows that maintain the same size, divisions and metal spandrel panels. The ground floor restoration includes installing new glazed commercial windows, re-introducing the knee wall along the bottom and installation of an appropriately sized signboard.

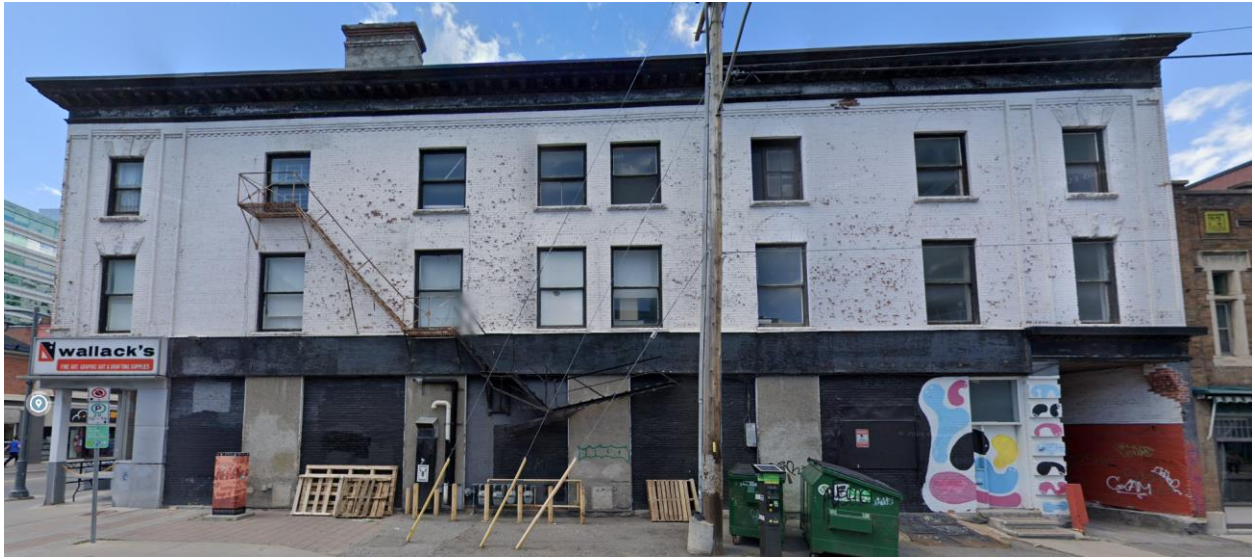
South façade of 223 Bank Street

This building is the largest on the block and is situated on the corner with frontage on both Bank and Lisgar Streets. The building is three storeys tall, with a large overhanging cornice, and brick cladding that has been painted white. The paint will be removed through a chemical wash which is a non-abrasive paint removal method. This will reveal the red brick below as well as the stone accents that have been obscured by paint for decades. The metal cornice will be repaired, and any masonry repairs required will be completed as needed. New sash windows will be installed on the upper floors. The metal fixtures on the Lisgar frontage will be removed, including the fire escape. On the ground floor, the unsympathetic alterations, including the variegated brick, infilled windows on Lisgar Street, and the oversized sign band will be removed. New brick will

be installed to match the existing, the boarded-up window openings will be revealed, and a new sign band will be applied above the ground floor.

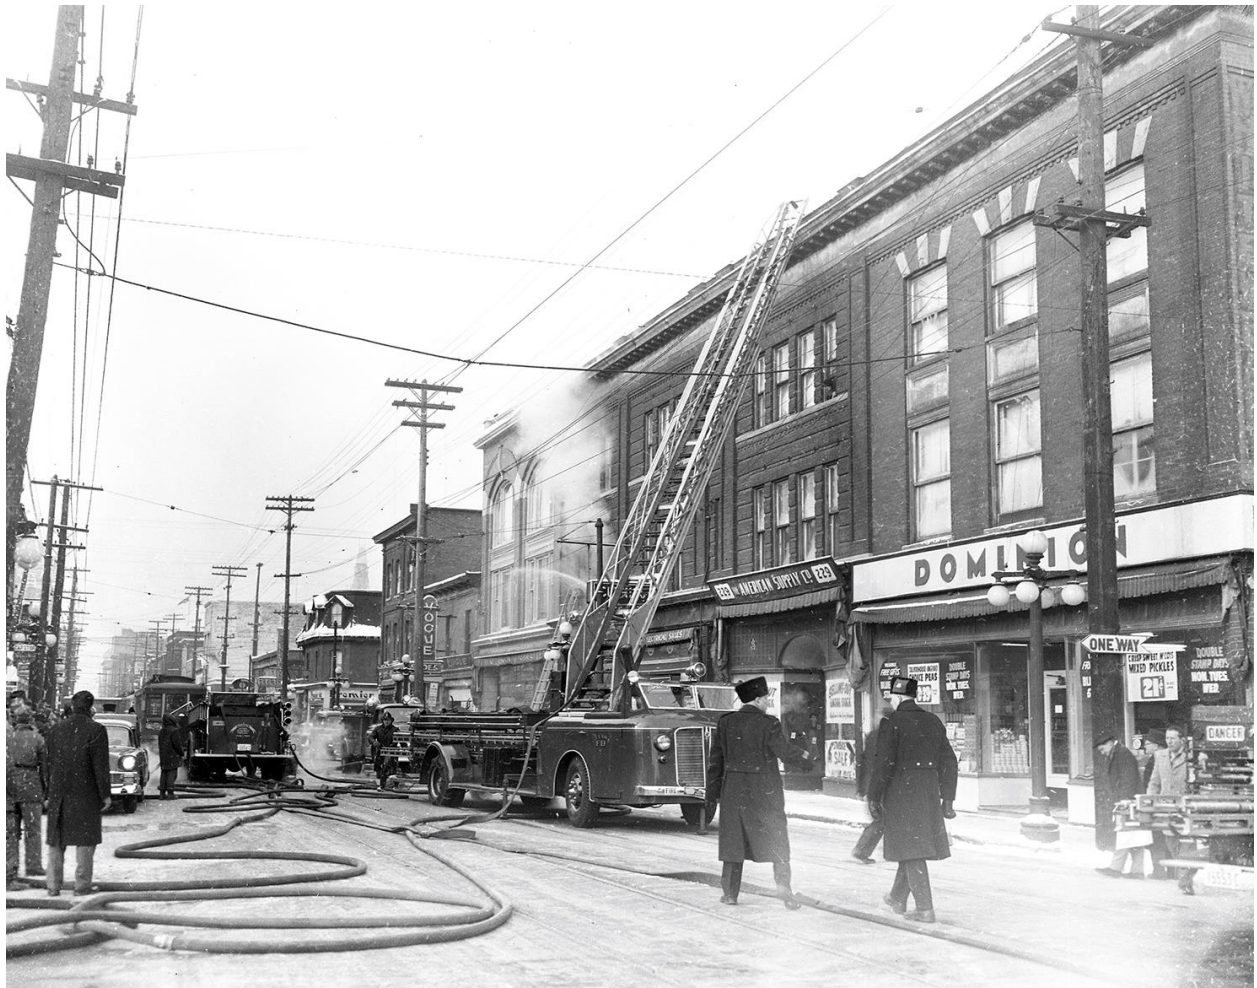
Fire on Bank Street between Lisgar and Nepean. Circa 1950. Credit: City of Ottawa Archives, MG 393-NP47801, CA042820

Through this project the façades on Bank, Nepean and Lisgar Streets will be rehabilitated and restored. One historic photo has been located, showing the block in approximately 1950 and has been attached as Document 3. Comparable examples of commercial storefronts from buildings elsewhere on Bank Street, Rideau Street and Sparks Street have also been used as reference to re-interpret window and door patterns.
