DESCHATELETS BUILDING RENOVATION
PROPOSED CECCE SCHOOL
APPLICATION FOR HERITAGE APPROVAL

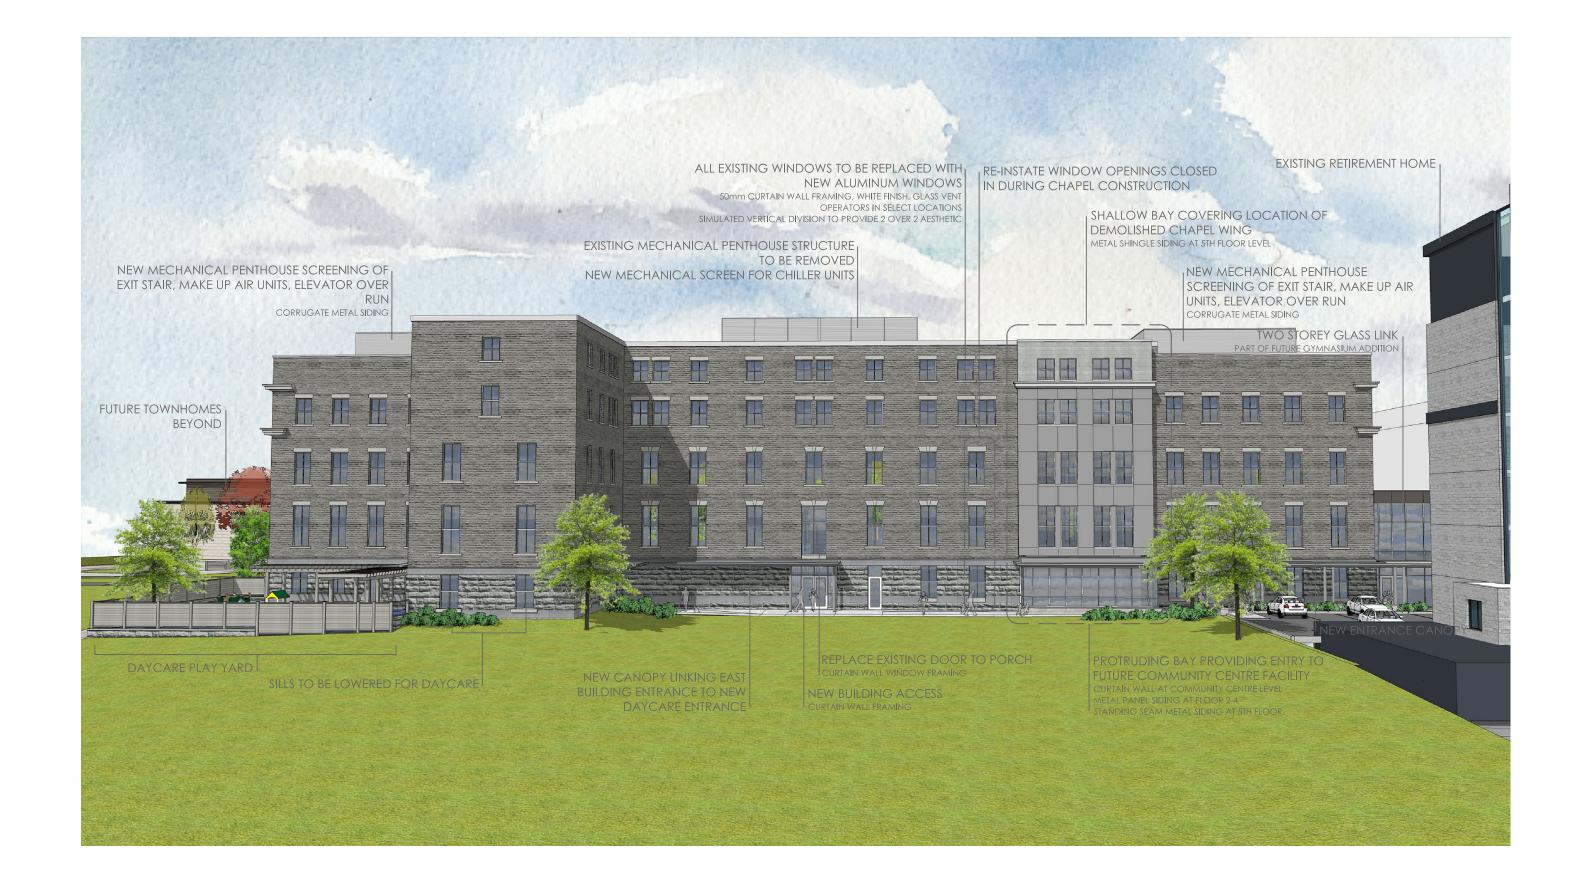
ALL EXISTING WINDOWS TO BE REPLACED WITH NEW ALUMINUM WINDOWS

50mm CURTAIN WALL FRAMING, WHITE FINISH, GLASS VENT
OPERATORS IN SELECT LOCATIONS
SIMULATED VERTICAL DIVISION TO PROVIDE 2 OVER 2 AESTHETIC

NEW MASONRY PIERS SUPPORTING EXISTING ENTRANCE PEDIMENT

NEW CURTAIN WALL ENTRANCE FRAMING AND ALUMINUM DOORS

NEW ENTRANCE CANOPY

NEW GUARD RAILS AT DEPRESSED ENTRANCE RAMPS

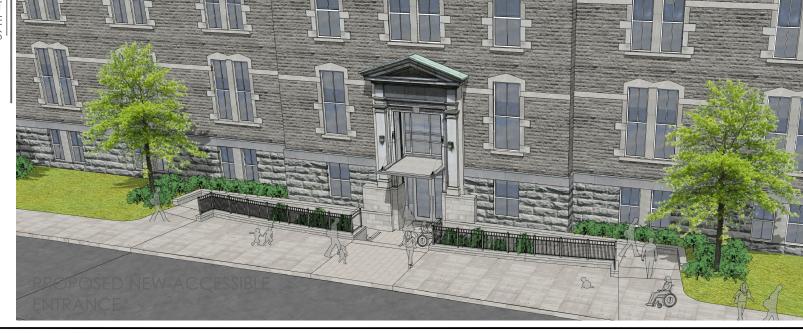
NEW ENTRY DOOR FOR RESIDENTIAL USE

ALL EXISTING WINDOWS TO BE REPLACED WITH NEW ALUMINUM WINDOWS

50mm Curtain Wall Framing, white finish, glass vent Operators in select locations Simulated vertical division to provide 2 over 2 aesthetic

> SHALLOW BAY COVERING LOCATION OF DEMOLISHED CHAPEL WING METAL SHINGLE SIDING AT 5TH FLOOR LEVEL

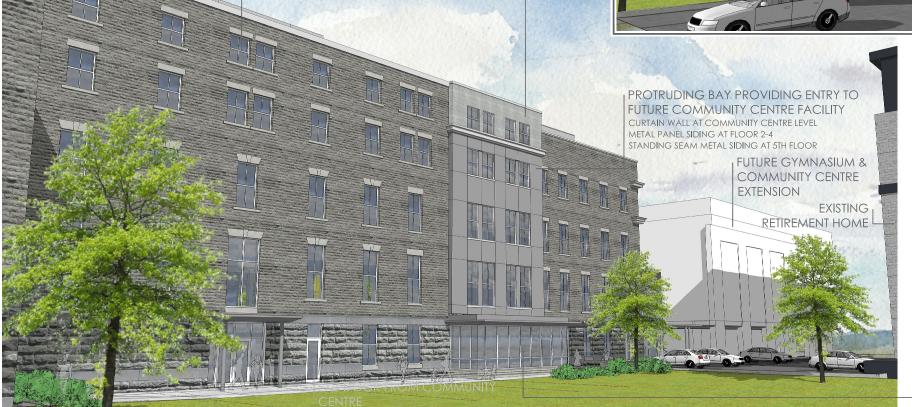
PROTRUDING BAY PROVIDING ENTRY TO FUTURE COMMUNITY CENTRE FACILITY CURTAIN WALL AT COMMUNITY CENTRE LEVEL METAL PANEL SIDING AT FLOOR 2-4

STANDING SEAM METAL SIDING AT 5TH FLOOR

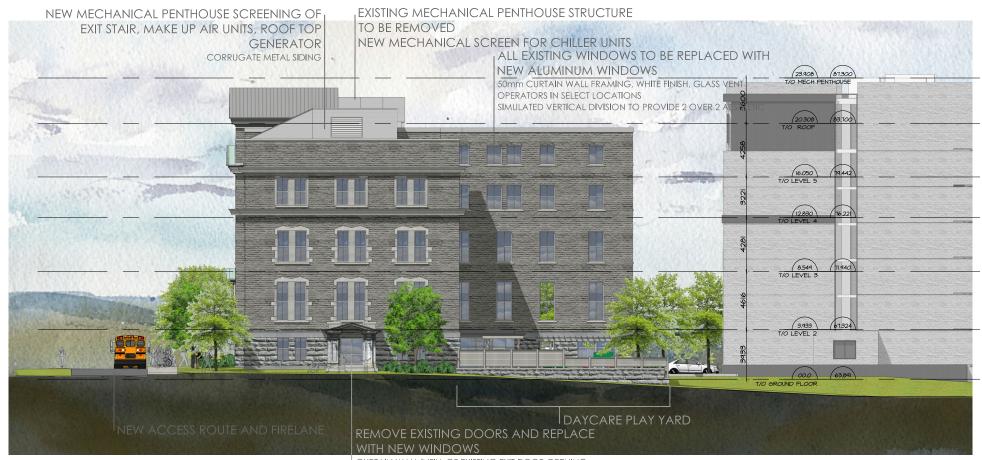
CURTAIN WALL INFILL OF EXISTING EXIT DOOR OPENING
