1. APPLICATION TO ALTER THE SOMERSET HOUSE, 352 SOMERSET STREET WEST, A PROPERTY DESIGNATED UNDER PART V OF THE *ONTARIO HERITAGE ACT* AND LOCATED IN THE CENTRETOWN HERITAGE CONSERVATION DISTRICT

1. Manager's report, Right of Way, Heritage and Urban Design Services, Planning, Infrastructure and Economic Development Department dated 28 March 2017 (ACS2017-PIE-RHU-0003)

SUBJECT: Application to Alter the Somerset House, 352 Somerset Street West, a property designated under Part V of the *Ontario Heritage Act* and located in the Centretown Heritage Conservation District

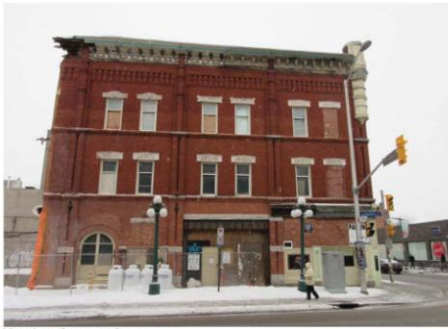
View from Somerset Street

The Somerset House is a good example of an early 20th century commercial structure. It was constructed in two phases with the three storey, westerly portion of the building built from 1900-02 and a four storey addition added in 1912. Constructed as a hotel, the building had storefronts with large plate glass windows that predominantly faced Bank Street, with the residential portions of the building on the upper floors. (See current photographs, Document 2, and historic photograph, Document 3).

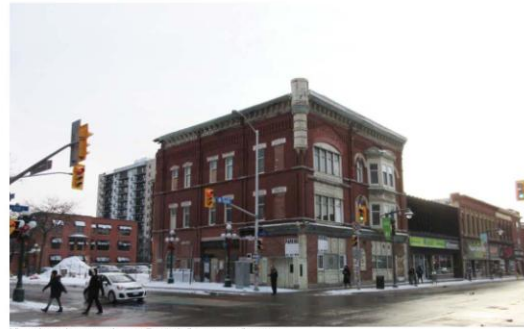
View from intersection at Bank & Somerset Streets

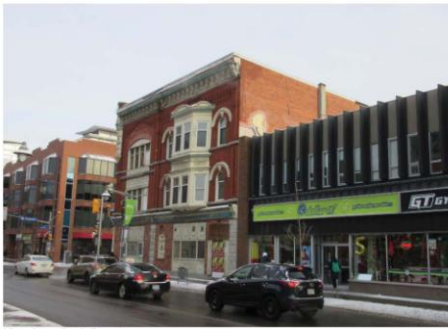
View from Bank Street

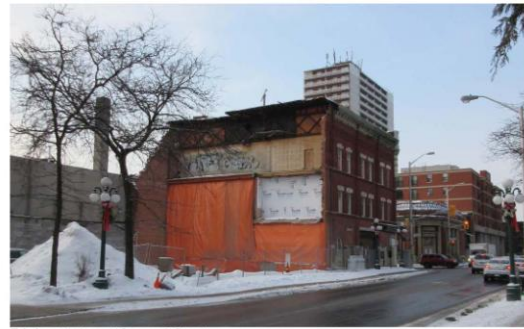
Existing structure at Somerset Street

The building was braced, stabilized and surrounded by a hoarding until the summer of 2016, when its physical condition had deteriorated to the point that the removal of the three most easterly bays of the north wall, and the potential removal of the fourth bay of the north wall was determined to be necessary for health and safety reasons. An application under the *Ontario Heritage Act* to allow the partial demolition was submitted in June 2016 and after consideration by the Built Heritage Sub-Committee (BHSC), Planning Committee and City Council, a heritage permit was issued to allow the partial demolition.

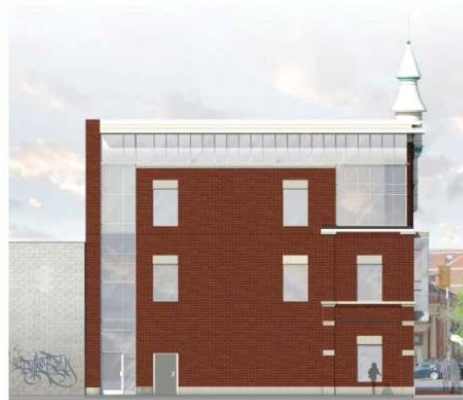
East Elevation

The east (rear) façade of the building will be of similar brick, with simple rectangular window openings, and a glass band to the south. The secondary cornices will wrap around the corner. The south façade will be a plain, undecorated brick wall. (See Renderings, Document 4, and Elevations, Document 5).

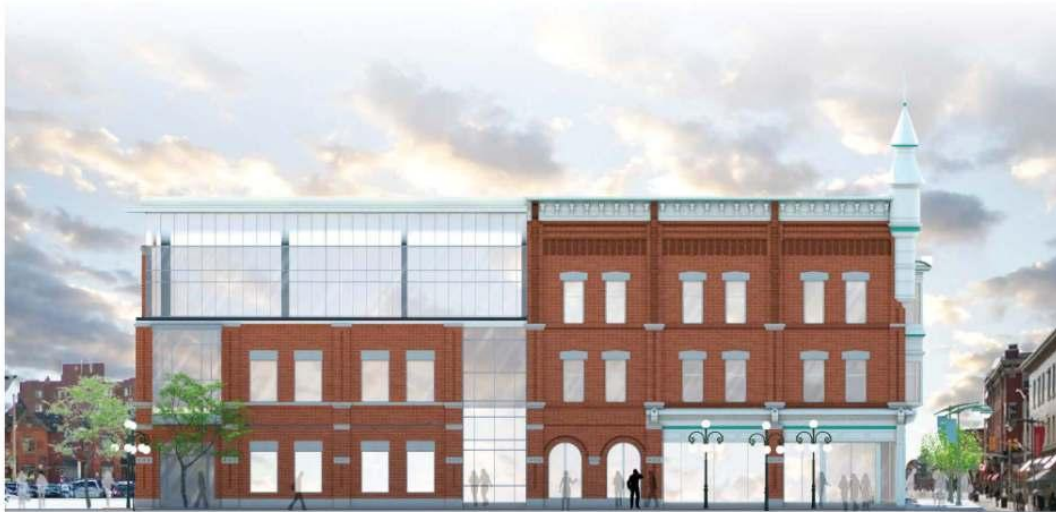
Somerset House - North Elevation View - Option 2
Somerset Street and Bank Street | 2017-03-28 | 16-1432

This “Application to Alter” the Somerset House is to construct a flat-roofed addition to the rear of the Somerset House. The proposed addition will be three storeys in height, matching the height of the existing Somerset House. A secondary cornice, at the same height as the brick stringcourse below the third floor windows, will roughly divide the

north wall into thirds, with the top third being a glass curtain wall, with glazed spandrel panels above, designed to evoke the existing historic roof cornice. The bottom two thirds of this wall will be a mixture of brick and glass, with a stylized, contemporary projecting bay window to echo the bay windows on the front façade. A three storey band of glazing will separate the original north wall of the Somerset House. The remaining section of the north wall will be a two storey brick wall that will feature the main entrance to offices above. It has been designed to evoke the character of the former north wall in this location, and will articulate up the long north façade of the building.

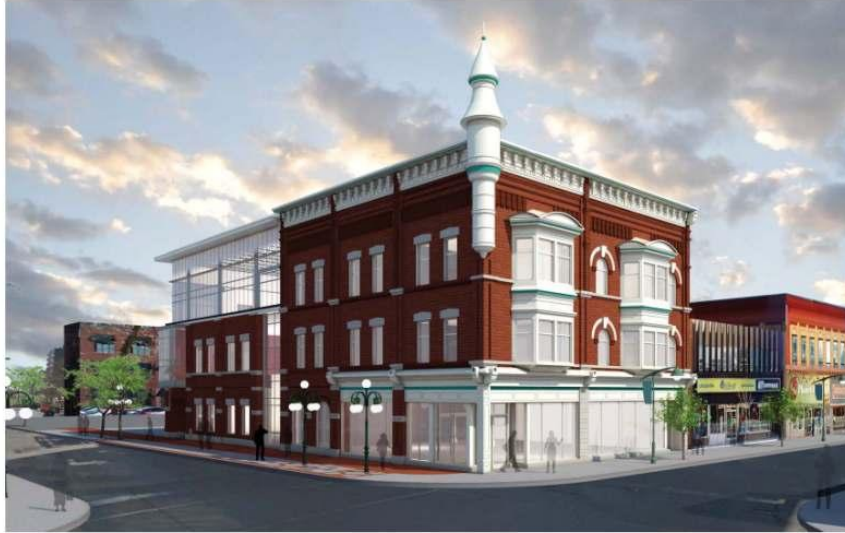
Somerset House - Perspective 01 - Option 2
Somerset Street and Bank Street | 2017-04-05 | 16-1432

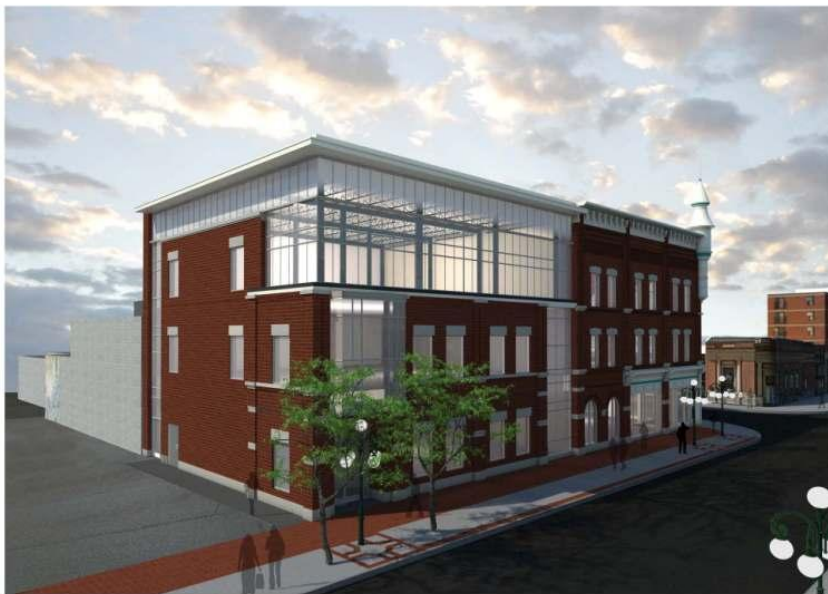
Somerset House - Perspective 02 - Option 2
Somerset Street and Bank Street | 2017-03-31 | 16-1432
