DILLON
CONSULTING

May 2019

CITY OF OTTAWA

Long-Term Strategy Review and Decommissioning Impact Study Porters Island Pedestrian Bridge (SN013260)

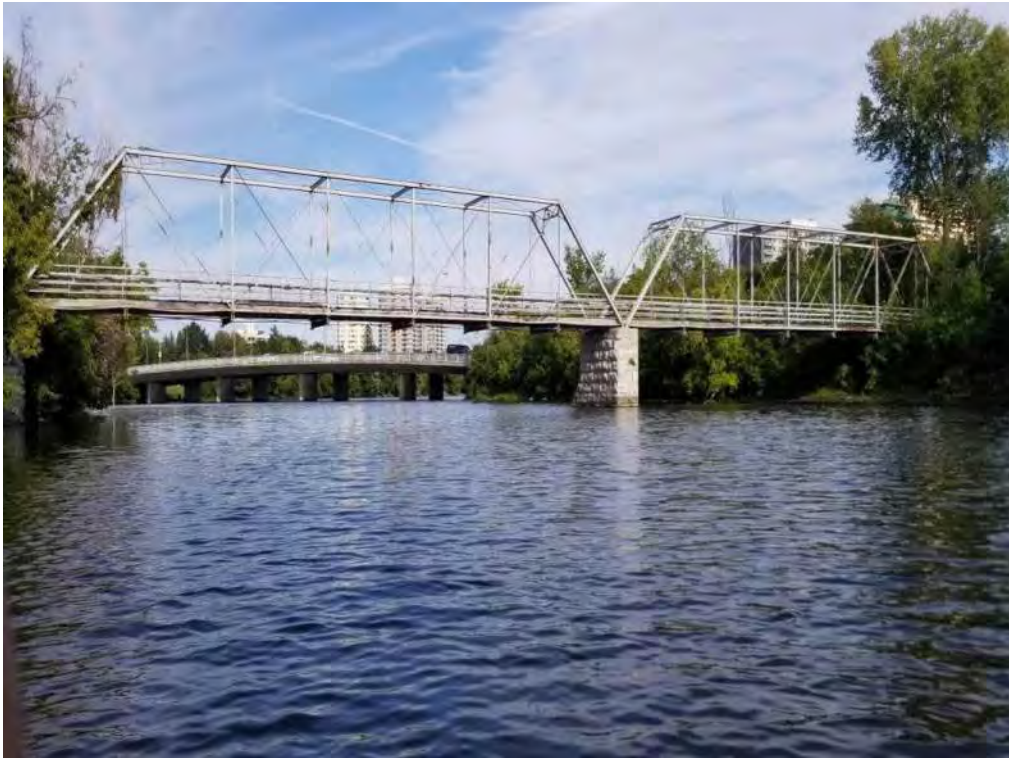
Photograph 1: West Elevation

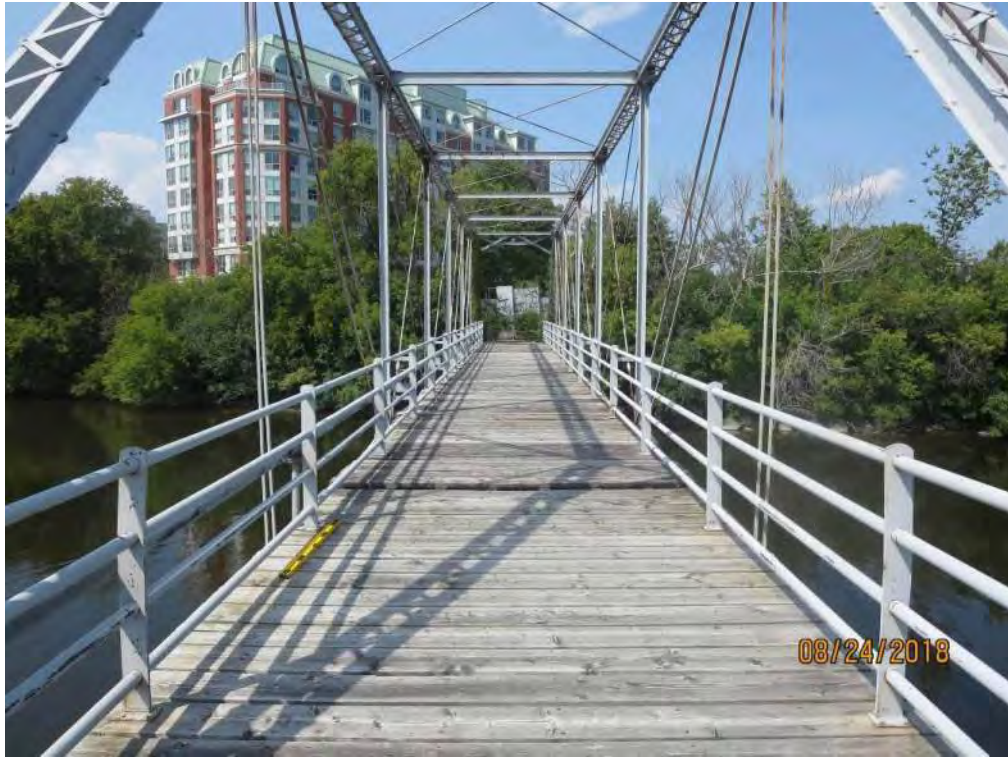
Photograph 3: Cross section of structure looking north at the pier.

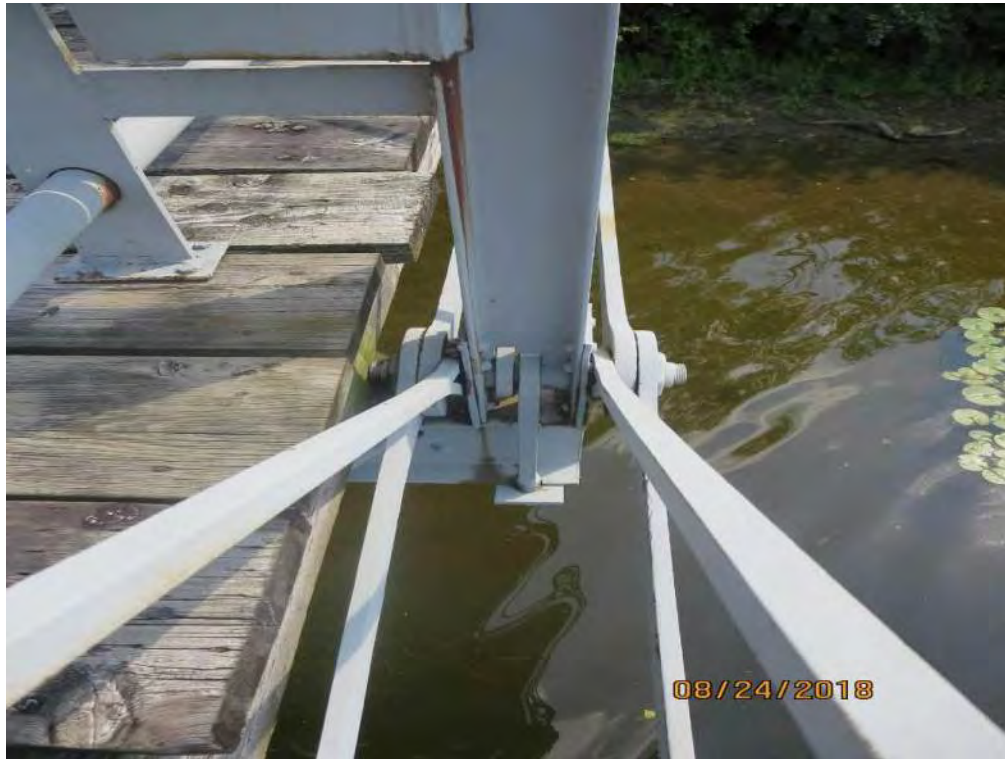
Photograph 15: Typical interior panel pin and hanger connection.

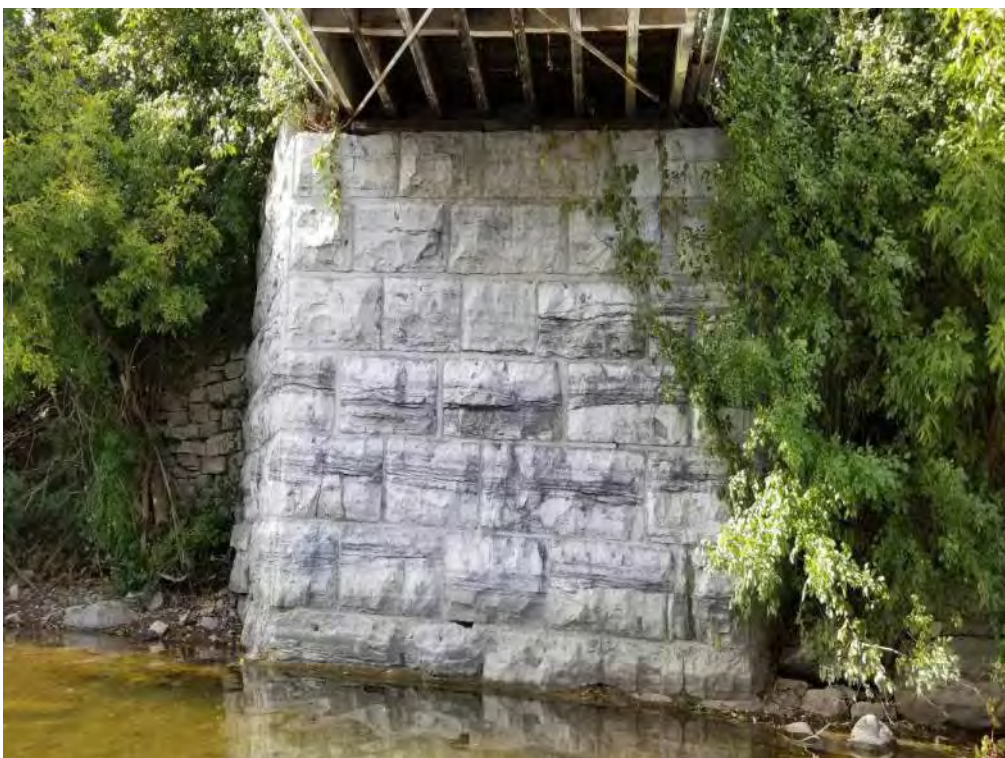
Photograph 42: North Abutment.

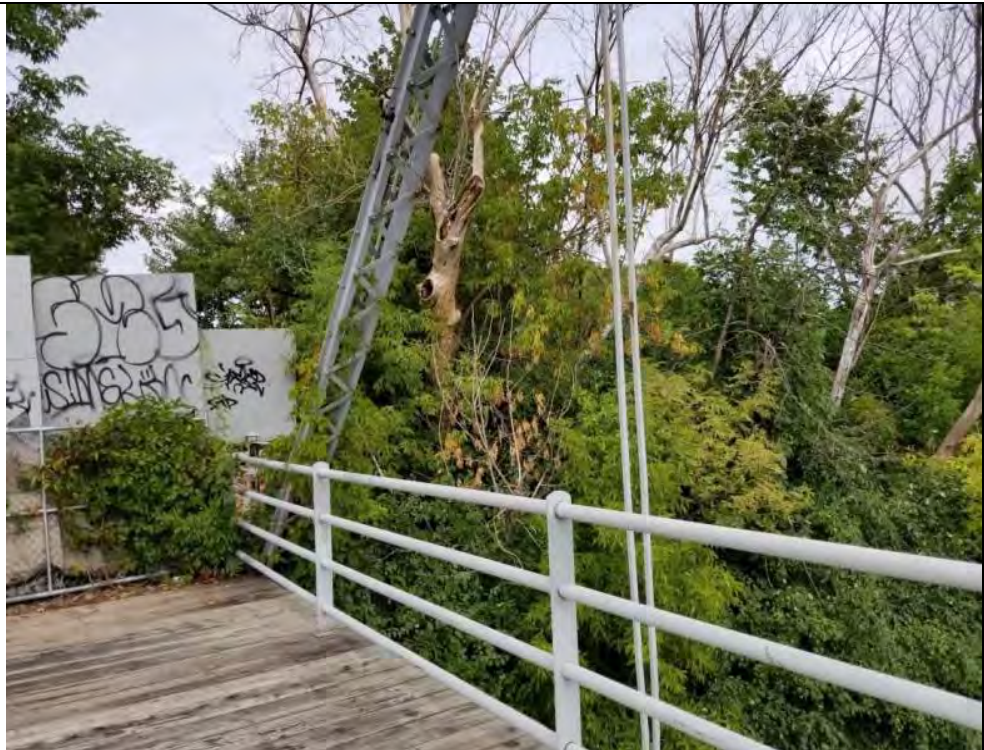
Photo 15:

Canopy and cavity trees observed in treed fencerow of south-east shoreline of Porters Island, north-east of closed pedestrian bridge.

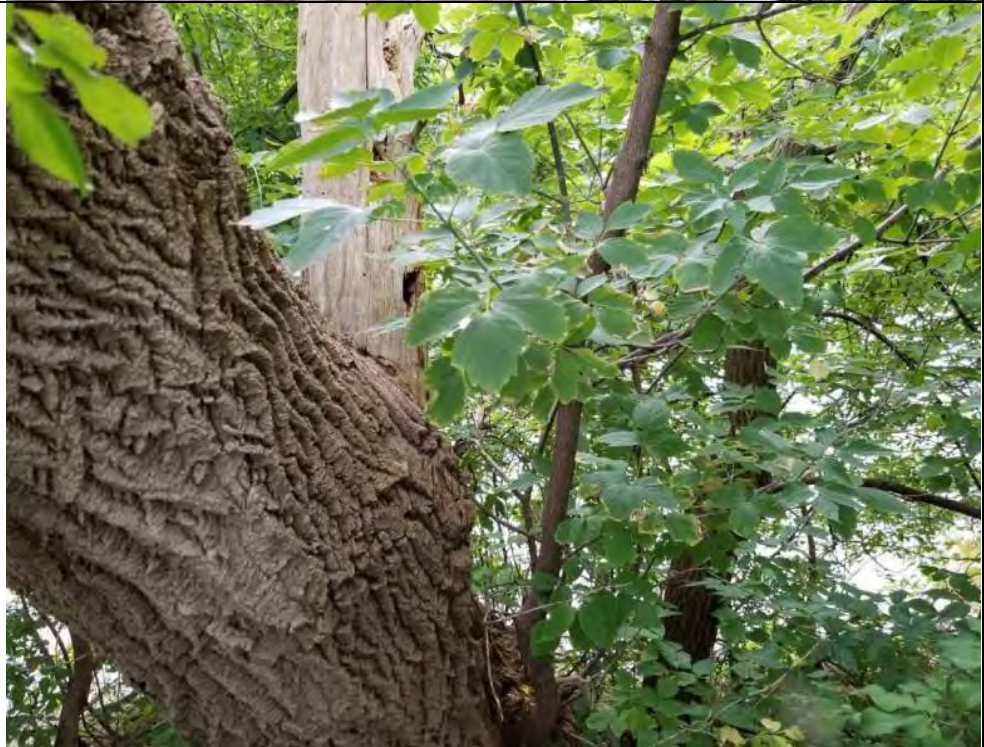
Photo 15:

Understory vegetation and cavity trees observed in treed fencerow north-east of closed pedestrian bridge.
